# Design Manual for Roads and Bridges

Highway Structures & Bridges  
Inspection & Assessment

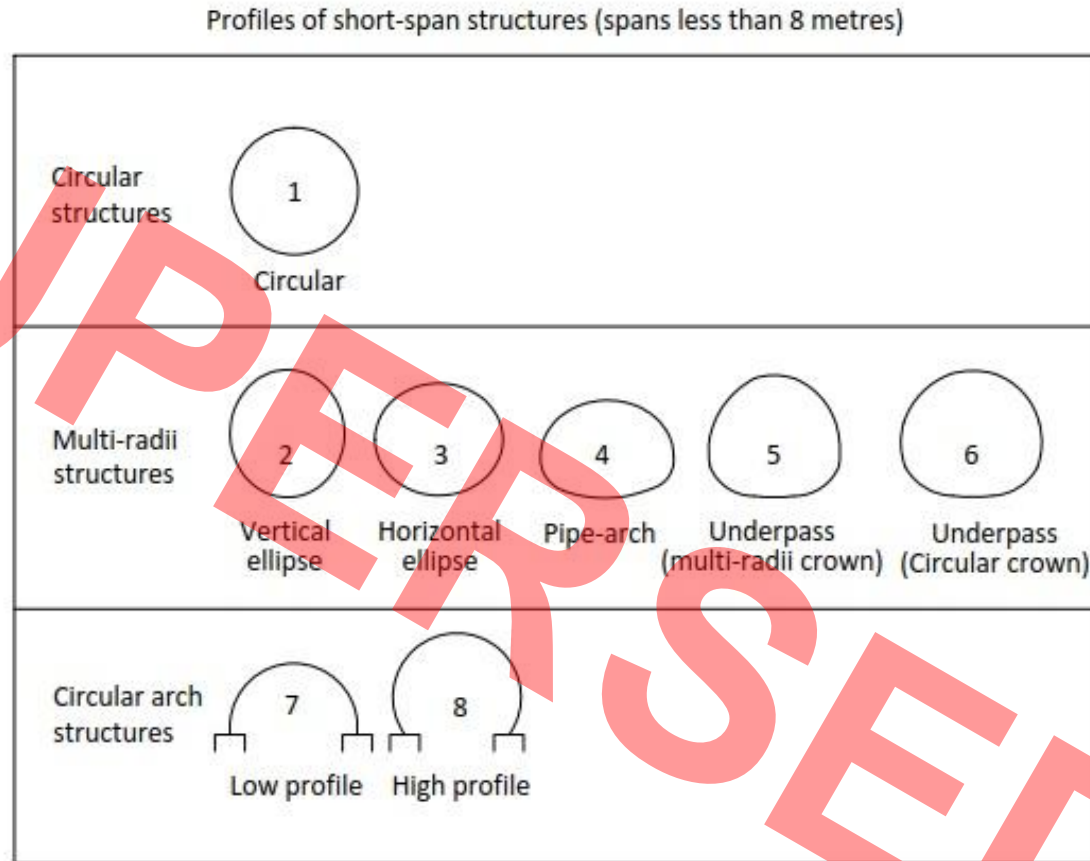
Profiles of larger structures incorporating thrust beams

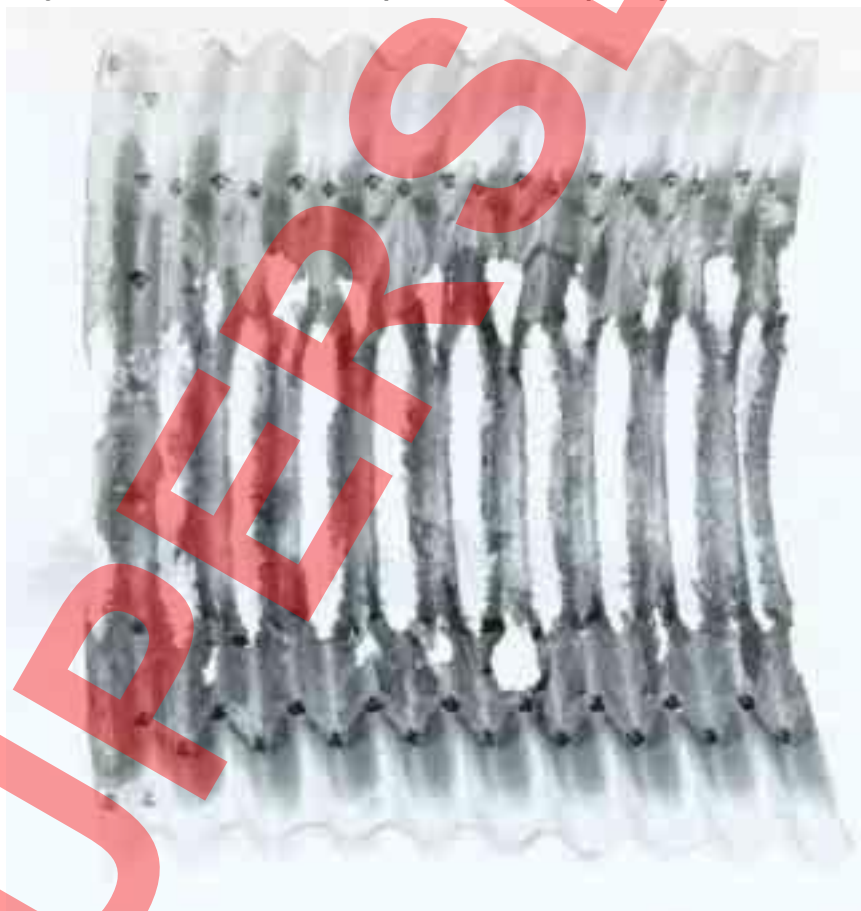
For CSBS subject to scour, invert pavings should be maintained as required and should have a sufficient extent to contain the stream during peak flow conditions.

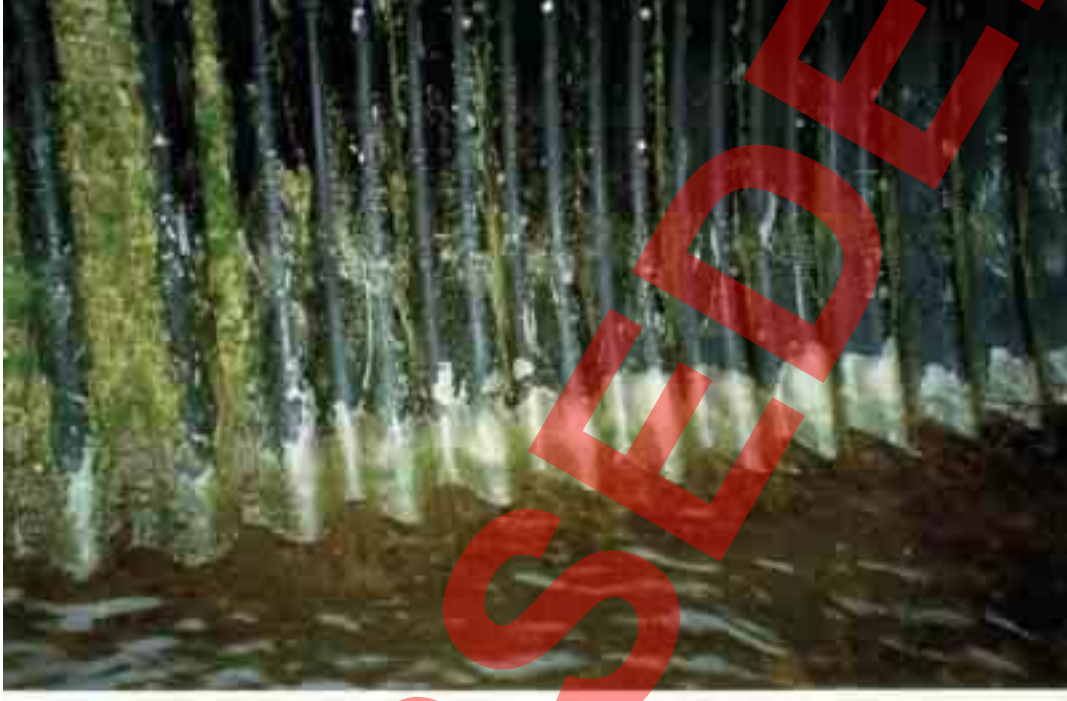
**Figure B.3 Damaged bitumen coating caused by overtopping of paving during turbulent flow**

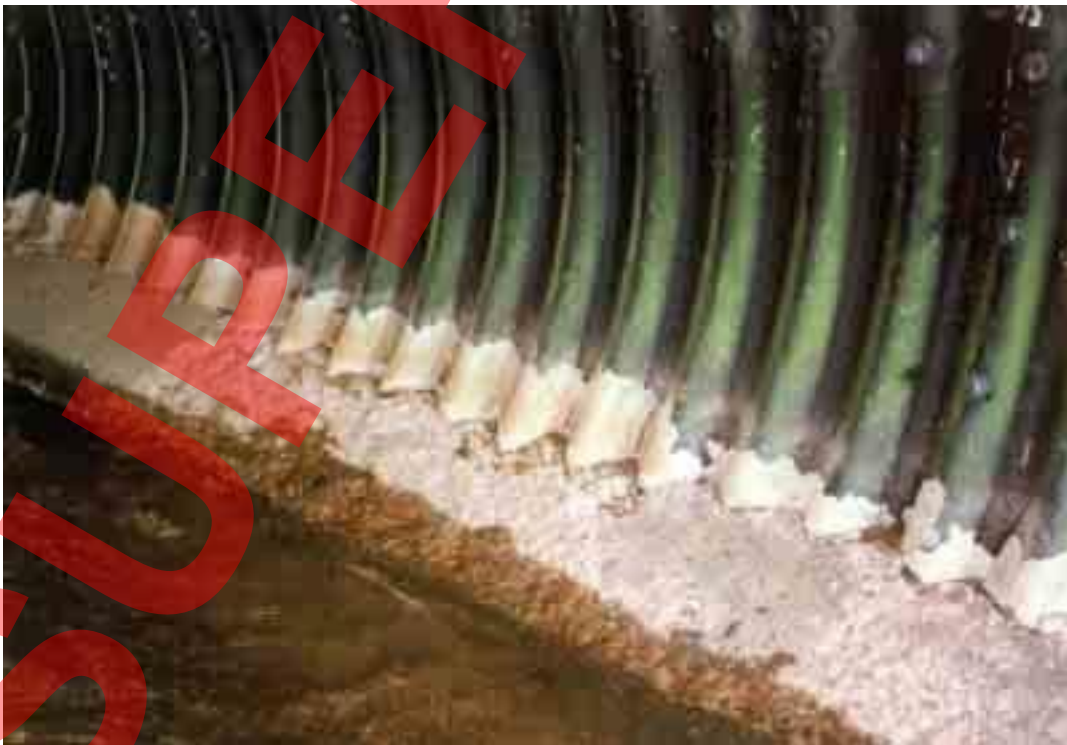
Figure B4 shows, the details of raising the sides of paving within a pipe arch structure that was constructed with a flat reinforced concrete paving.

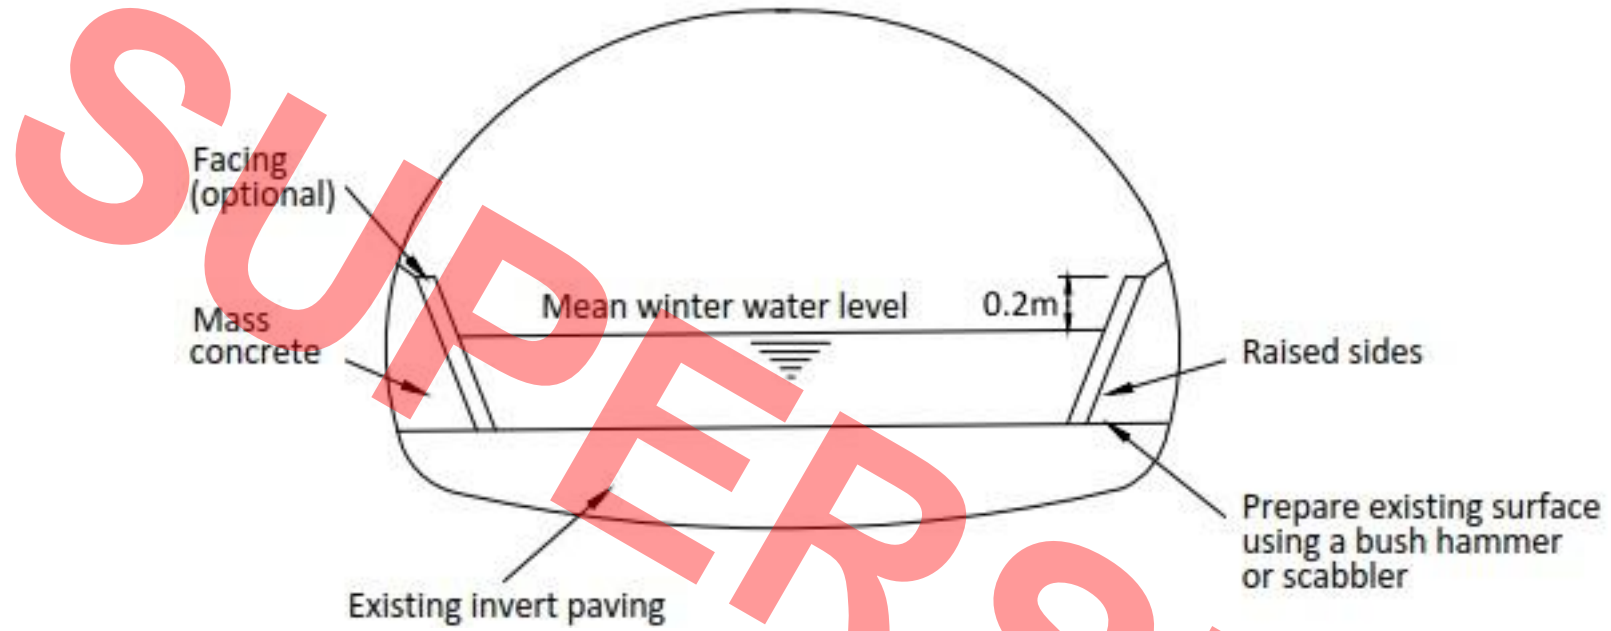
### B3 Deterioration of bitumen paving

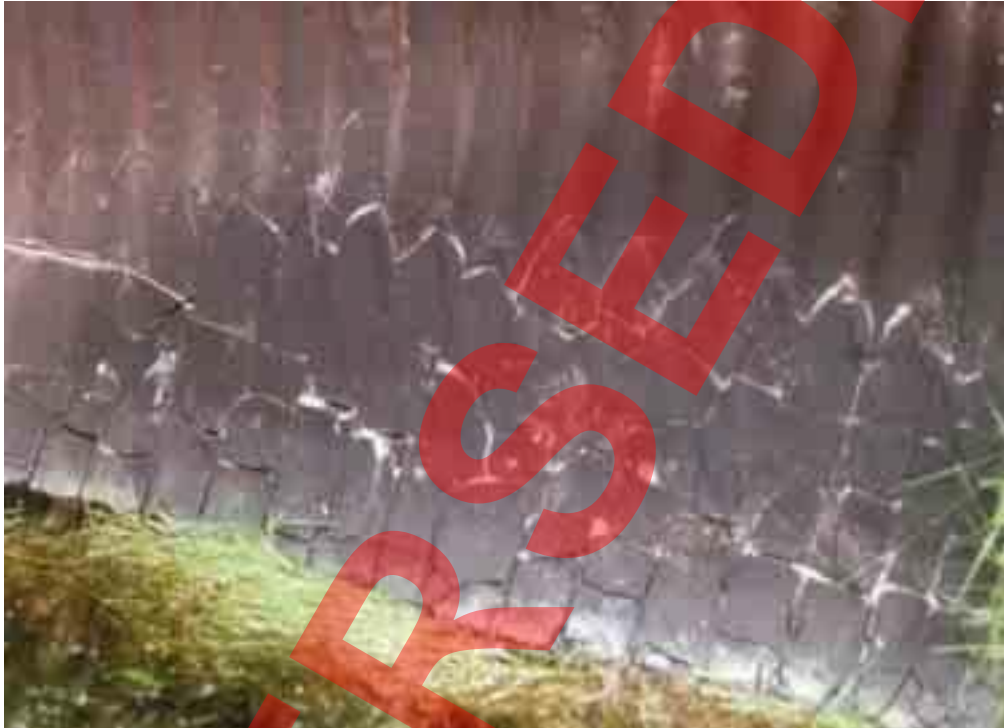
Where the steel in the invert has deteriorated substantially the use of a structural reinforced concrete paving should be considered rather than the replacement of the structure.

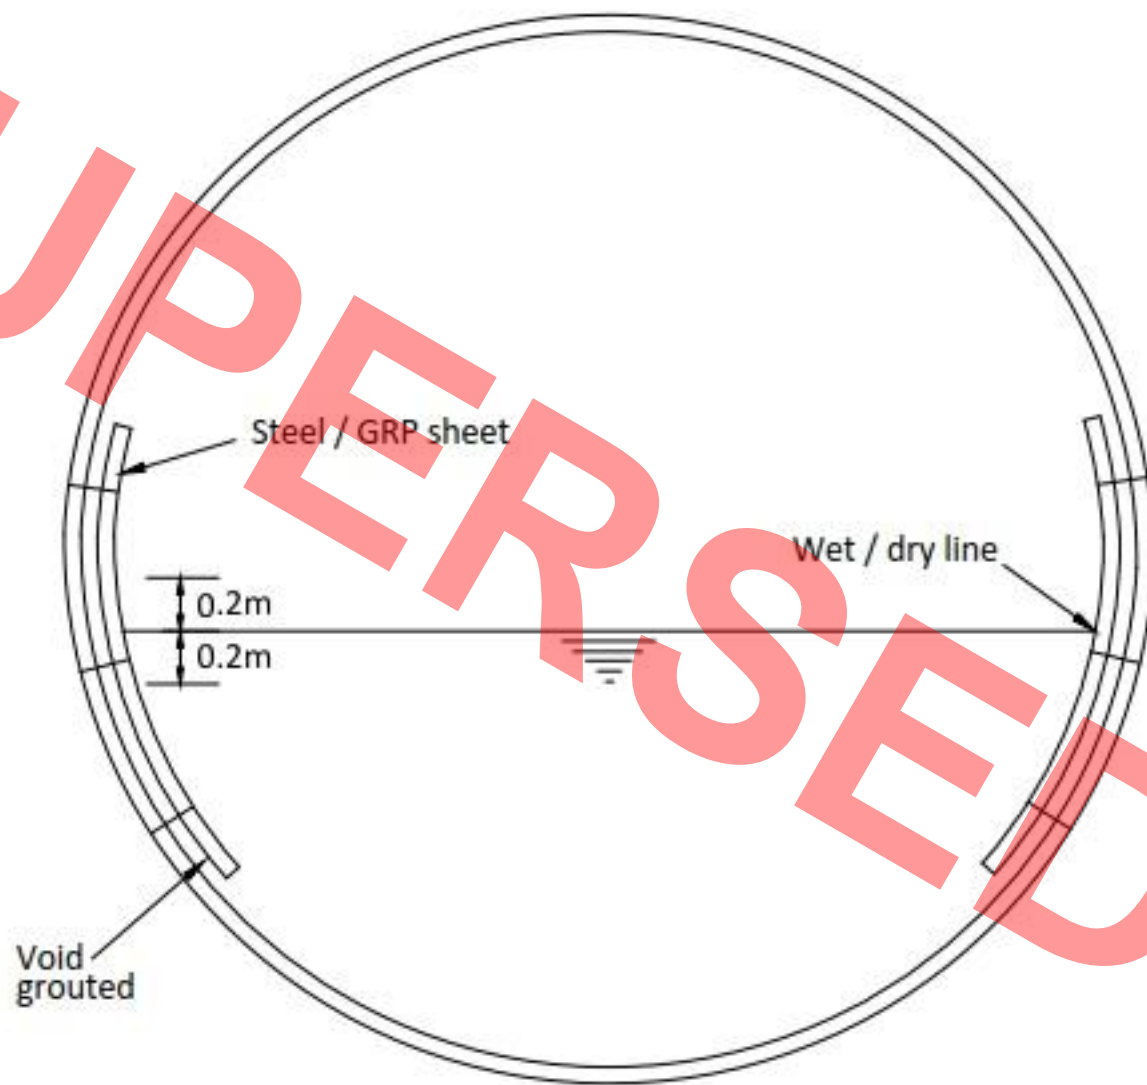
Coatings that are reapplied to the wet/dry zone are likely to be quickly removed and again expose the underlying zinc coating and steel to the environment. The placement of a paving to contain the flow would protect the wet/dry zone, but there are a number of cheaper options. For example, the use of pre-coated galvanised steel or glass-reinforced plastic (GRP) sheets as shown in Figure B7. This can be done in the following manner:

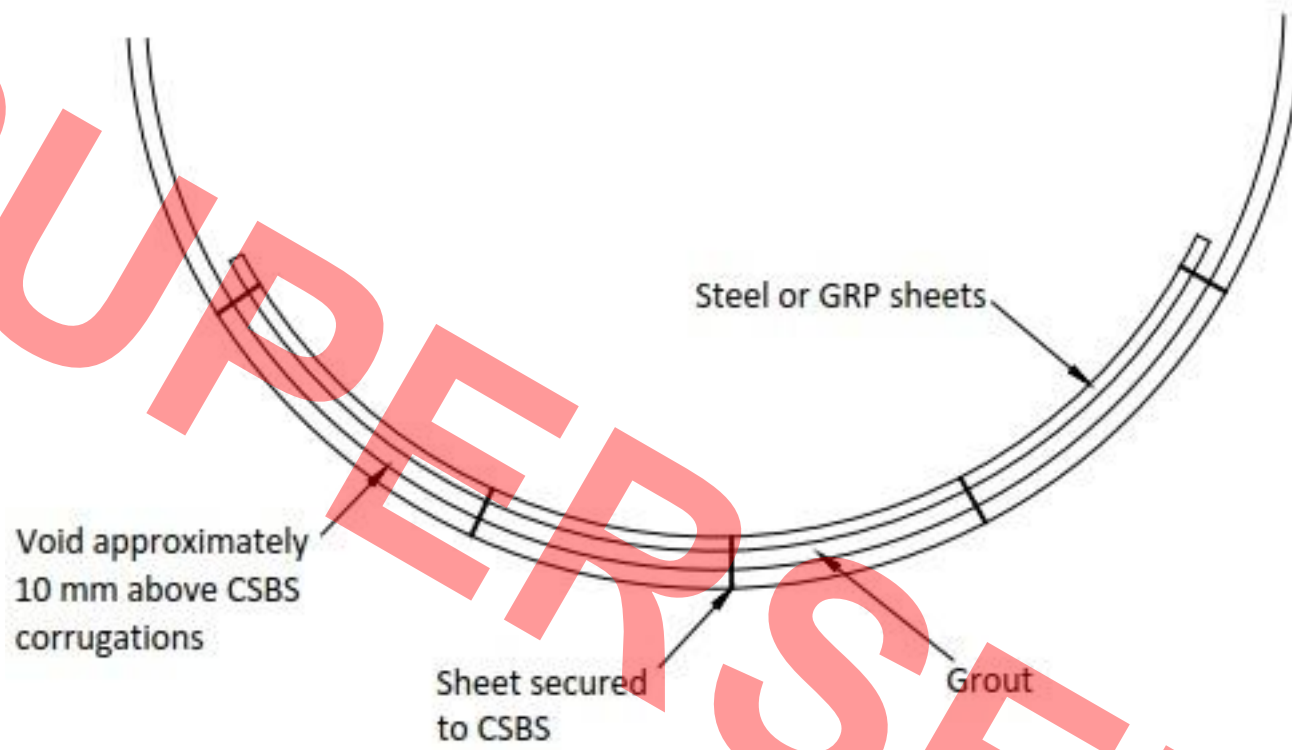
## B5 Deterioration due to seepage

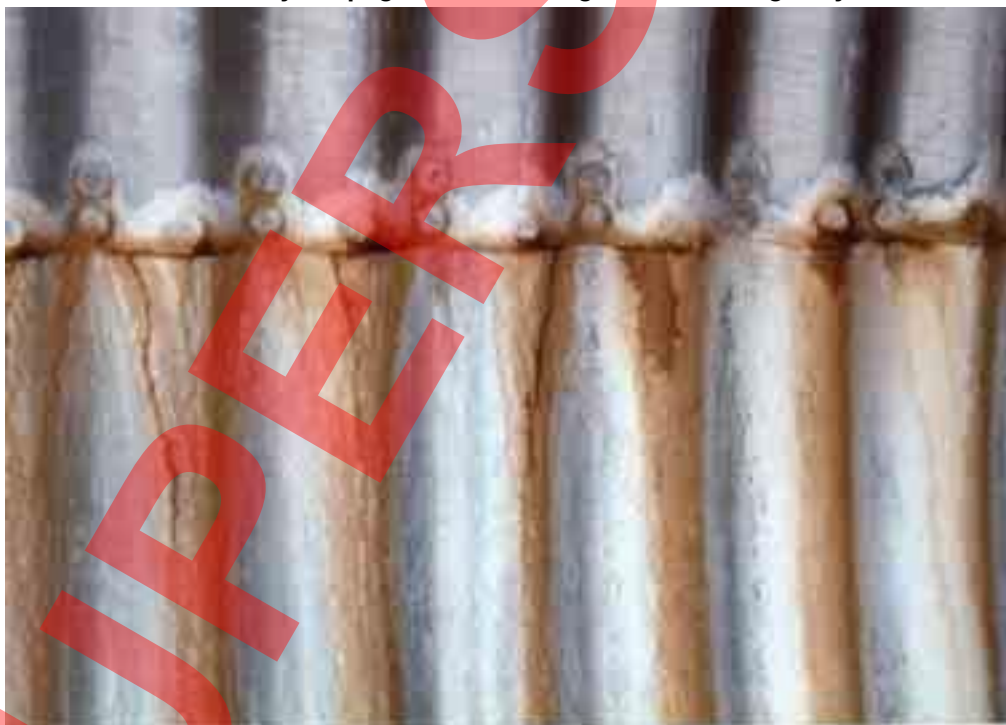
Figure B9 shows the deterioration in a 25-year-old plain galvanised arch structure. Water laden with deicing salts has percolated into the structure below the edges of the carriageway. Corrosion is most noticeable around bolt holes and plate edges in the crown and also where it has ponded in the seating channel of the arch. The rest of the structure is in good condition.

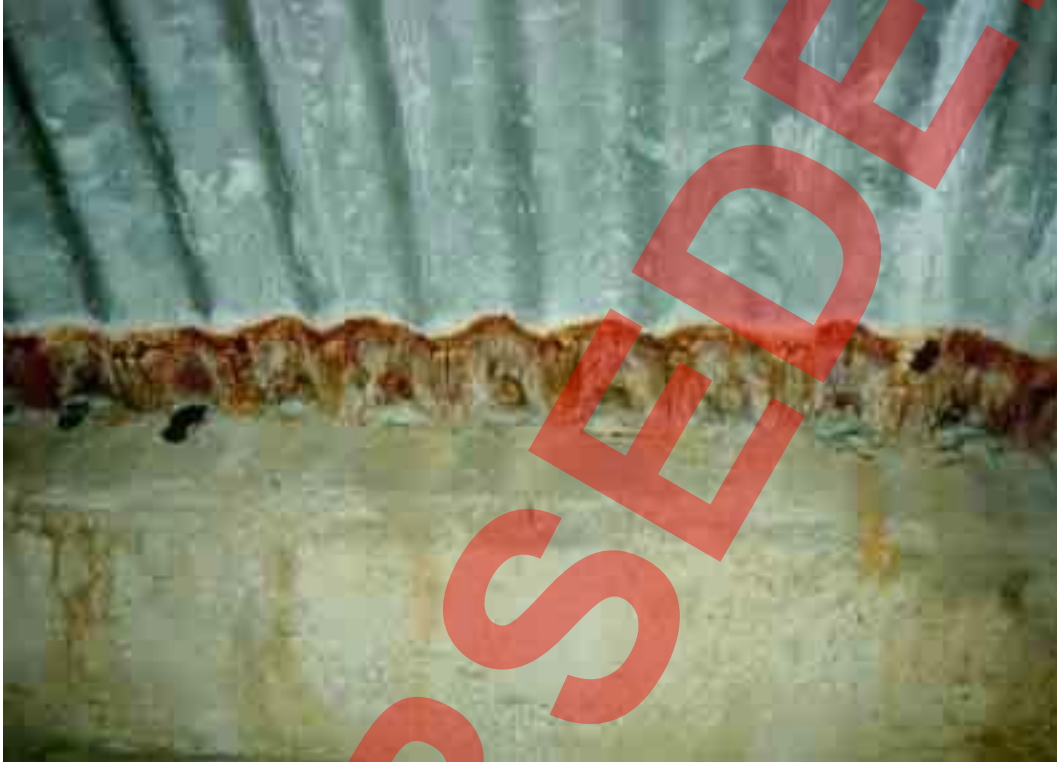
The maintenance to the structures with deterioration caused by seepage and ponding water could be carried out as follows:

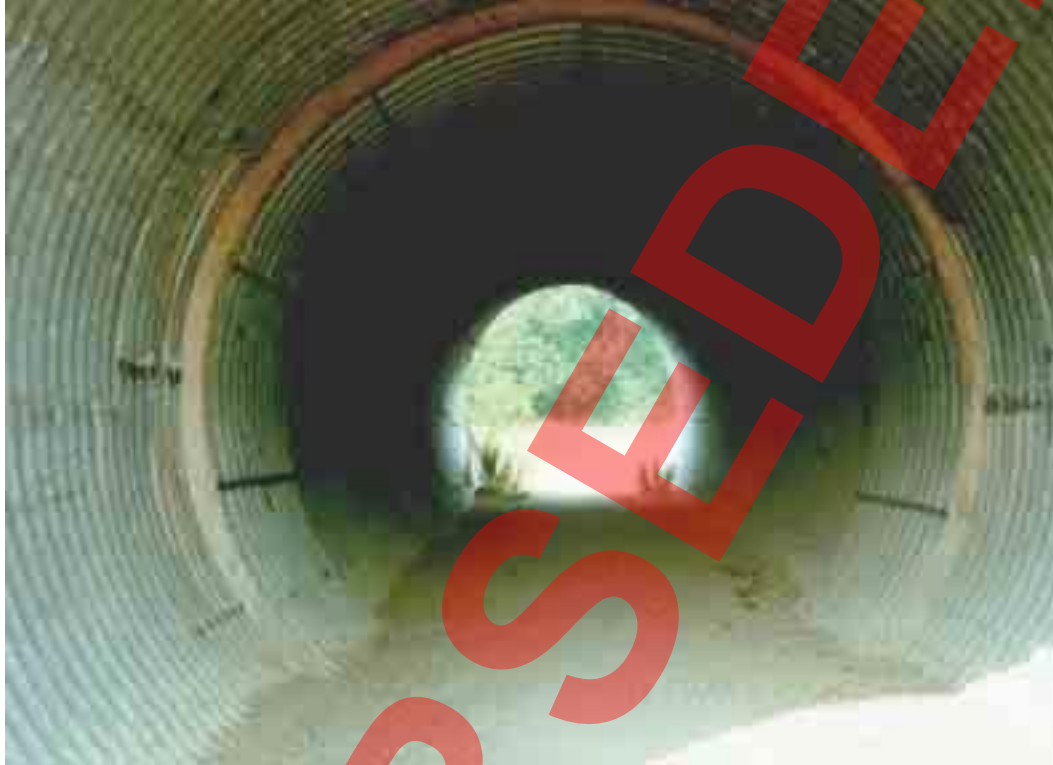
## **B6 Structural instability of the invert**

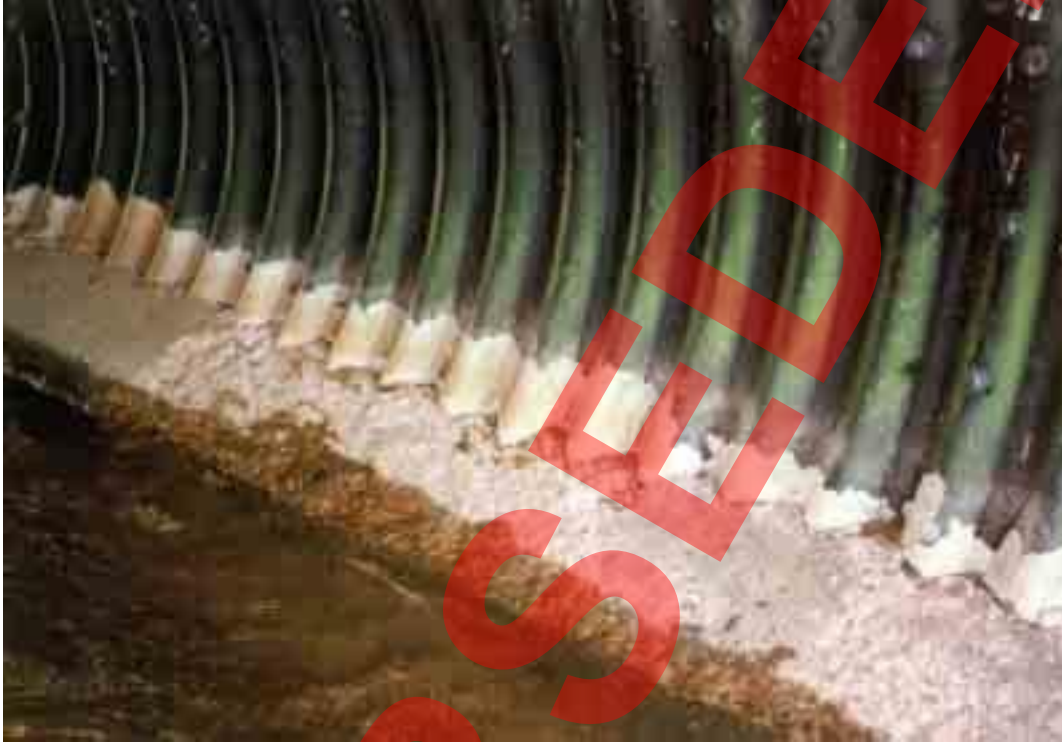
**Figure B.11 Damaged bitumen coating caused by overtopping of paving during turbulent flow**
