Design Manual for Roads and Bridges

CS 460

Management of Corrugated Steel Buried Structures

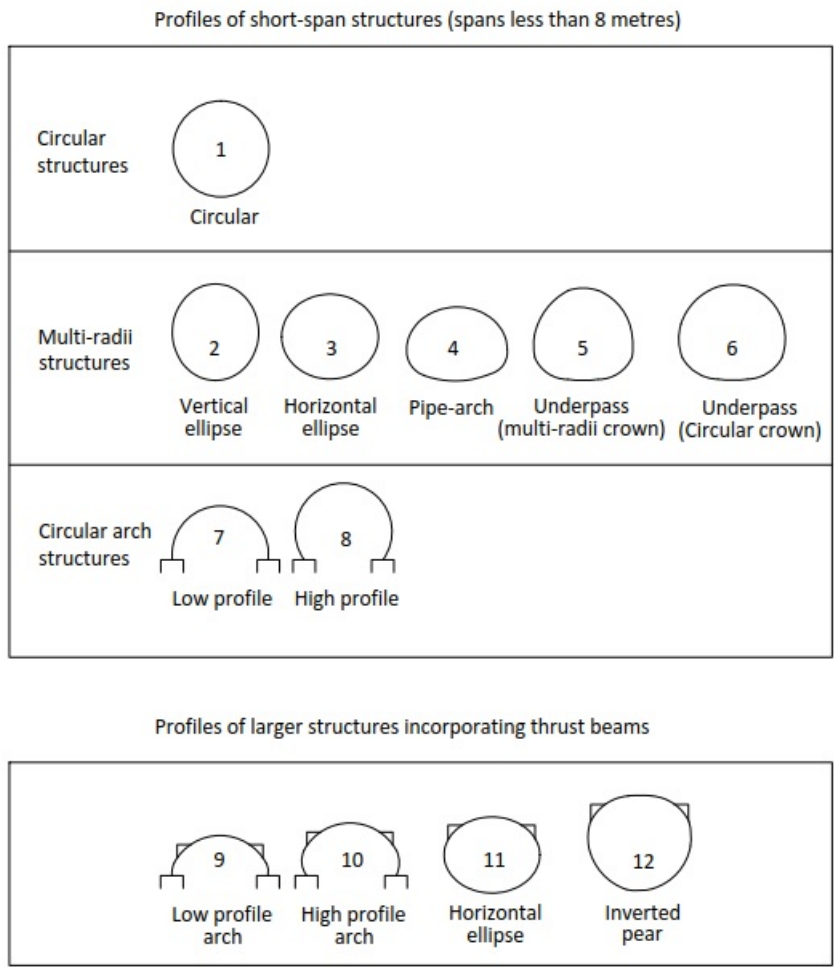
Figure A.1 Typical profiles of CSBS commonly installed in the UK

Corrugation size mm (Imperial units)	Approximate range of spans metres (Imperial units)	Thickness range of steel plate mm (Gauge size)	Shape (see Figure A1)
Riveted - prefabricated 20ft (6.0m) standard lengths			
68 x 13* (2 2/3" x 2")	0.9 - 1.8 (36" - 72")	1.5, 1.9, 2.7, 3.4, 4.2 (16, 14, 12, 10, 8 gauge)	1 & 4
Spirally corrugated lock seam - normally supplied in 6.0m lengths			
68 x 13	0.9 - 1.2	1.5, 2.0, 2.5, 3.0, 3.5	1
100 x 20	0.9 - 3.0	1.5, 2.0, 2.5, 3.0, 3.5	1
125 x 25	1.2 - 3.6	1.5, 2.0, 2.5, 3.0, 3.5	1
Bolted			
68 x 13	0.9 - 2.0	1.5, 2.0, 2.7, 3.5	1 & 4
100 x 20	0.9 - 3.0	1.5, 2.0, 2.5, 3.0, 3.5	1 & 4
100 x 22	0.9 - 3.6	1.5, 2.0, 2.5, 3.0, 3.5	1 & 4
152 x 32	1.2 - 3.5	2.0, 3.0, 4.0	1 & 4
152 x 51* (6" x 2")	1.5 - 7.0 (5' - 24')	2.7, 3.5, 4.2, 4.7, 5.5, 6.2, 7.0, (12, 10, 8, 7, 5, 3, 1 gauge)	1 - 7, 9 - 12
200 x 55	3.5 - 12.0	2.75, 3.25, 4.0, 4.75, 5.5, 6.25, 7.0, 7.75, 8.0	1 - 12
Note: * Denotes product originally manufactured to Imperial dimensions

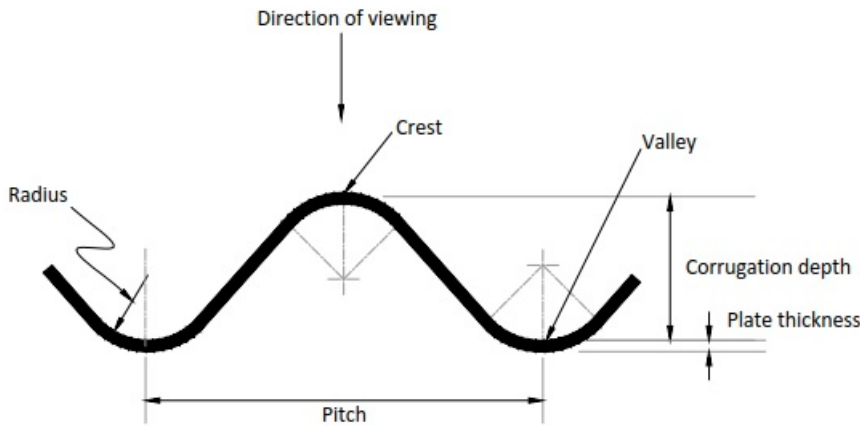
Figure A.5 Terminology relating to the corrugation profile

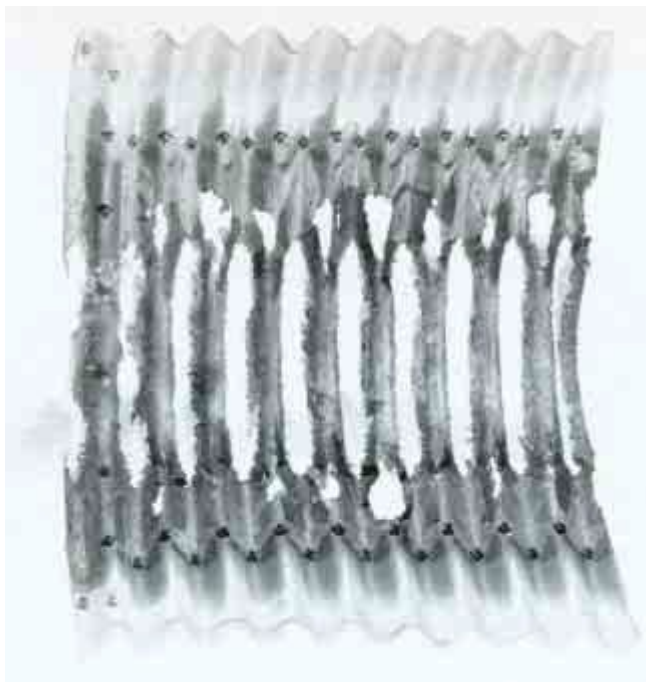
Figure B.1 Example of extreme corrosion in the invert of a structure subject to scour (this 30 year old structure was not provided with a paving or bitumen coating)

Figure B1 shows the deterioration in the invert of a 1.8 m diameter CSBS. This structure was subsequently replaced with a larger diameter helically wound corrugated steel pipe incorporating a reinforced concrete paving. If the deterioration had been less severe it might have been possible to install a reinforced concrete structural paving.

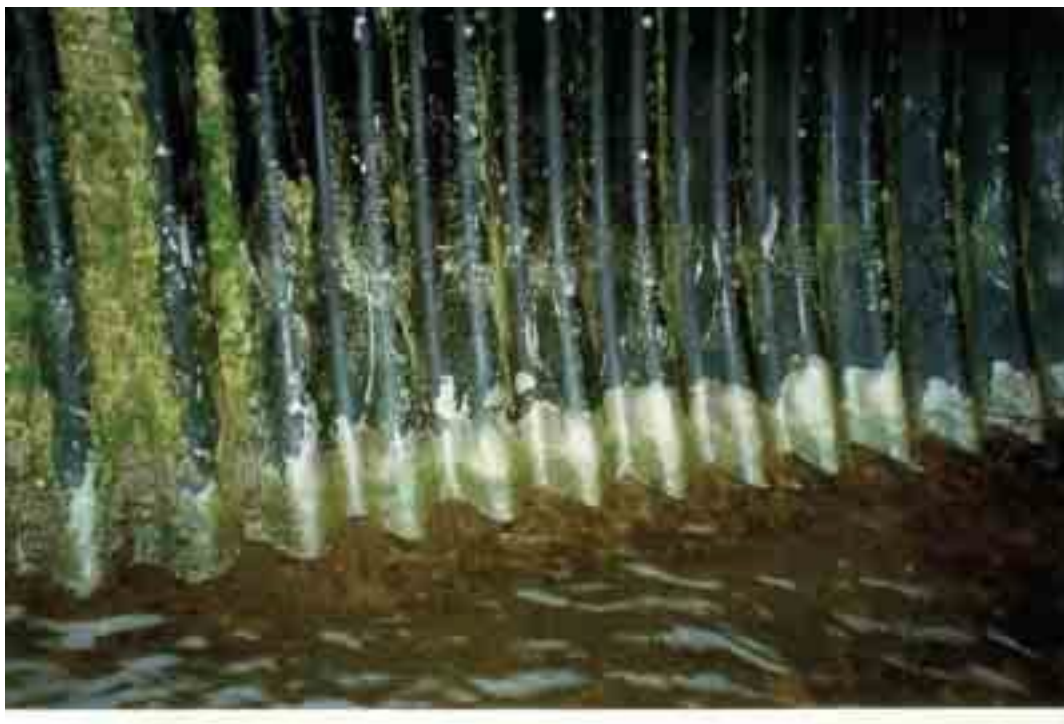
Figure B.2 Deterioration of bitumen coating along the wet/dry line in low flow condition

Figure B2 shows typical deterioration of a bitumen coating caused by frequent cycles of wetting and drying. Figure B3 shows the deterioration of the bitumen coatings above the paving in a pipe arch structure due to overtopping through turbulent flow. In Figure B3 the bitumen coating was in good condition elsewhere in the structure.

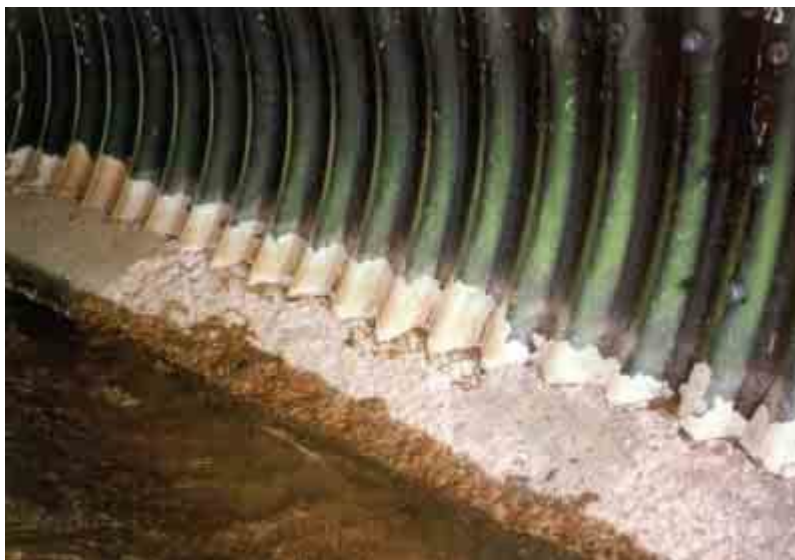
Figure B.3 Damaged bitumen coating caused by overtopping of paving during turbulent flow

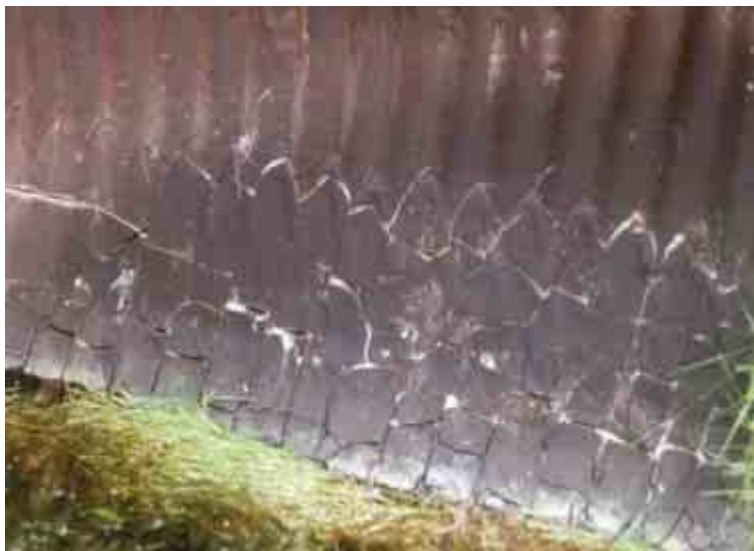
Figure B.5 Cracking in a bitumen paving due to exposure to sunlight

Bitumen pavings are generally hard wearing and resistant to scour by water-borne debris. The most common form of deterioration of bitumen pavings takes the form of cracking as the bitumen hardens with age and loses its more volatile constituents. This is usually most evident at the ends of the structure (particularly those with bevelled ends) exposed to direct sunlight and potentially turbulent water flows. Figure B5 shows an example of the form of deterioration.

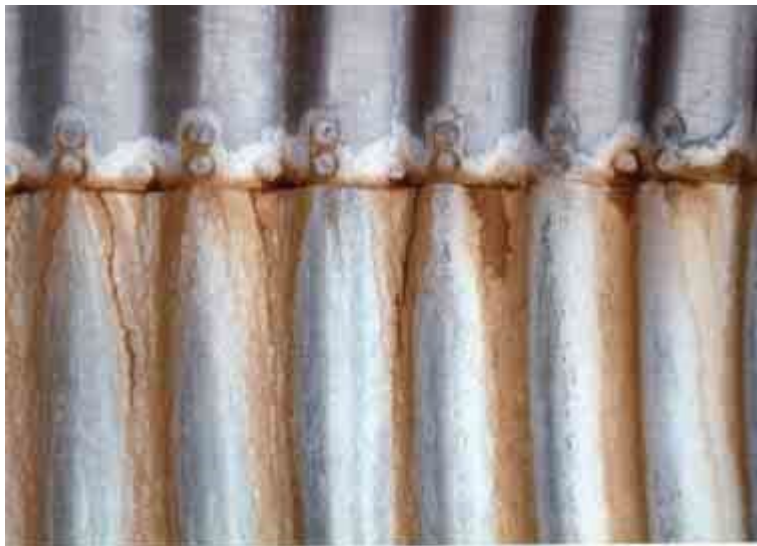
Figure B.8 Deterioration to side plates in a plain galvanised bolted segmental CSBS caused by seepage below the edge of the carriageway

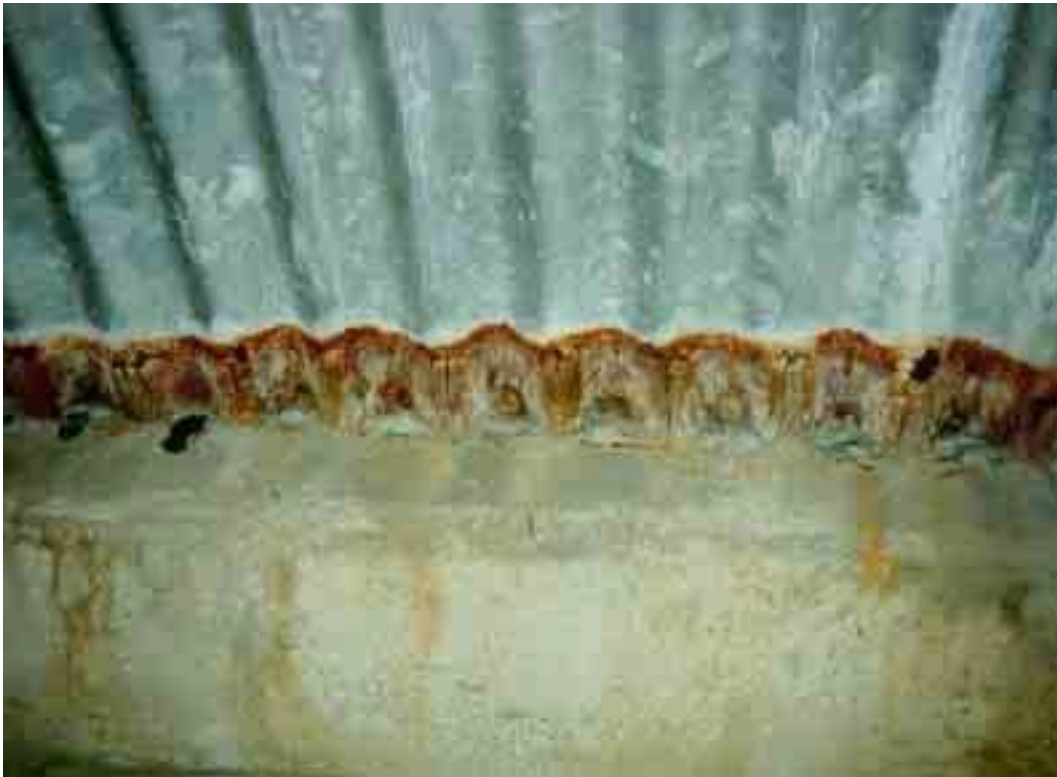
Figure B.9 Deterioration at the arch seating of a plain galvanised arch structure due to seepage and ponding of water containing de-icing salts

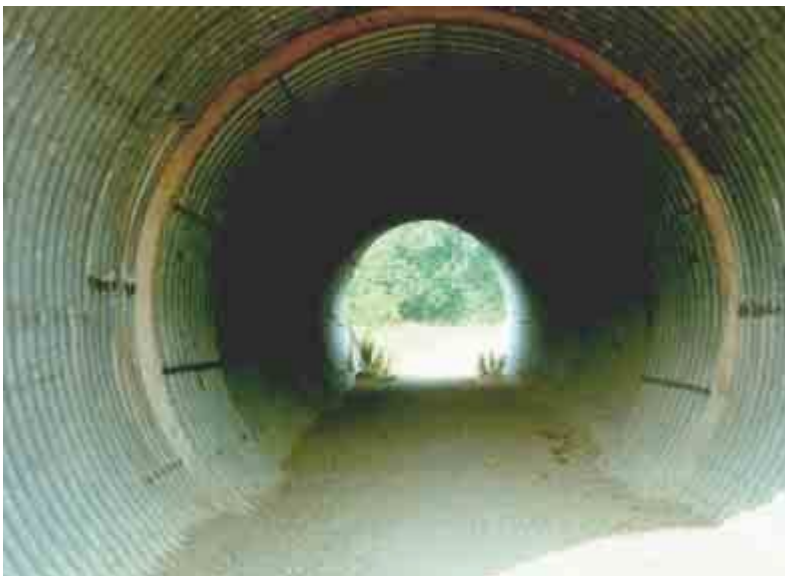
Figure B.10 Use of liner plates to repair a bolted segmental CSBS showing deterioration below the edge of the carriageway due to seepage of water containing de-icing salts
