**VOLUME 3 HIGHWAY STRUCTURES:
INSPECTION AND
MAINTENANCE**

BA 87/04

**MANAGEMENT OF CORRUGATED
STEEL BURIED STRUCTURES**

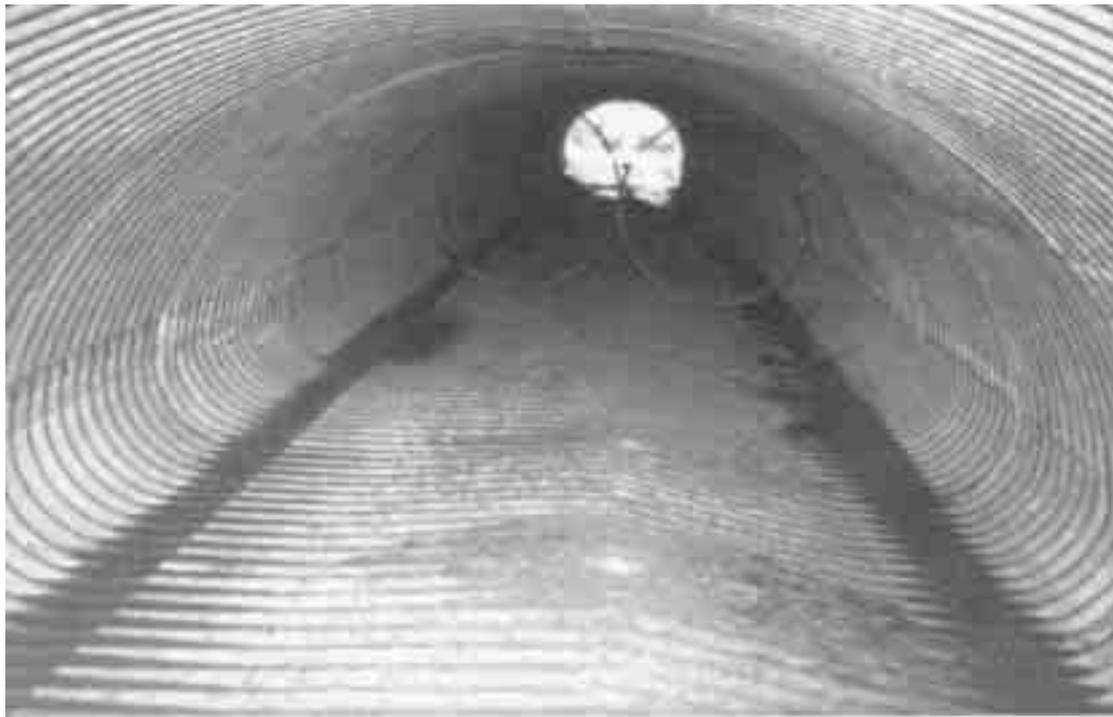
Figure 5.1a Reverse curvature in the invert of a multi-plate pipe-arch caused by settlement of the surrounding embankment (from SETRA, 1992)

Figure 5.1 Reverse curvature in the invert and its repair

- (a) **Reverse curvature.** Such cases are rare in the UK, but without exception they require urgent consideration. (Such cases are also likely to occur shortly after construction.) Reverse curvature in the invert of a multi-plate pipe-arch caused by settlement of the surrounding embankment is shown in Figure 5.1a. The use of a mass concrete paving to repair flood relief structure that suffered from reverse curvature is shown in Figure 5.1b.
- (b) **Bolt failure.** This is a potentially catastrophic mode of failure, and investigations should be undertaken where there is bolt failure. Immediate strengthening around the area of a failed bolt should be considered as a matter of priority. (The loss of bolt through corrosion should not be

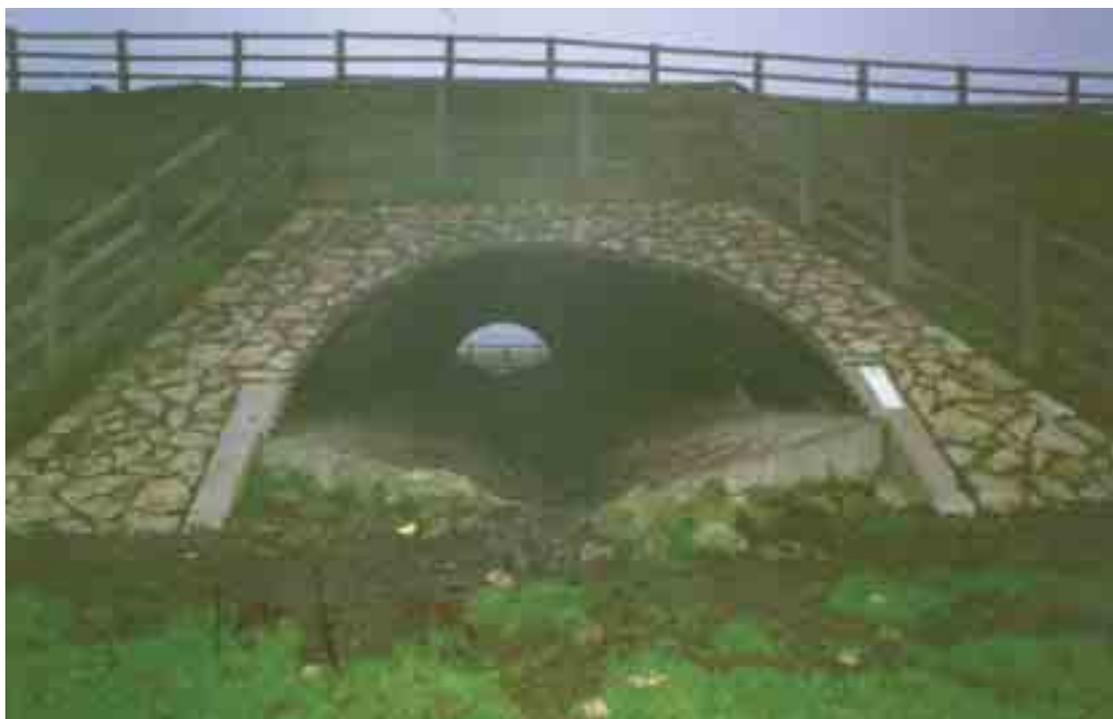
Figure 5.1b Mass concrete invert placed into a multi-plate pipe-arch with reverse curvature in the invert

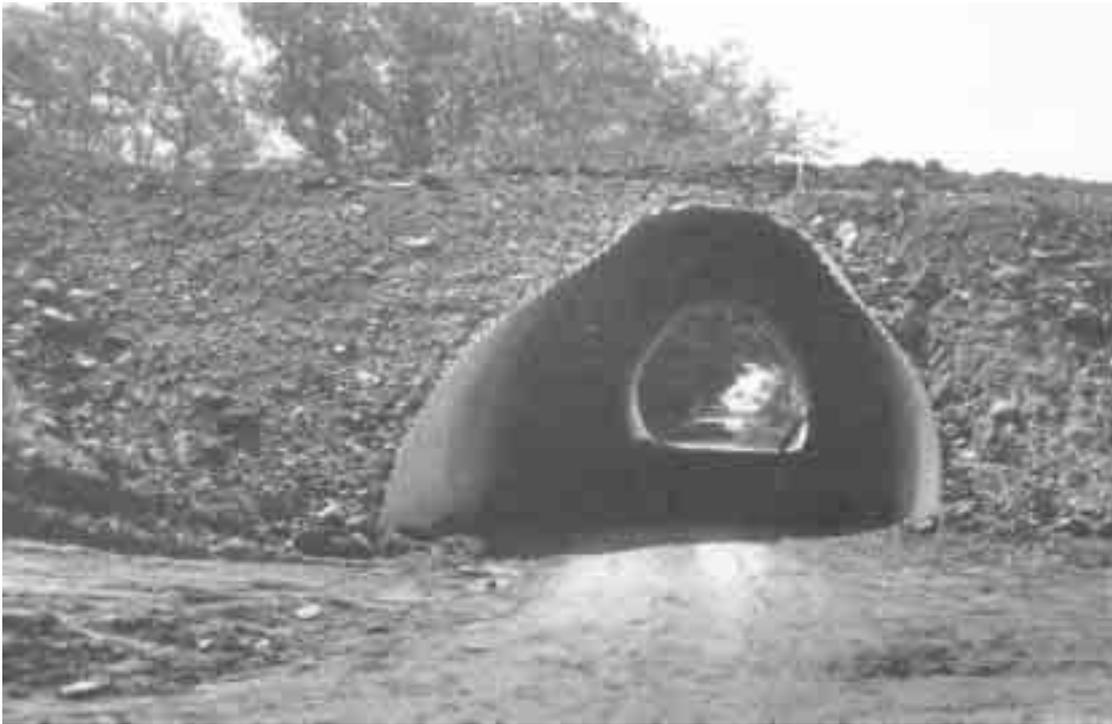
Figure 5.2a Excessive deflection of a multi-plate pipe-arch in France (from SETRA, 1992)

Figure 5.2 Excessive deflections of CSBS due to poor construction practice

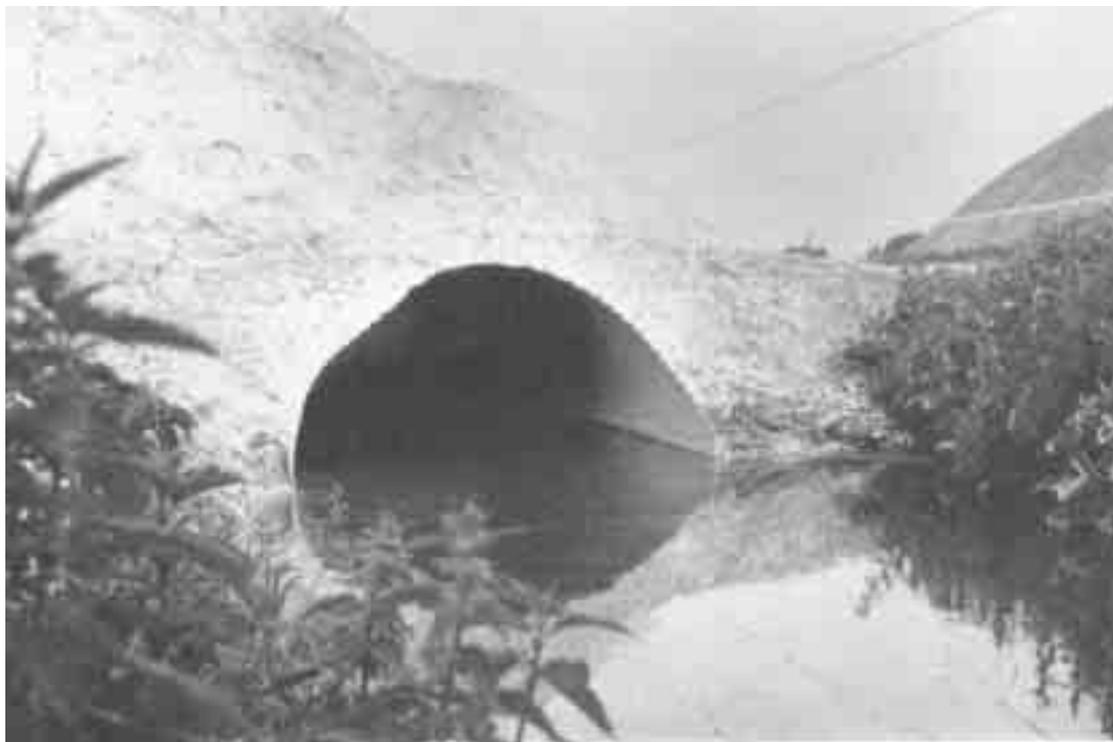
Figure 5.2b Partial collapse of a multi-plate pipe-arch in France (from SETRA, 1992)

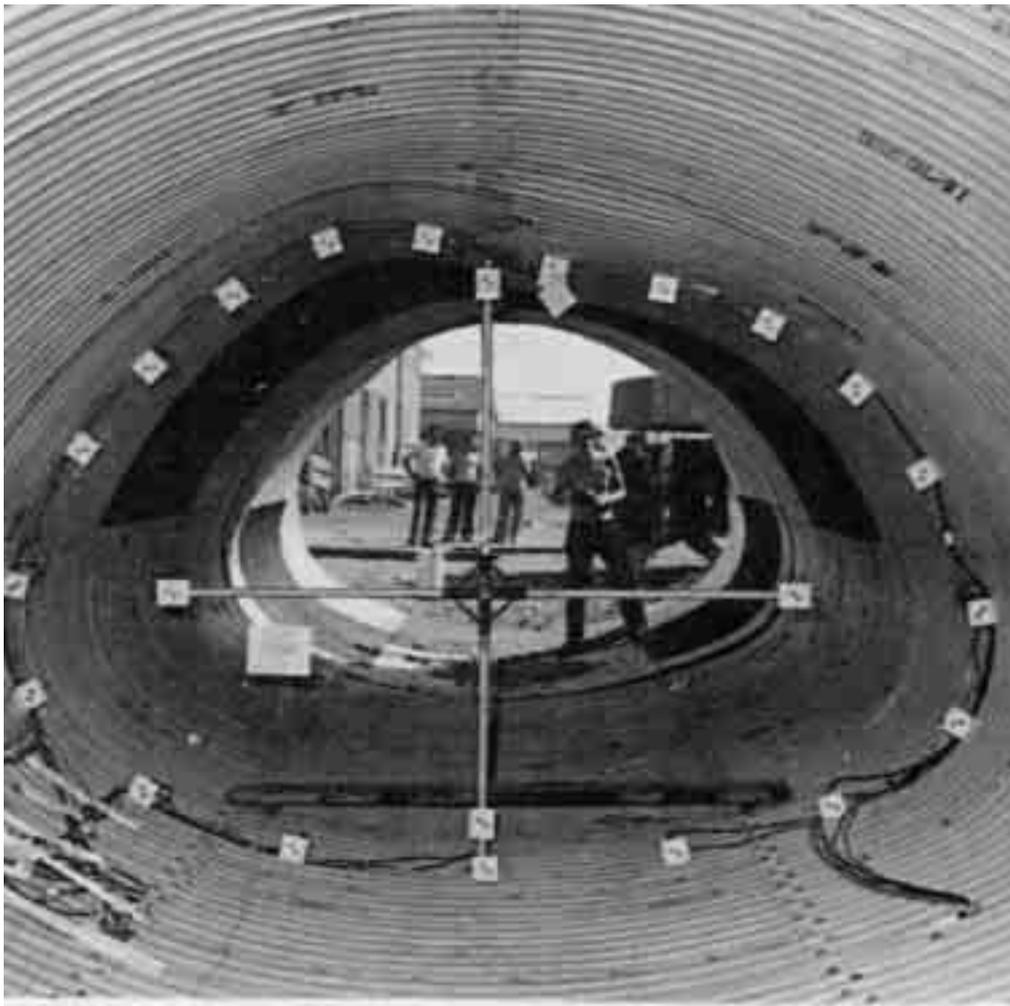
Figure 5.3 Reverse curvature - buckling due to excessive live loading at low depths of cover

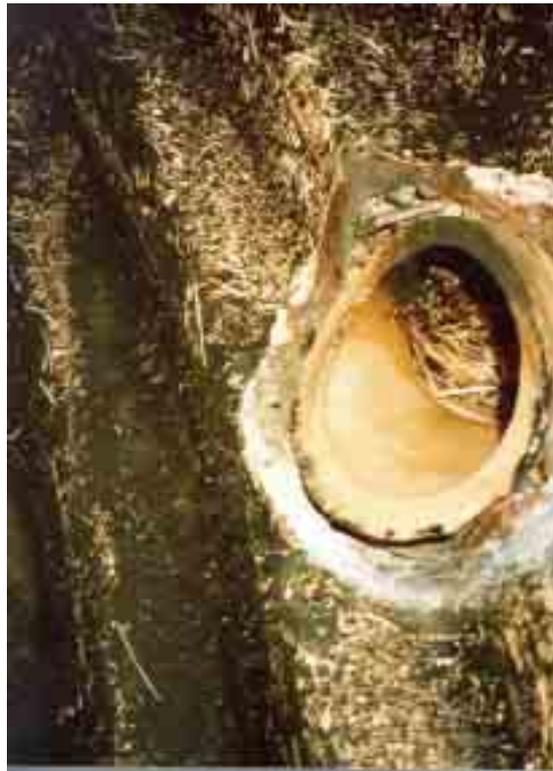
Figure 5.4a Ceramic pipe entering close to the crown

Figure 5.4 Corrosion around road drainage gulleys entering multi-plate pipe-arches

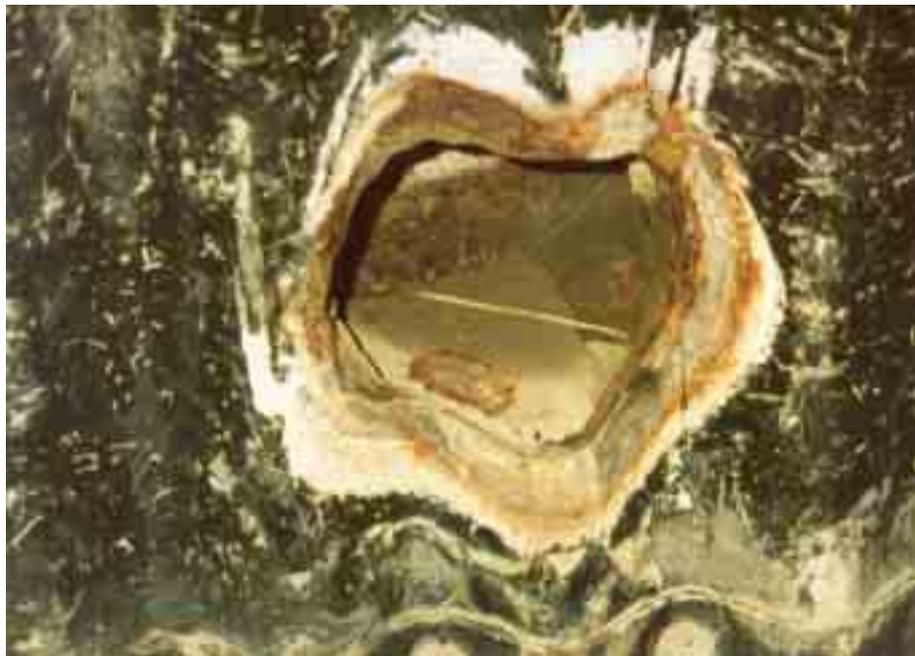
Figure 5.4b Side entry gulley just above the paving

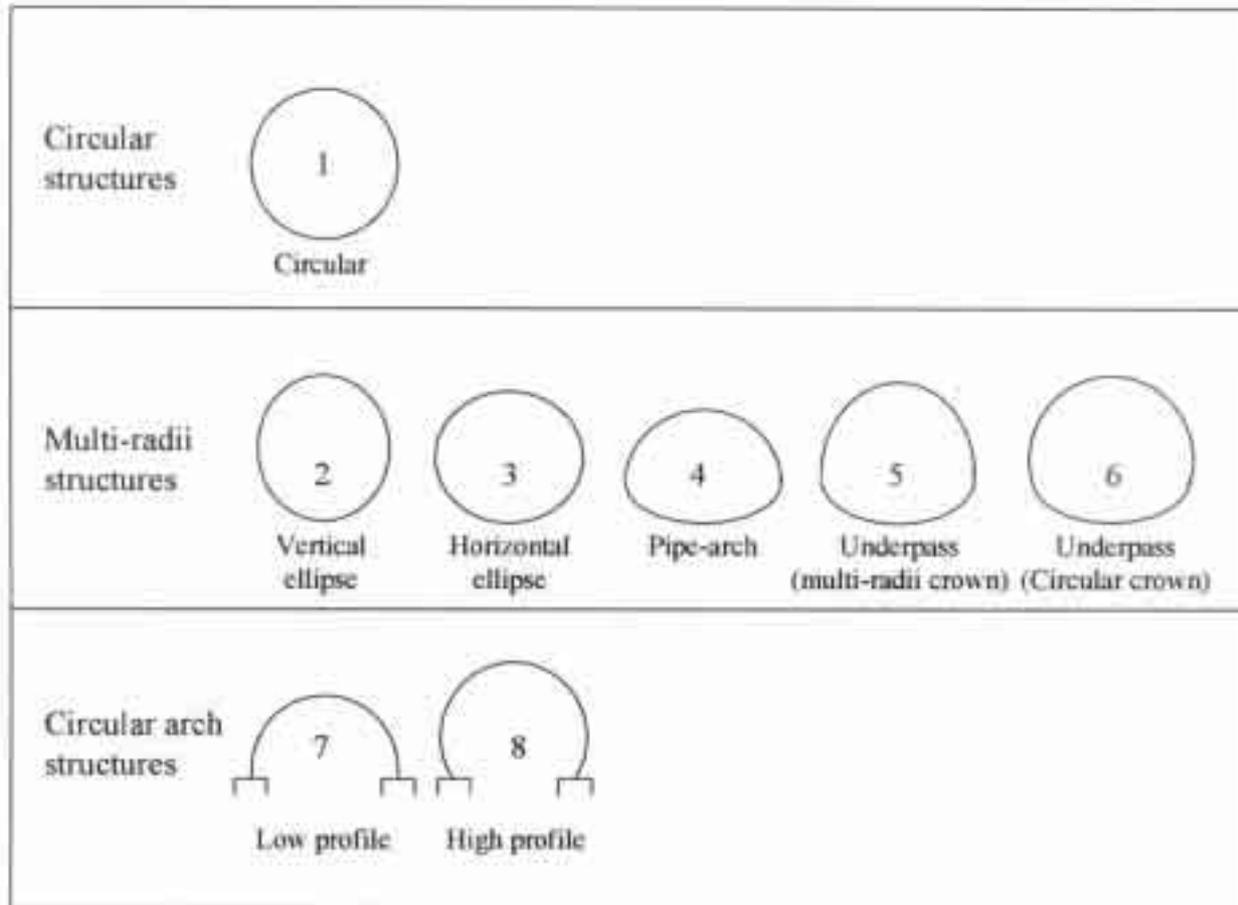
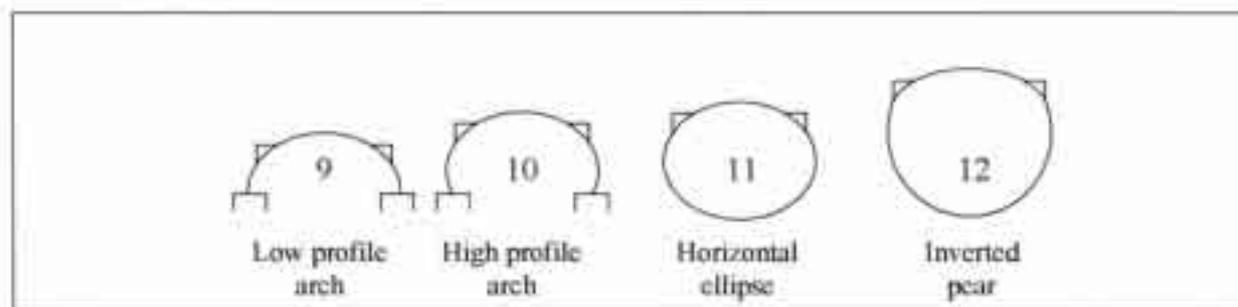
Profiles of short-span structures (spans less than 8 metres)

Profiles of larger structures incorporating thrust beams

Figure A1 Typical profiles of CSBS commonly installed in the UK

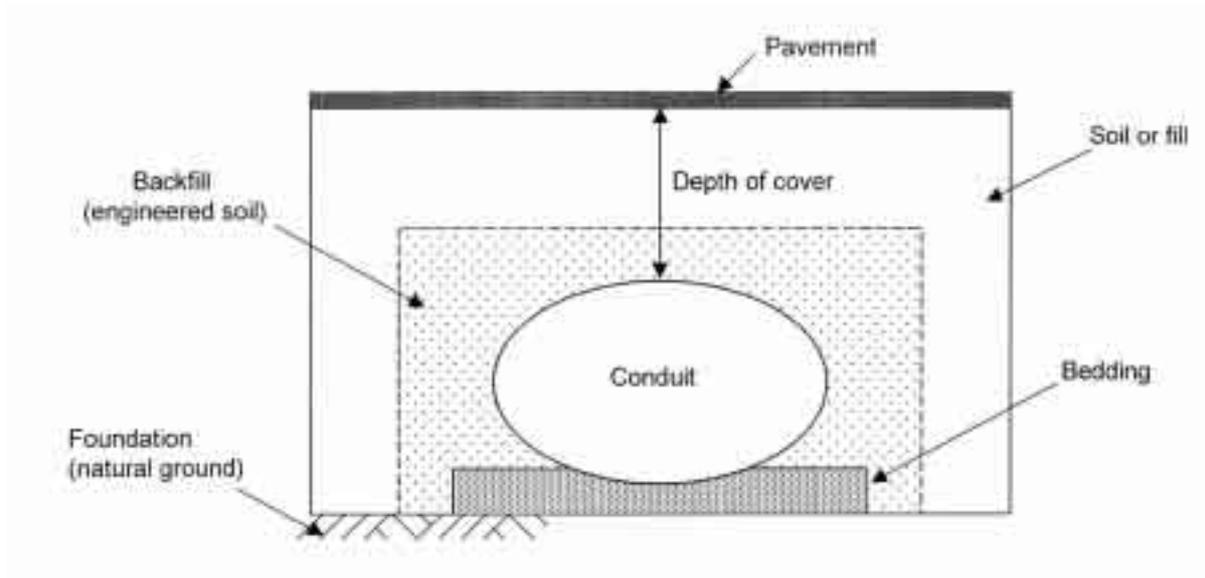
Figure A2(a) Terminology relating to surrounding fill and soil

Figure A2 Definition of terms for CSBS (part 1 of 3)

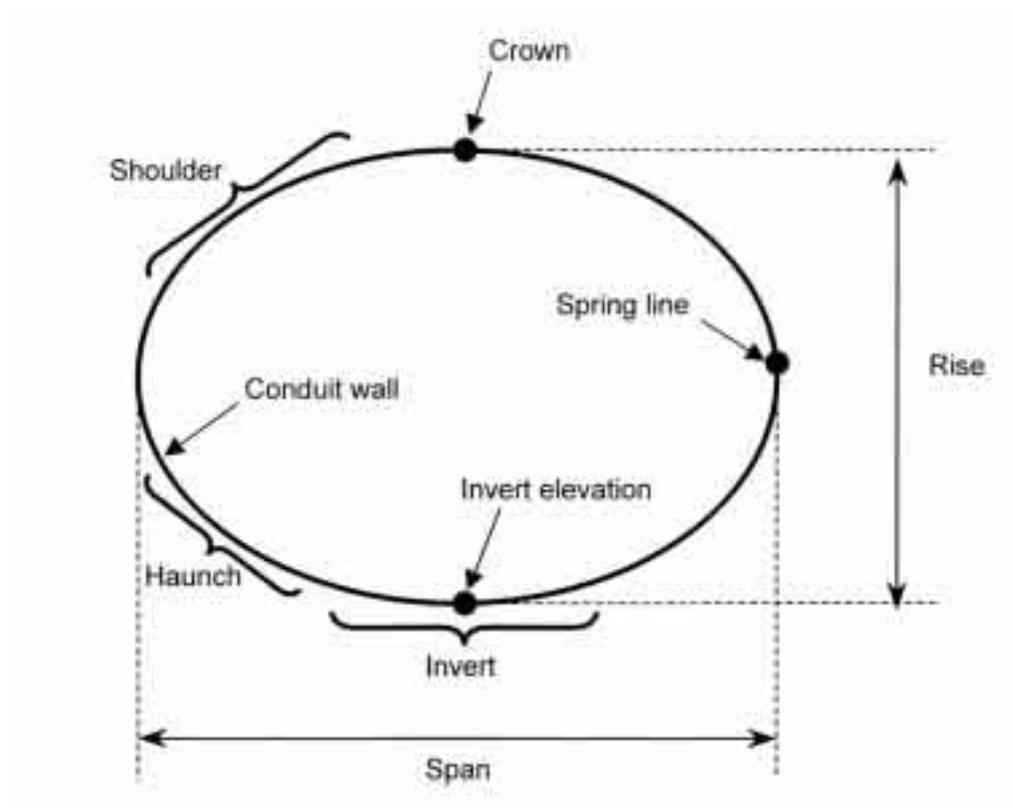
Figure A2(b) Terminology relating to the cross section of closed invert structures

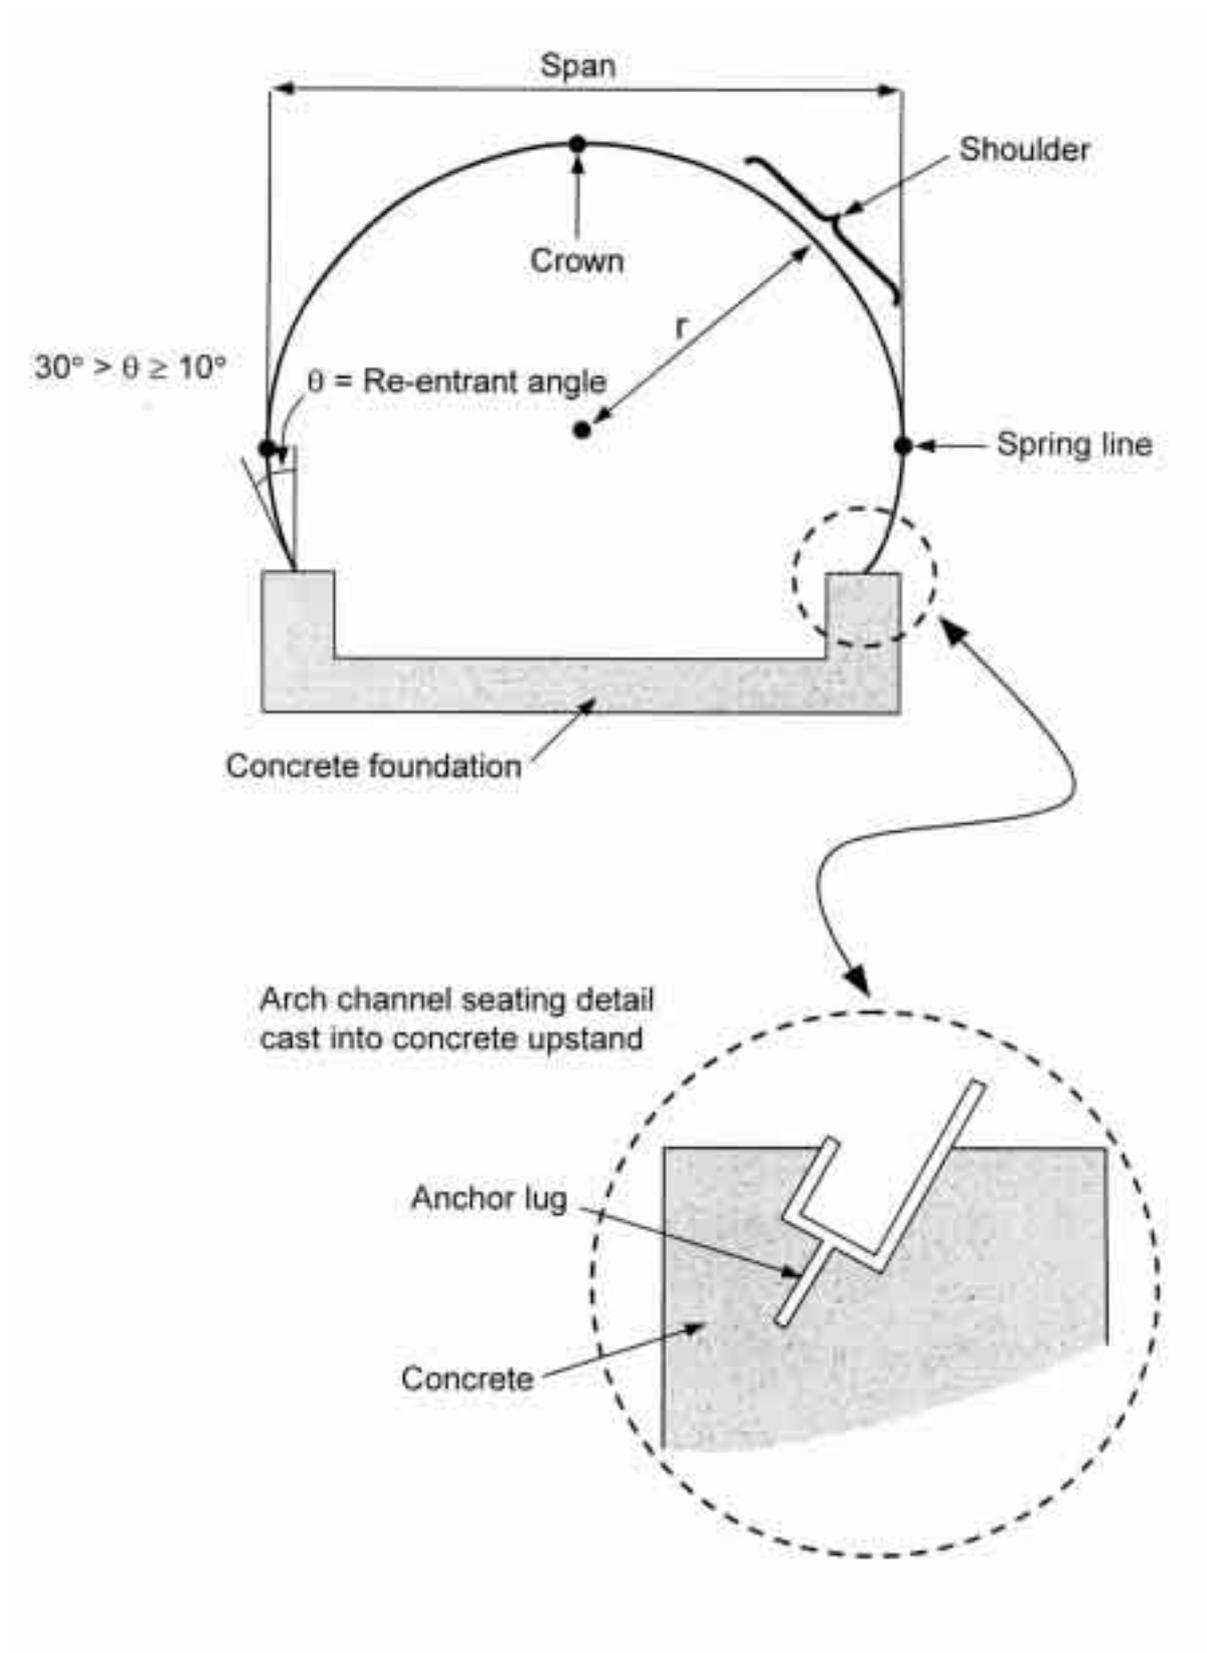
Figure A2(c) Terminology relating to the cross section of arch structures

Figure A2 Definition of terms for CSBS (part 2 of 3)

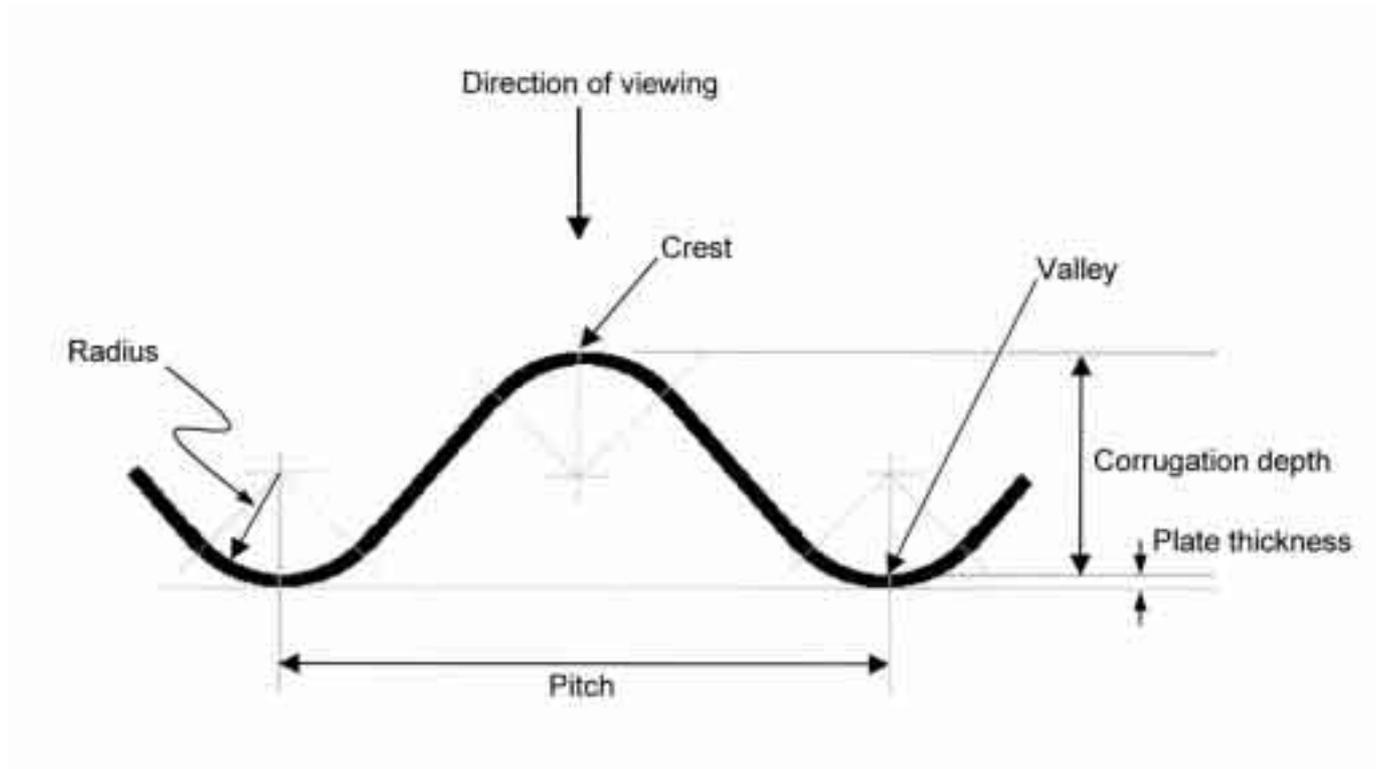
Figure A2(d) Terminology relating to the corrugation profile

Figure A2 Definition of terms for CSBS (part 3 of 3)

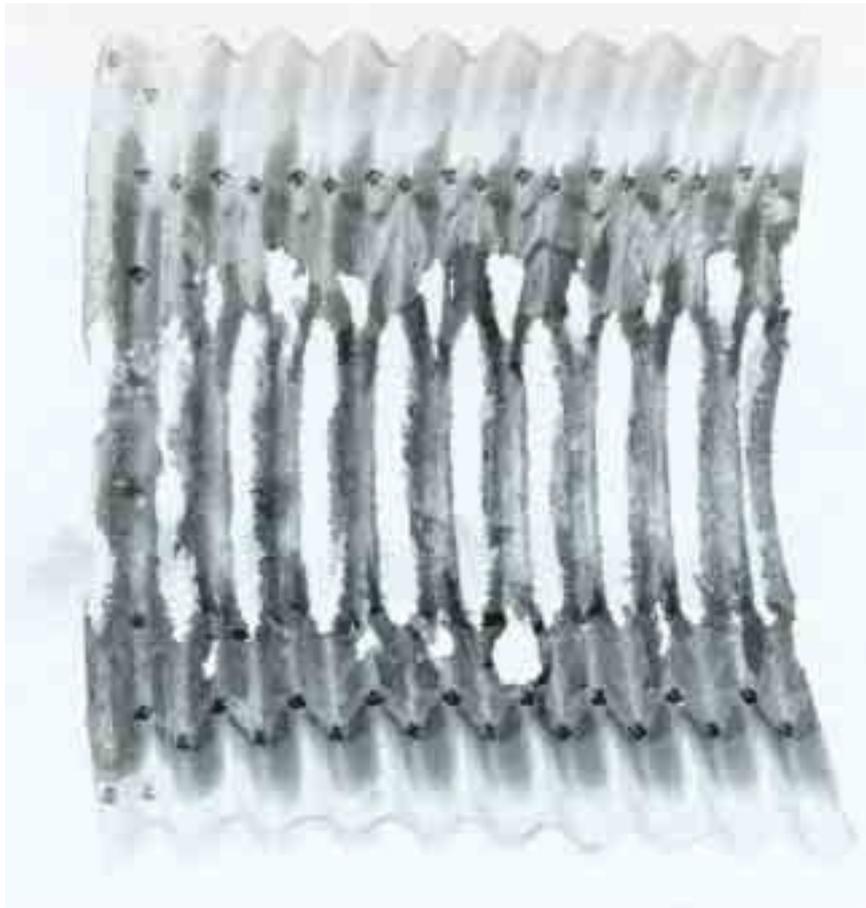
Figure E1 Example of extreme corrosion in the invert of a structure subject to scour
(this 30 year old structure was not provided with a paving or bitumen coating)

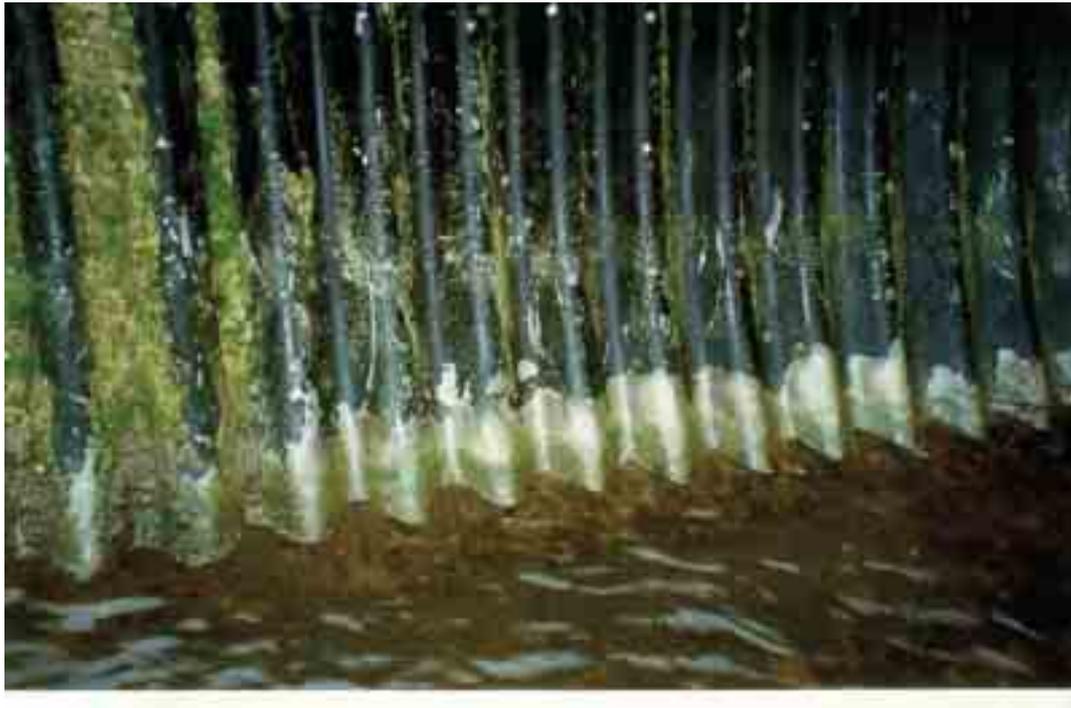
Figure E2a Deterioration along the wet/dry line in low flow conditions

Figure E2 Damage to bitumen coatings by low and turbulent flows

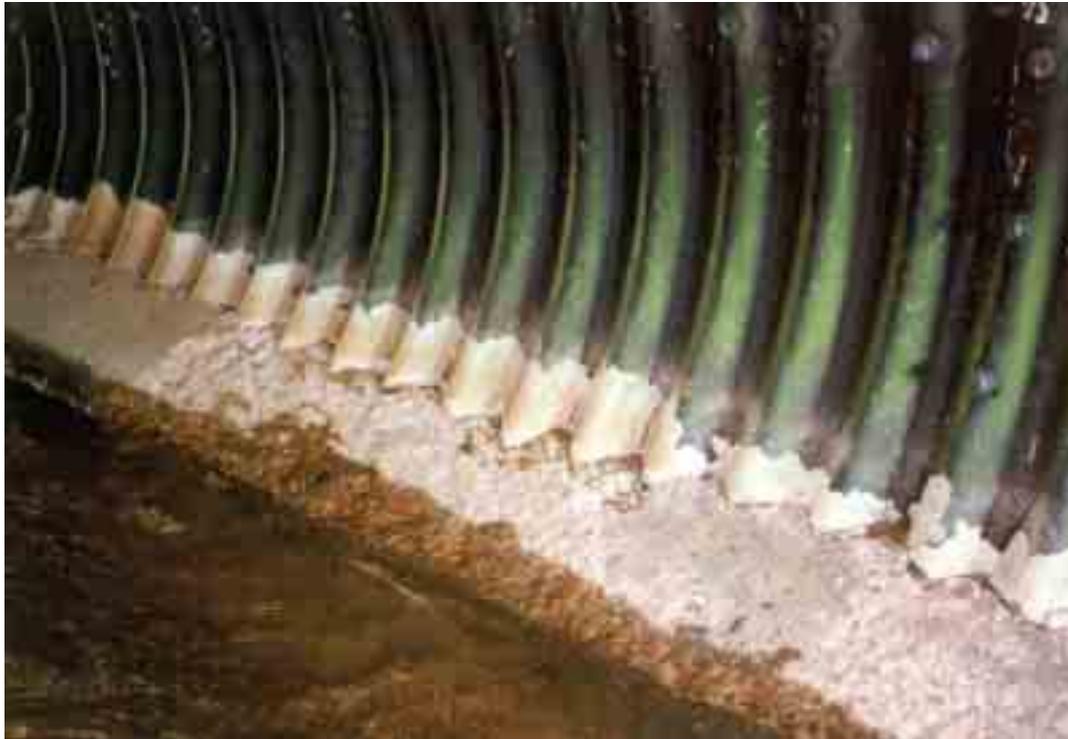
Figure E2b Damaged caused by overtopping of paving during turbulent flow

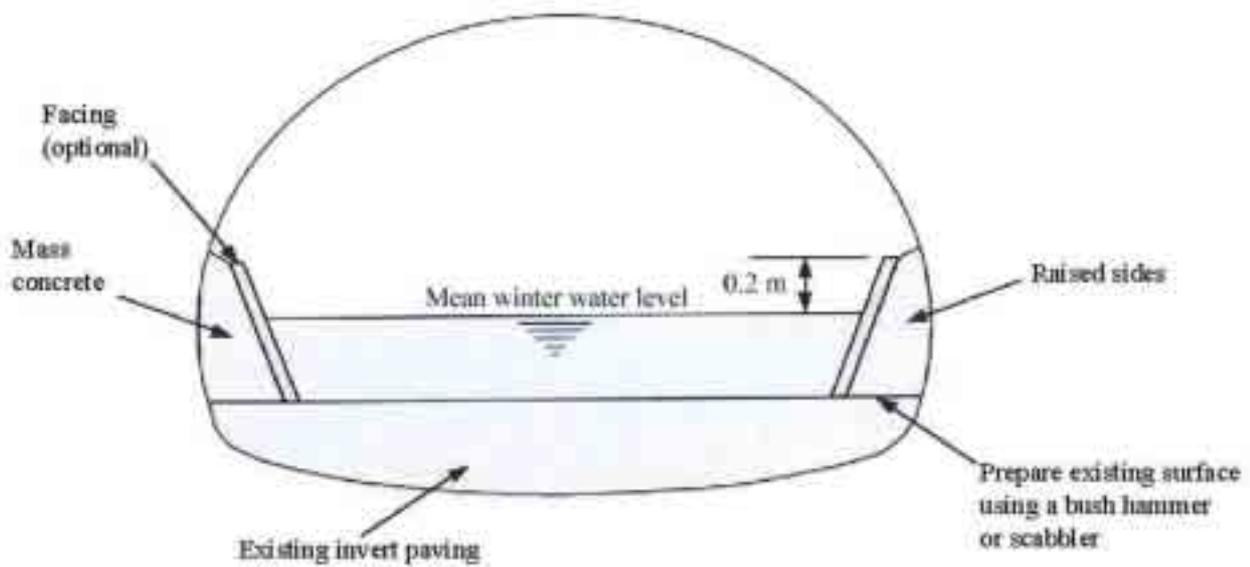
Figure E3 Extension of an invert paving

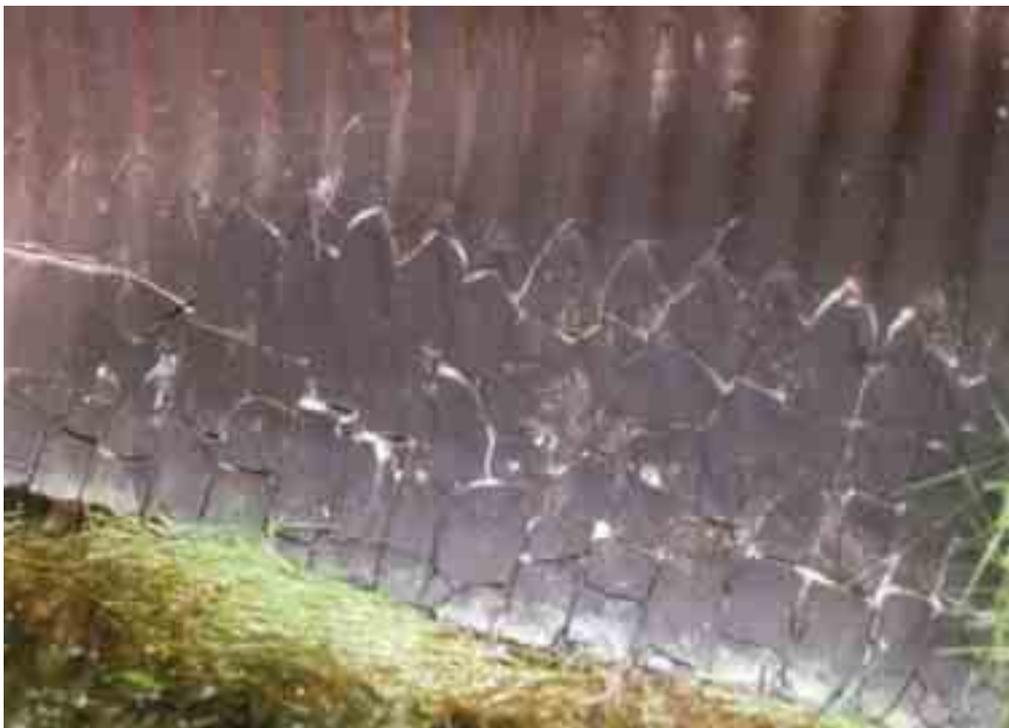
Figure E4 Cracking in a bitumen paving due to exposure to sunlight

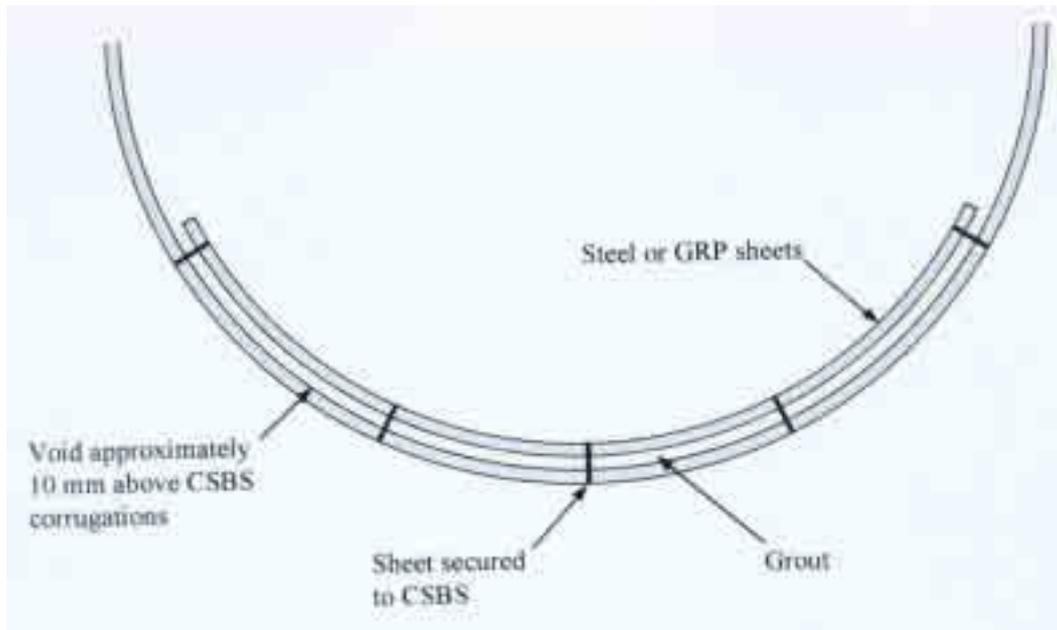
Figure E5 Use of liner plates to protect an invert

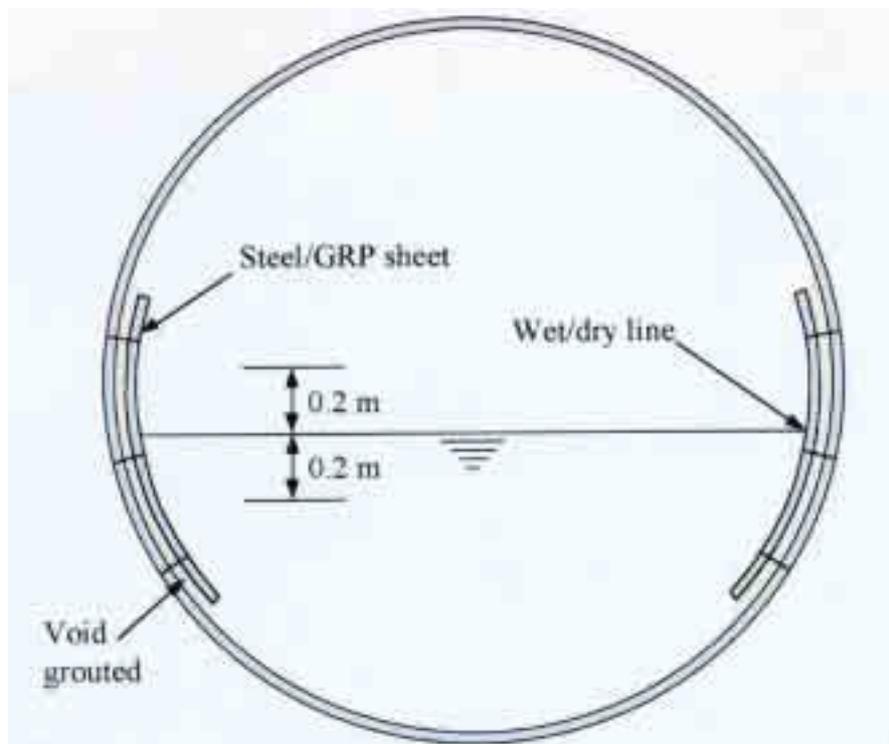
Figure E6 Use of liner plates to protect wet/dry line

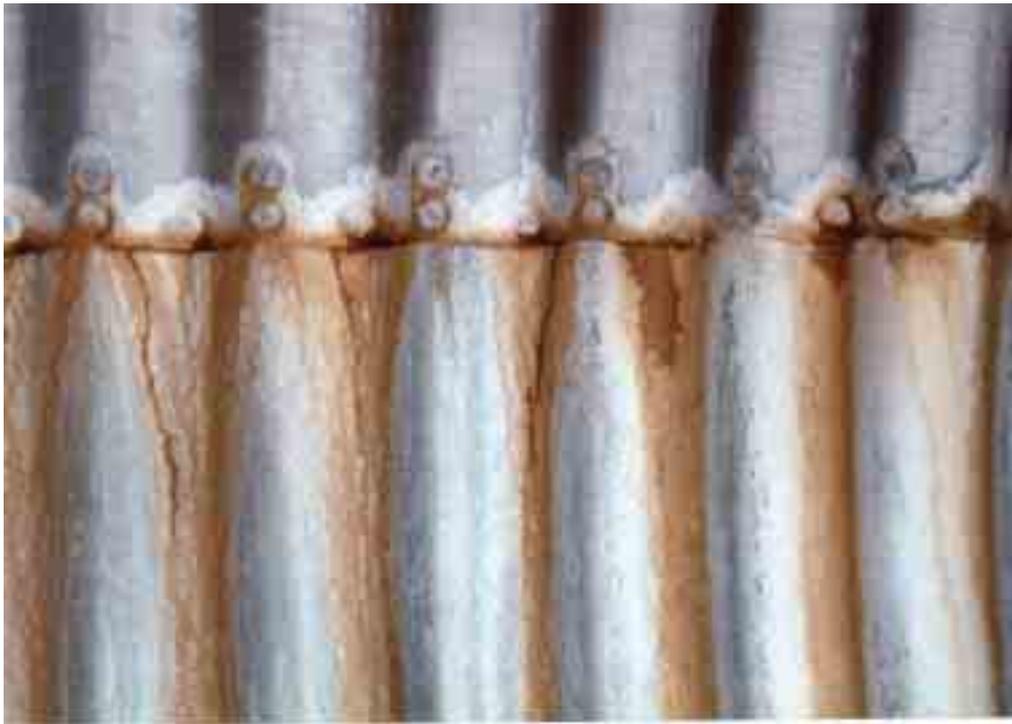
Figure E7 Deterioration to side plates in a plain galvanised bolted segmental CSBS caused by seepage below the edge of the carriageway

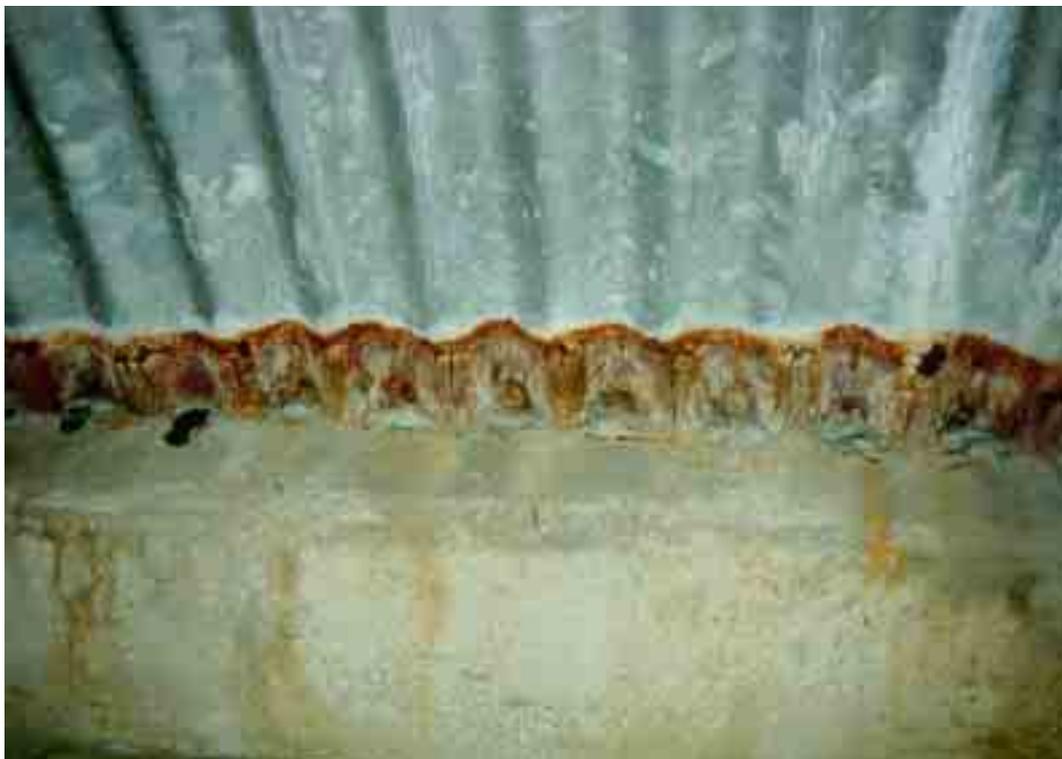
Figure E8 Deterioration at the arch seating of a plain galvanised arch structure due to seepage and ponding of water containing de-icing salts

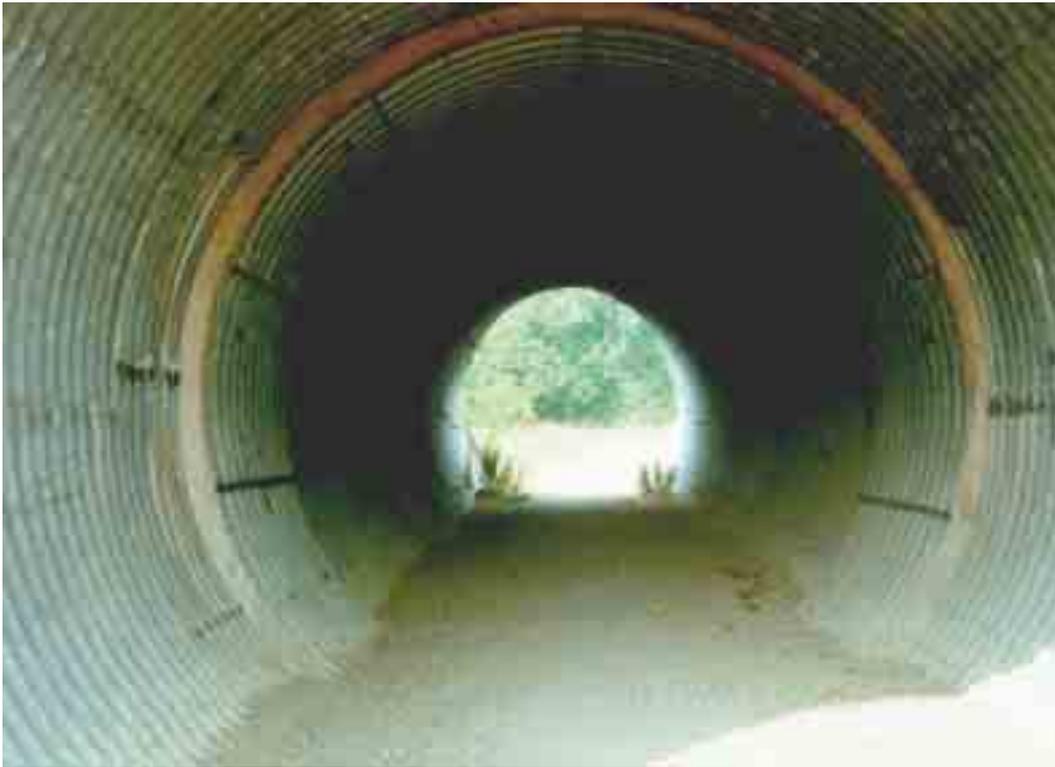
Figure E9 Use of liner plates to repair a bolted segmental CSBS showing deterioration below the edge of the carriageway due to seepage of water containing de-icing salts

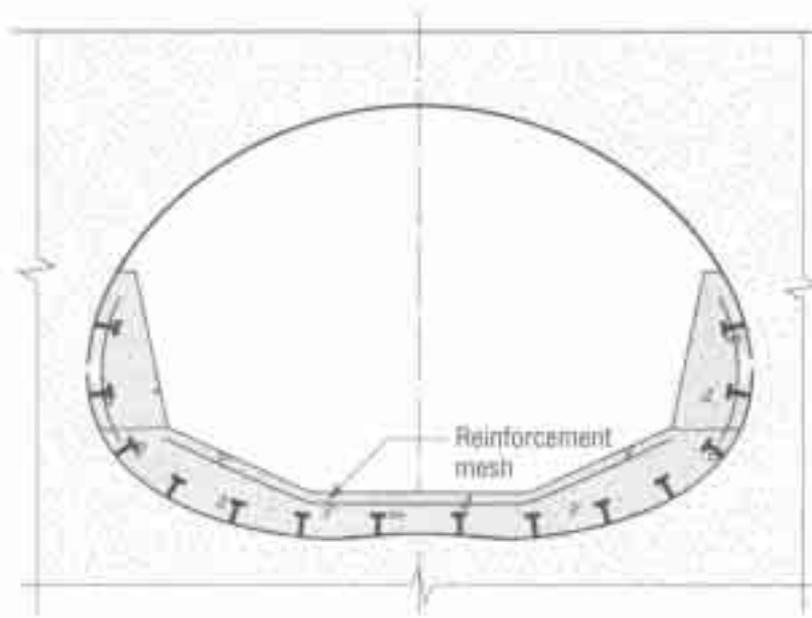
Figure E10a Reinforced concrete paving (after Abdel-Sayed et al, 1993)

Figure E10 Details of structural concrete pavings for repairing the invert of CSBS (part 1 of 3)

E17 Details of various arrangements for structural pavings are provided in Figures E10a to f.

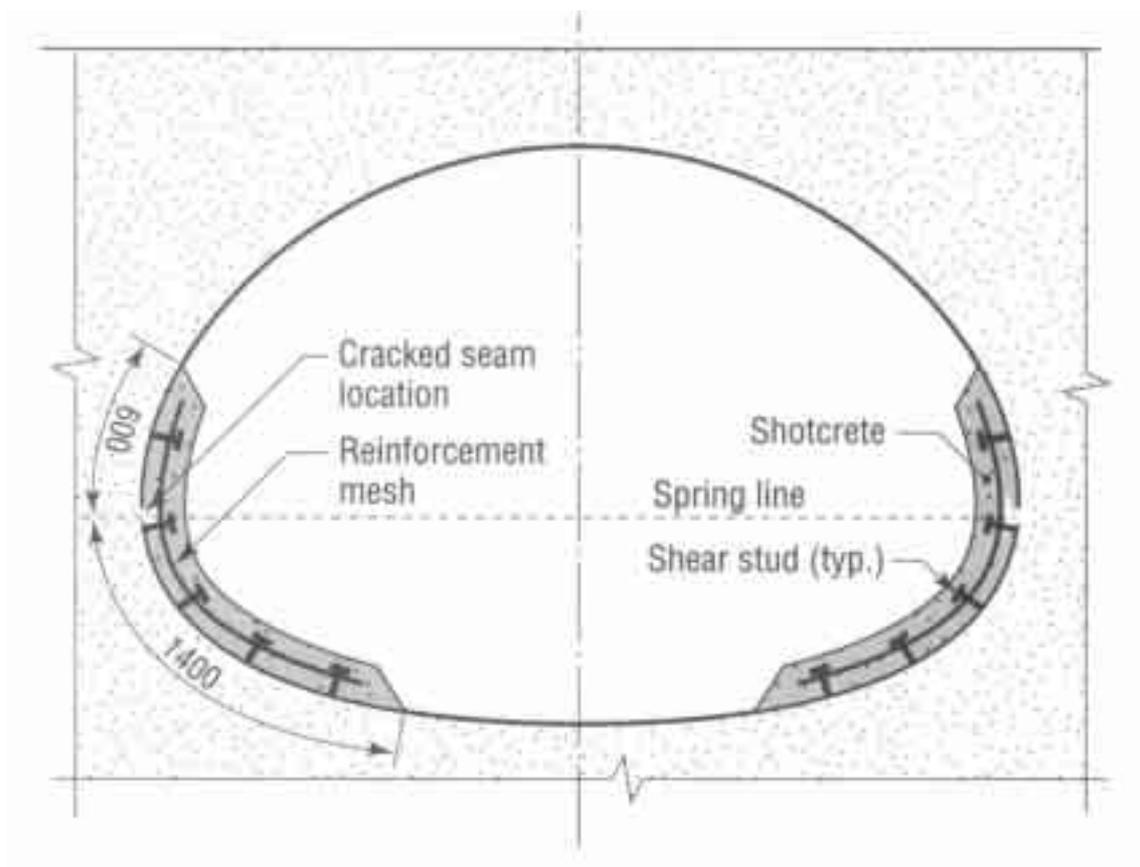
Figure E10b Shotcrete reinforced concrete paving (after Abdel-Sayed et al, 1993)

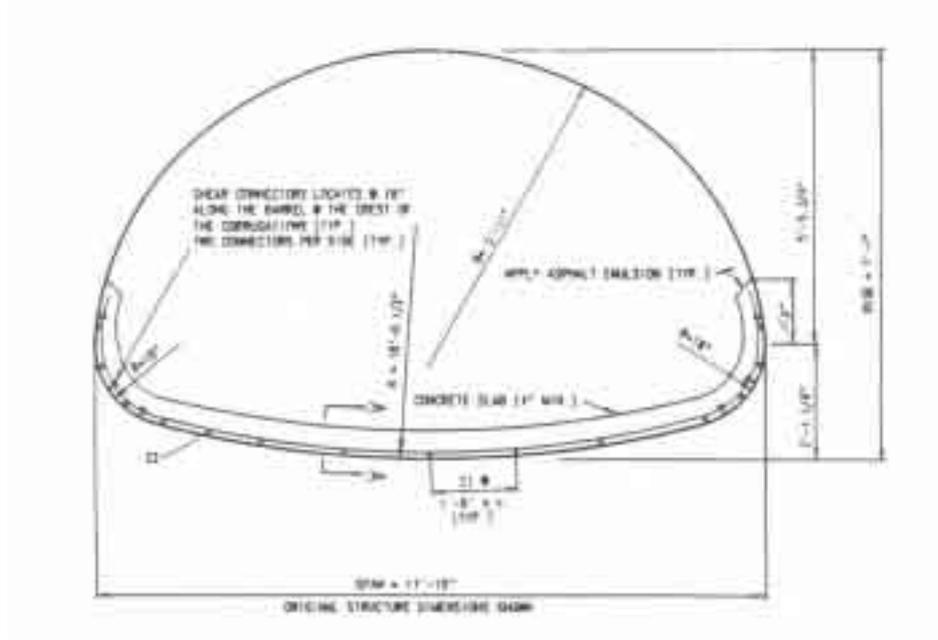
Figure E10c Reinforced concrete paving in a multi-plate pipe-arch as used in Maine (after Alexander et al, 1994)

Figure E10 Details of structural concrete pavings for repairing the invert of CSBS (part 2 of 3)

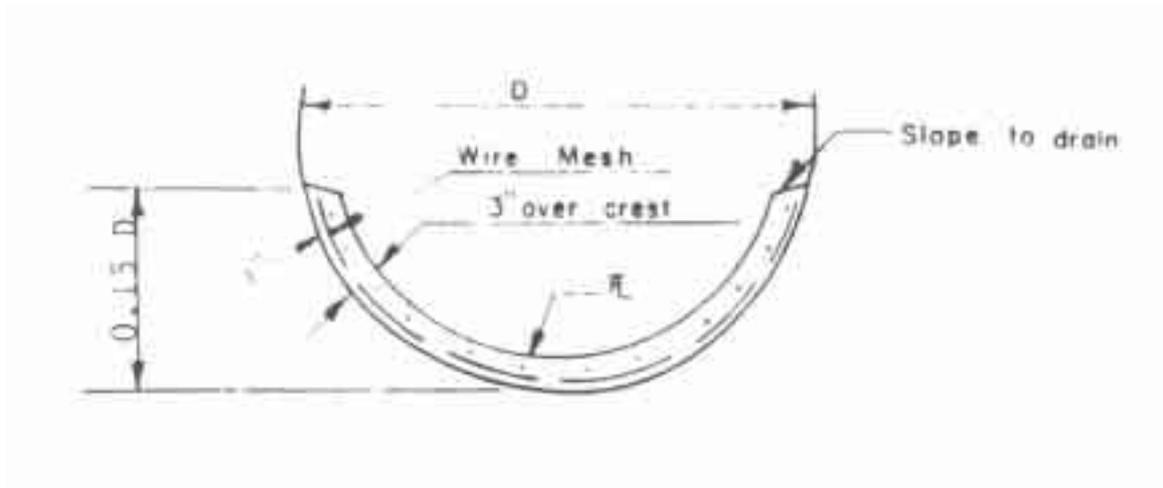
Figure E10d Reinforced concrete paving in a circular pipe as used in Ohio (after Alexander et al, 1994)

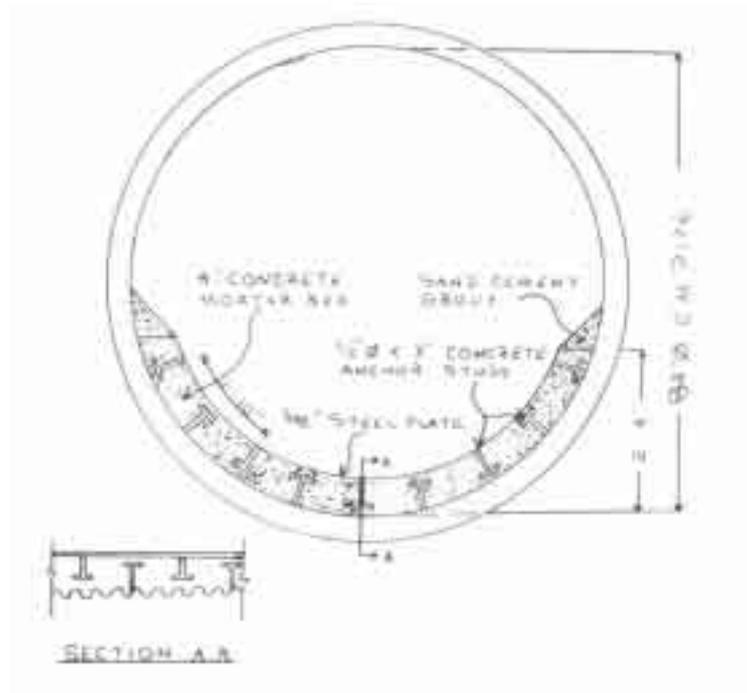
Figure E10e Paving formed from a steel plate and mass concrete as used in Alabama (after Ikerd, 1984)

Figure E10 Details of structural concrete pavings for repairing the invert of CSBS (part 3 of 3)
