**VOLUME 3 HIGHWAY STRUCTURES:
INSPECTION AND
MAINTENANCE**

BA 87/04

**MANAGEMENT OF CORRUGATED
STEEL BURIED STRUCTURES**

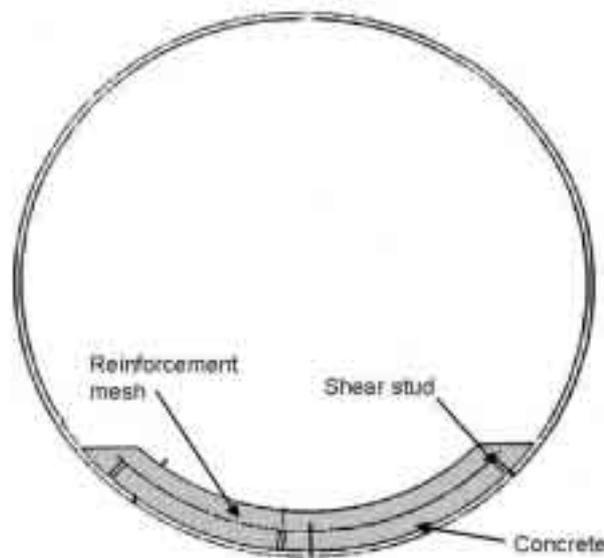
Figure E10f Reinforced concrete paving as used in Hawaii (after Alexander et al, 1994)

Figure E10 Details of structural concrete pavings for repairing the invert of CSBS (part 3 of 3)

E17 Details of various arrangements for structural pavings are provided in Figures E10a to f.
