**VOLUME 7 PAVEMENT DESIGN AND
MAINTENANCE**
**SECTION 4 PAVEMENT
MAINTENANCE
METHODS**

HD 40/01

FOOTWAY MAINTENANCE

This part provides guidance on footway maintenance. It provides advice on inspection of footways, the likely causes of defects and the possible treatment options that are available.

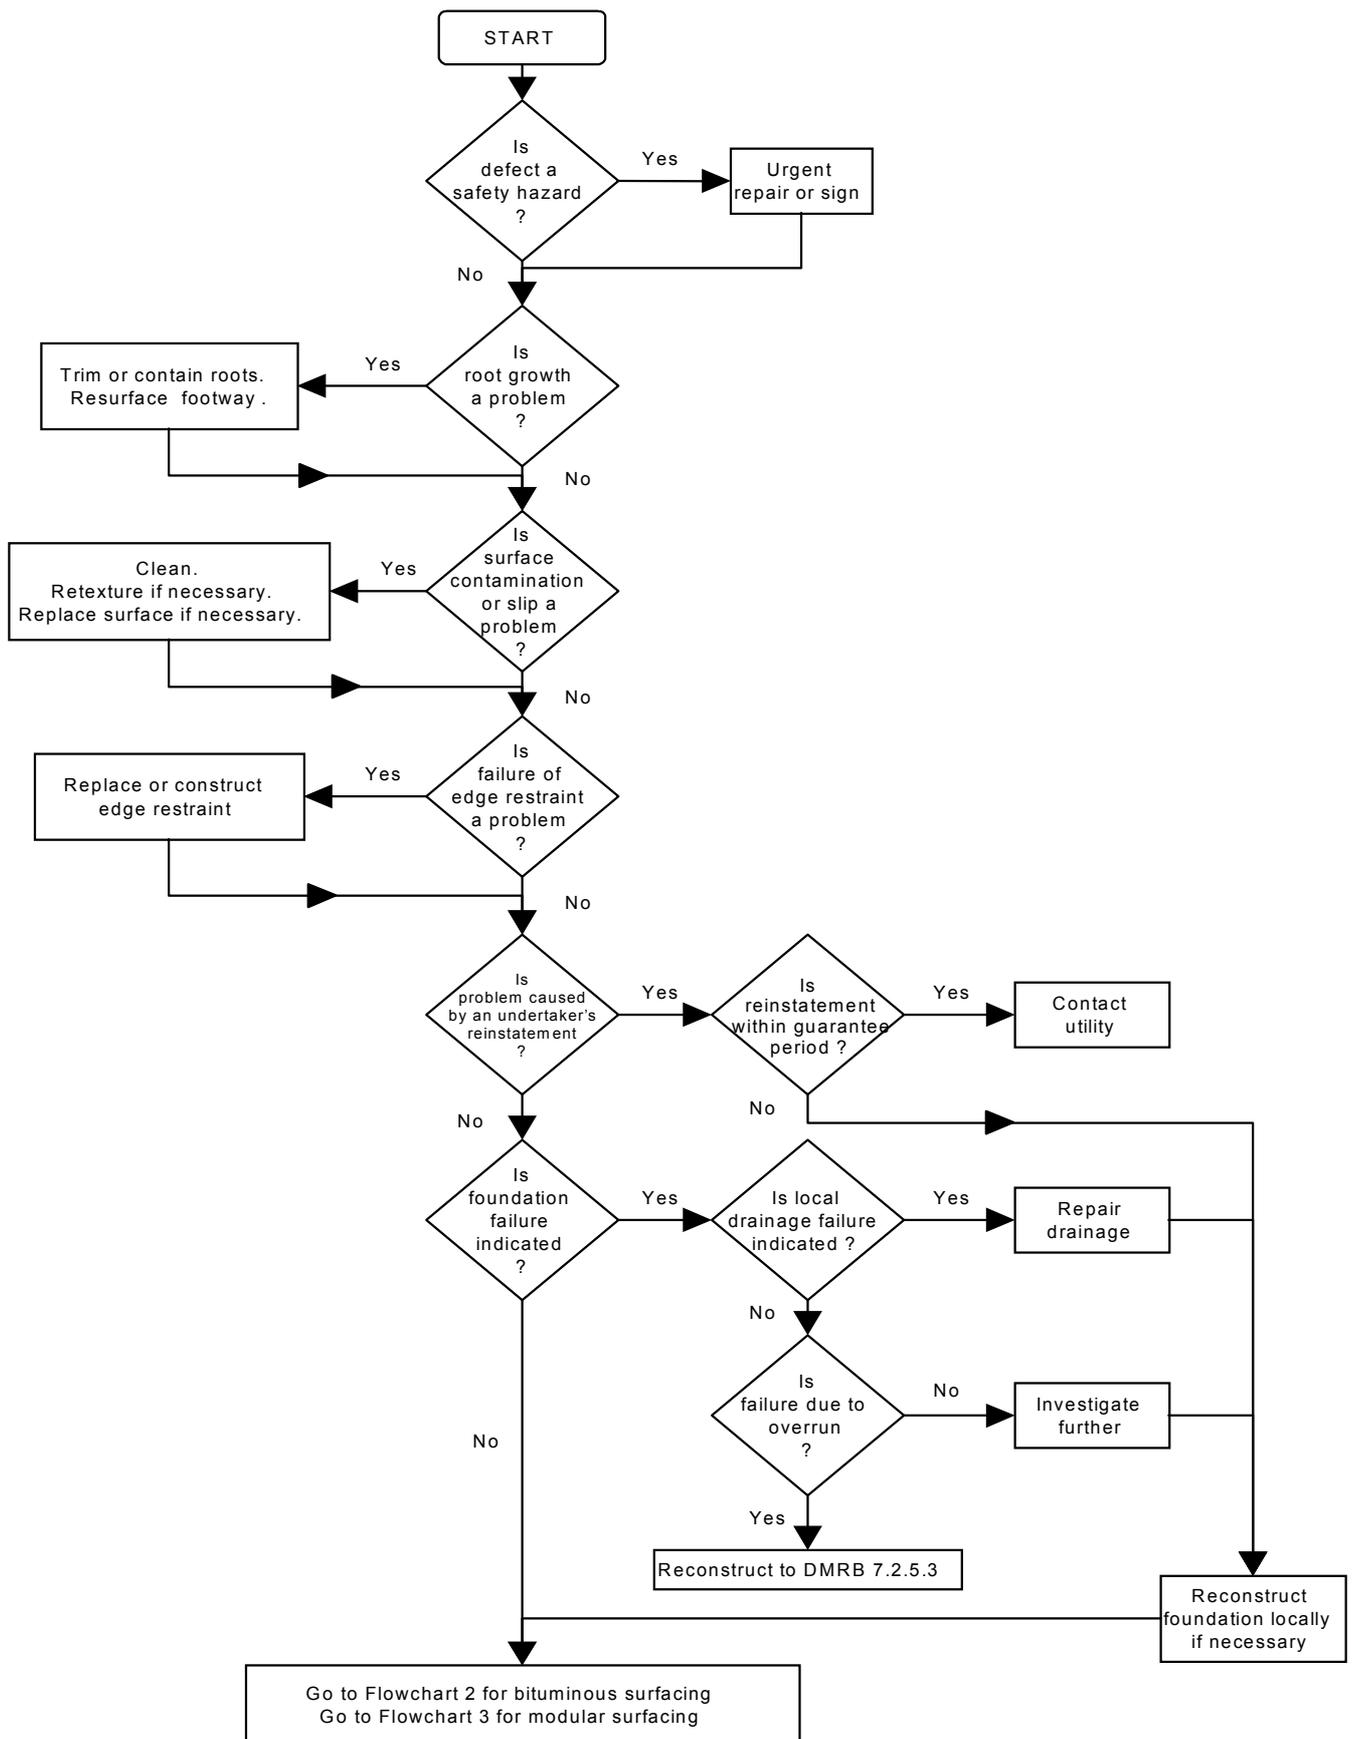
FLOWCHART 1 : GENERAL

5.70 A series of flowcharts is presented below to assist the choice of appropriate maintenance. Flowchart 1 is applicable to all types of footways and leads into Flowcharts 2 and 3, which apply to bituminous and modular surfacings respectively. There is no flowchart for concrete surfacing as such footways are not common.

Following Flowchart 1, root growth and surface contamination or slip are not a problem, but there is some failure of the edge restraint as the kerb is low and the back edge of the footway is not well supported. Defects are not due to reinstatement failure, but foundation failure is indicated as there is rutting behind the kerb.

Following Flowchart 1, there is no root growth, surface contamination or slip, failure of edge restraint or failure of reinstatement. The longitudinal rut indicates foundation failure due to overrun (Chapter 3, Clause 3.23).

Following Flowchart 1, there is no root growth, surface contamination or slip, failure of edge restraint, reinstatement or foundation.

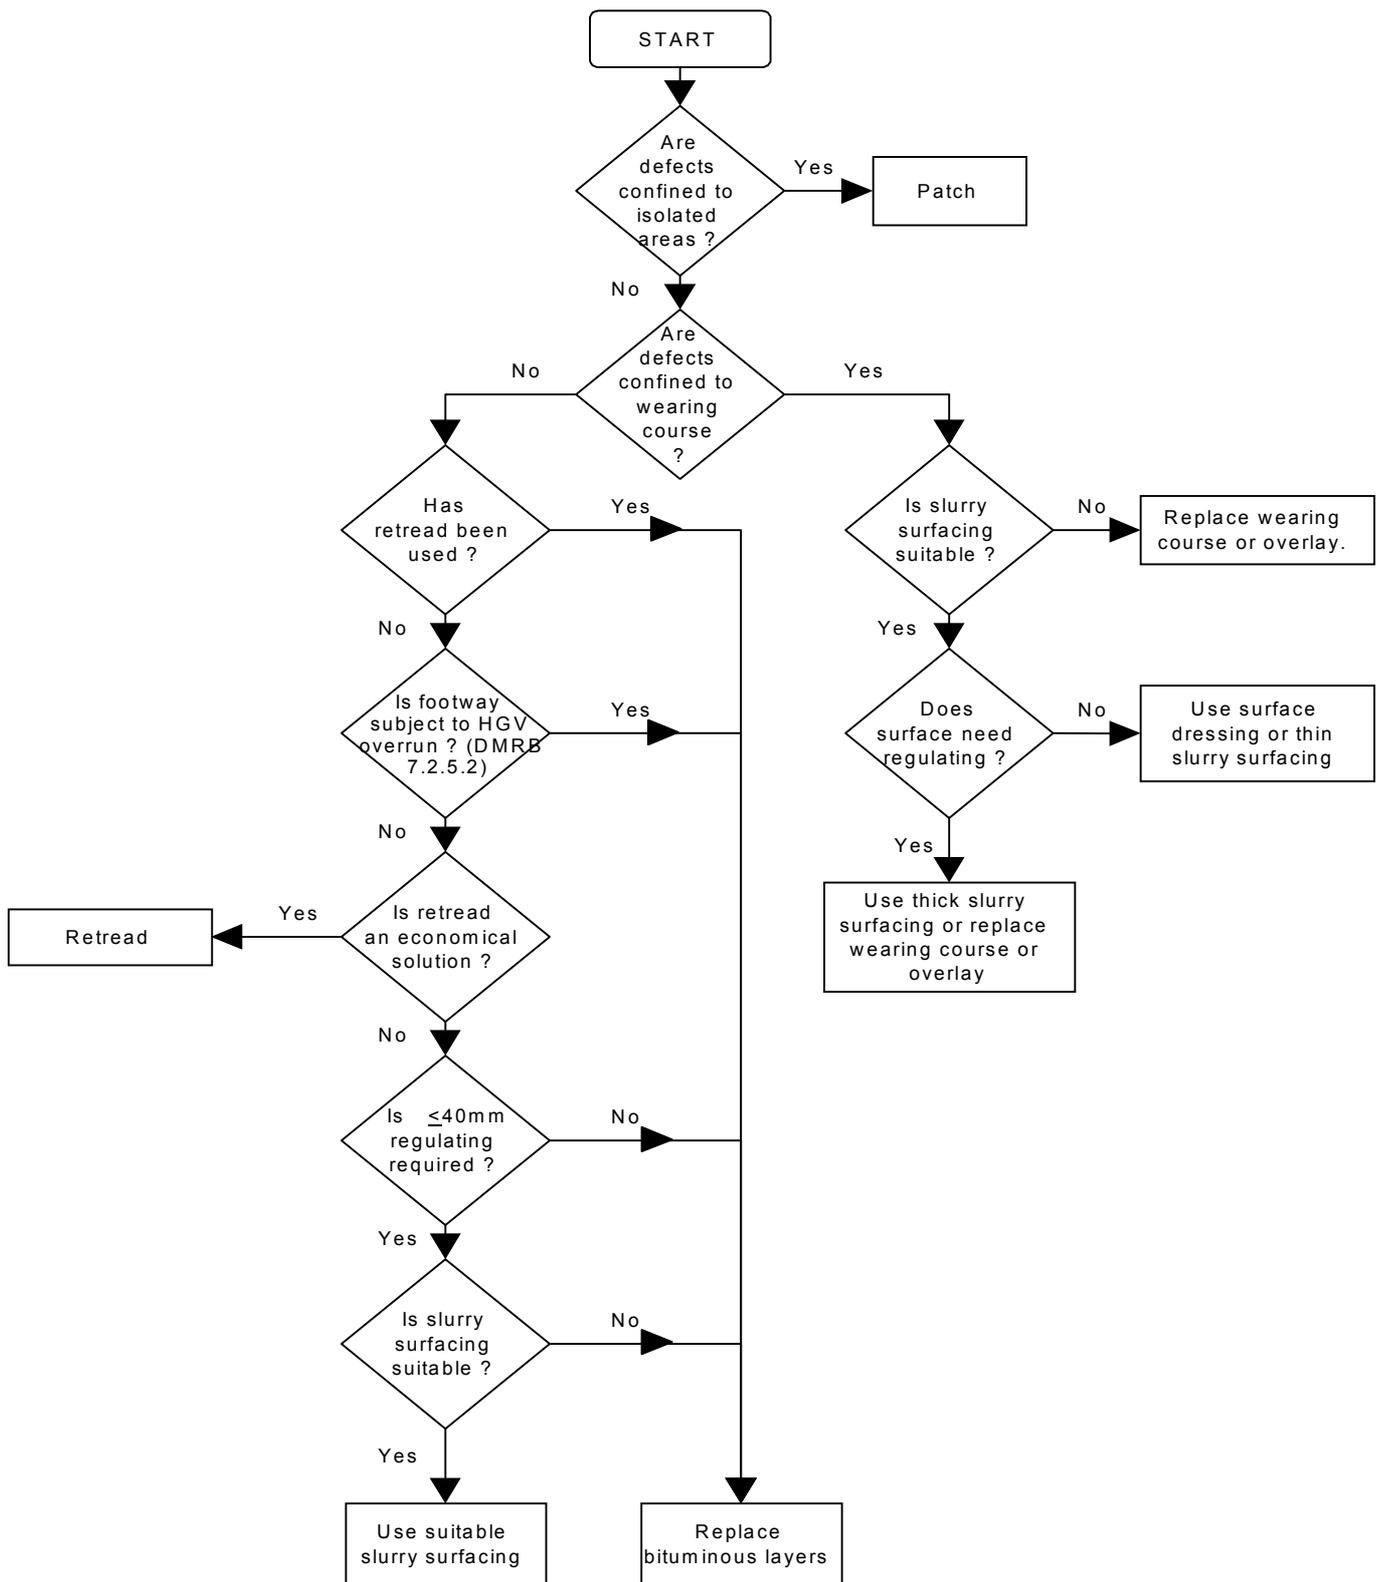
FLOWCHART 2 : BITUMINOUS

Notes If slurry surfacing has already been used twice for maintaining the surface, it is probable that the bituminous surface needs replacing rather than another application of slurry surfacing.

Any overlay, including thick slurry surfacing, can only be used if levels of damp proof courses etc allow.

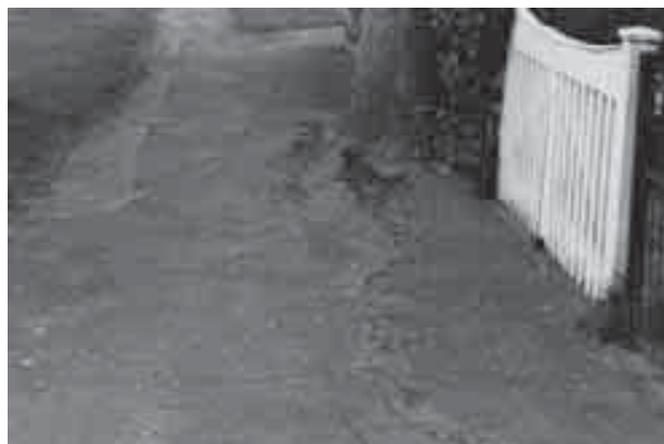
Depressions and bumps:

Circular or oval shaped depressions are usually a sign of local failure at sub-base or subgrade level. The causes are many and varied and should be investigated if the problem is more than an occasional depression. Local depressions can occur where vehicles park or overrun the footway, especially where the foundation is weaker than surrounding areas, possibly as a result of a drainage problem. Long narrow depressions are usually a sign of settlement in an undertaker's trench and are often accompanied by cracks and steps along the edges of the depressions.

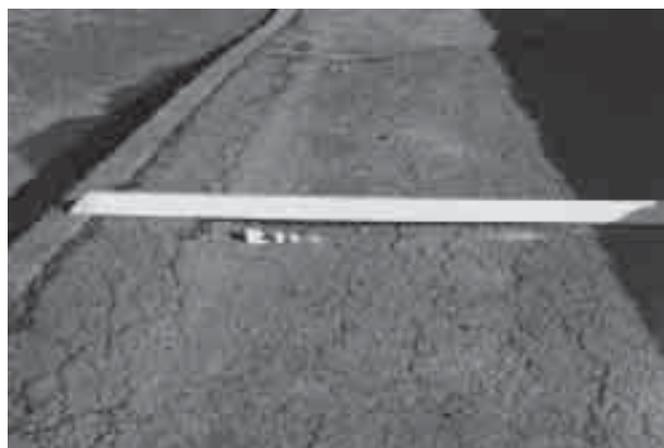
Rutting:

Longitudinal rutting usually occurs close to the kerb, caused by vehicles parking on the footway to avoid causing an obstruction in the road. Transverse rutting may occur at vehicular accesses. Although longitudinal ruts are more frequent and often deeper than transverse ruts, the latter are noticed more by pedestrians who may trip over them. In flag footways rutting is generally associated with cracked flags. It is important to identify whether the rutting is structural (due to failure of the foundation as for 'depressions') or non-structural (confined to surface layers only, exacerbated by long loading times of parked vehicles, and both high temperatures and high penetration binders in bituminous materials).

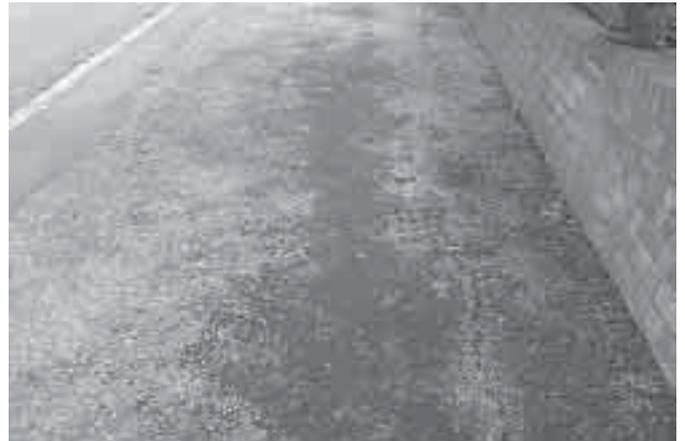
Slippery surface:

The majority of materials used for footway surfacing have a satisfactory inherent slip resistance. However, slip resistance can be affected by polishing of the surface due to constant trafficking, use of inappropriate aggregate, or growth of moss or lichen. Slurry surfacings, in particular, may become polished with age and wear.

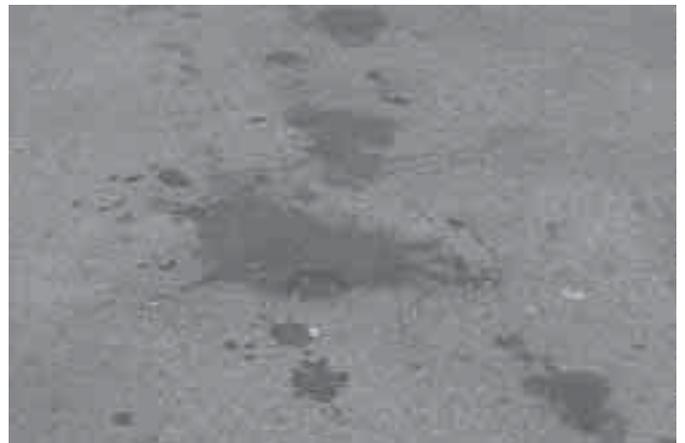
Surface contamination:

Surface contamination by foreign substances affects the aesthetic appearance of a footway by staining or discoloration. Fuel spillage may seriously lower the skid resistance, or soften bituminous material. It requires rapid removal, or the application of a neutralising agent, if damage is to be avoided.

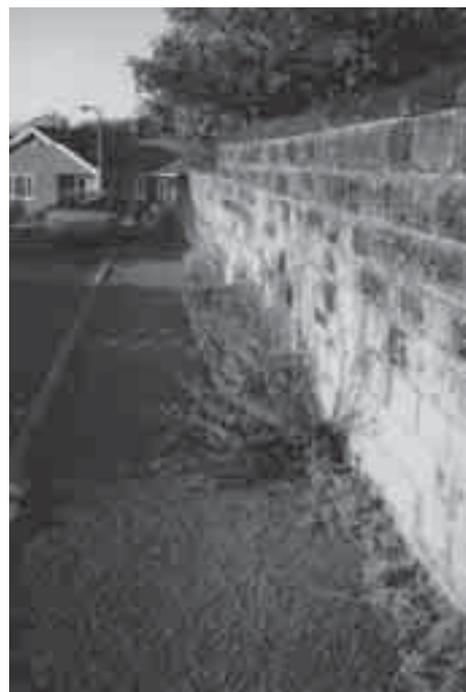
Vegetation:

Vegetation is remarkably persistent and will grow in any crack or gap which becomes filled with debris. Vegetation will therefore tend to be less of a problem in those footways which are cleaned and maintained regularly. Tree roots cause heave of the footway with associated cracks and trips. Weed growth in cracks and gaps causes them to widen leading to unevenness. Moss and lichen may make the surface slippery when wet.

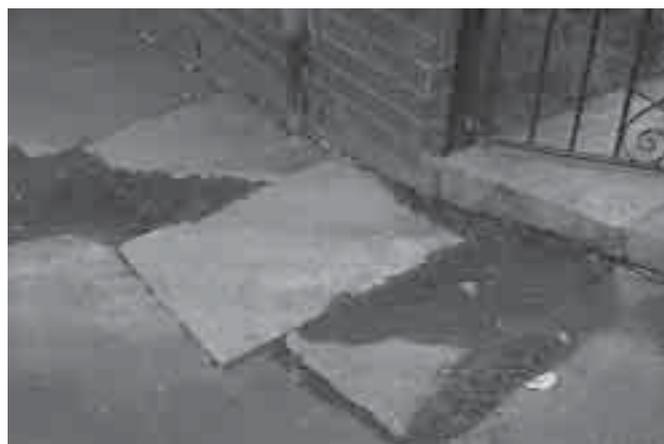
Water:

Water emerging from the footway is a nuisance to pedestrians and will lead to rapid deterioration of the footway if left untreated. It could be caused by a spring or, in urban areas, it is probably due to a leaking water main or a blocked drain. During freeze/thaw cycles the water may cause safety hazards. Standing water may occur in depressions, due to deterioration or to insufficient gradient on the surface profile, and may become a hazard to pedestrians in freezing conditions.

Cracks or joints in the footway surface may allow the ingress of water which will subsequently weaken the structure. Freezing water in cracks will cause further damage.

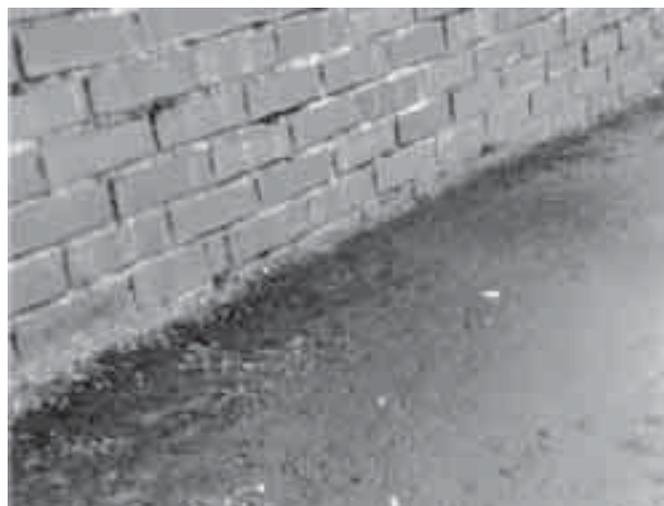
Excess binder:

This may be due to high temperatures or to binder rich material having been used. It requires treatment because of the inconvenience to pedestrians.

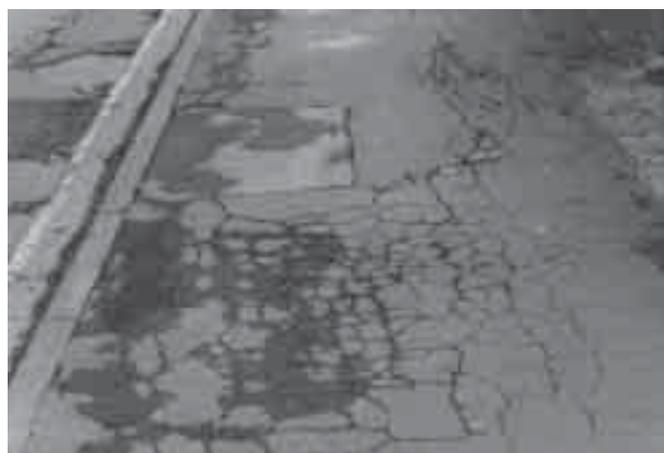
Mosaic cracking:

This may be due to structural failure of the foundation or embrittlement of the bituminous material. (Bitumen hardens in the presence of air and sunlight, and can lead to material which becomes brittle). Mosaic cracking appears as an area of approximately hexagonal plates with the dimension of the plates of the order of 50 to 100mm; the thicker the bituminous construction the larger the plate.

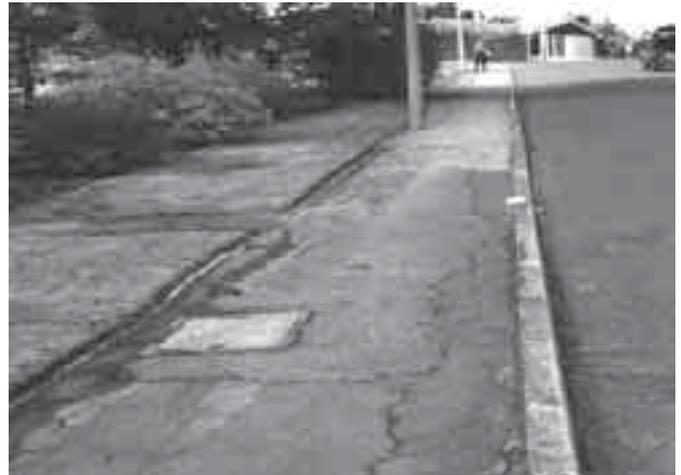
Linear cracking:

Cracking can vary from occasional hairline cracks, only visible in a drying surface, to major problems with gaps over 15mm and a difference in level across the crack of a similar dimension. The cause of the cracking needs to be established in order that appropriate maintenance be carried out. Linear cracking can occur due to ground heave or to differential settlement alongside a reinstatement. It may be reflective cracking, occurring if a bituminous surfacing is placed on a stabilised base, where cracks can be initiated by thermally induced stresses and by vertical movements between adjacent cementitious slabs caused by loading.

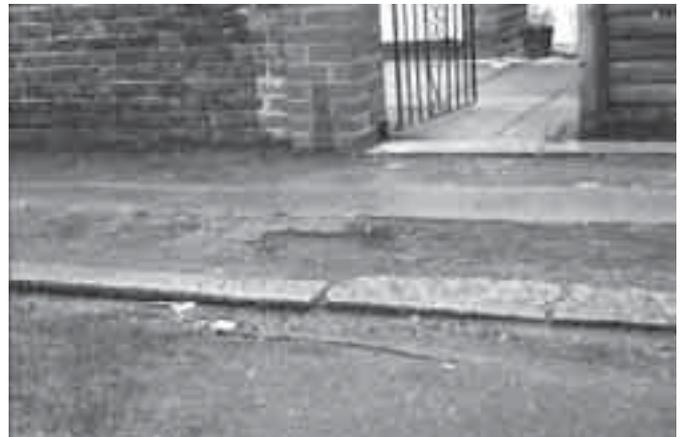
Loss of surface aggregate:

This can be due to fretting, stripping or loss of binder due to local pollution. Superficial **fretting** appears as a 'dryness' of the surface and a slight dustiness which arises as fine particles of aggregate in the surface loosen from the bitumen. This usually occurs in winter when the bitumen is more brittle. If it remains untreated it is likely to lead to loss of coarse aggregate on the surface and to ingress of water. Loose surface material can become a safety hazard. When aggregate is lost from slurry surfacing it can result in a smooth and, sometimes, slippery surface.

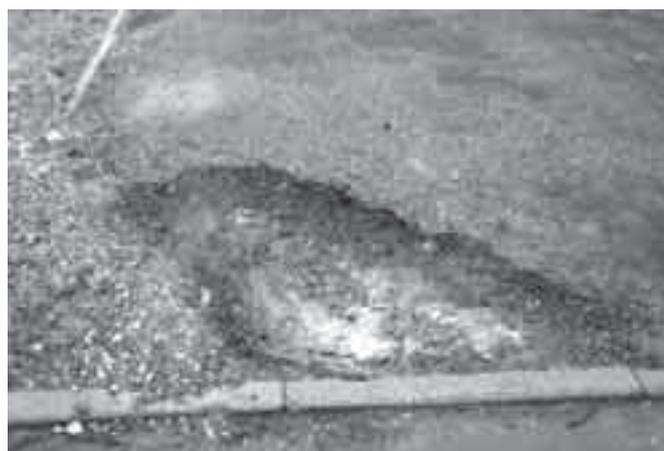
Potholes:

If fretting or stripping are allowed to continue unabated then it is likely that potholes will develop due to loss of material. This is the most obvious sign of failure of the upper layers of the footway and can be dangerous. The depth of a pothole usually equates to one or more complete bituminous layers.

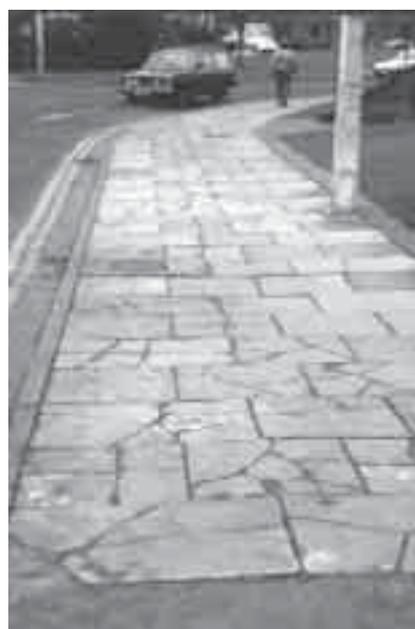
Broken or damaged modules:

Cracking can be merely unsightly or can be a hazard where it leads to wide gaps or trips. It can occur due to a combination of thermal warping and/or traffic loading. Thermal warping will lessen the support under the flag and traffic loading may then produce stresses higher than the modulus of rupture of the flag. The larger and thinner the flag, the larger the warping and traffic induced stresses. Cracking can also be a result of fatigue due to repeated loading. A stabilised bed provides no support to a warped flag and is thus unsuitable.

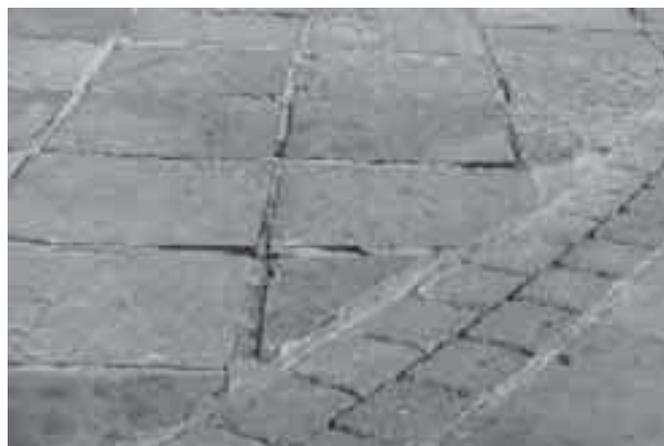
Loss of jointing material:

Loss of jointing material can be caused by trafficking, weather, water ingress, vegetation growth or the suction action of mechanical sweepers. For rigid jointing material the defect mechanisms leading to loss are the same as those of concrete. Mechanical breakdown or loss of jointing material causes modules to lose any interlock, thus reducing the load spreading ability of the modular surfacing. Modules also become free to move laterally and to rotate, which may result in rocking modules or widening of joints.

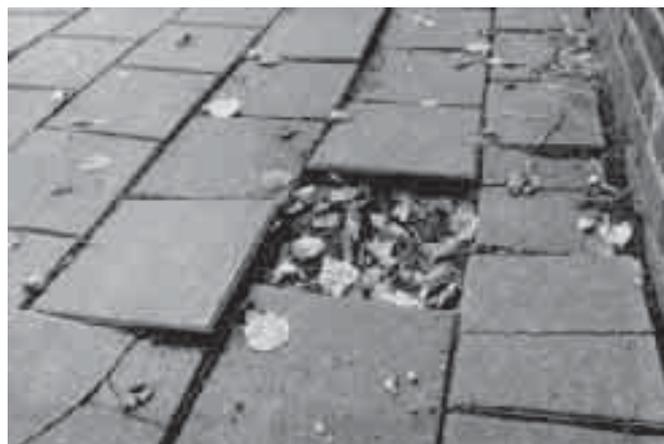
Missing modules:

Missing modules leave holes and trips, allow water to accumulate and weaken the structure of the remaining modules.

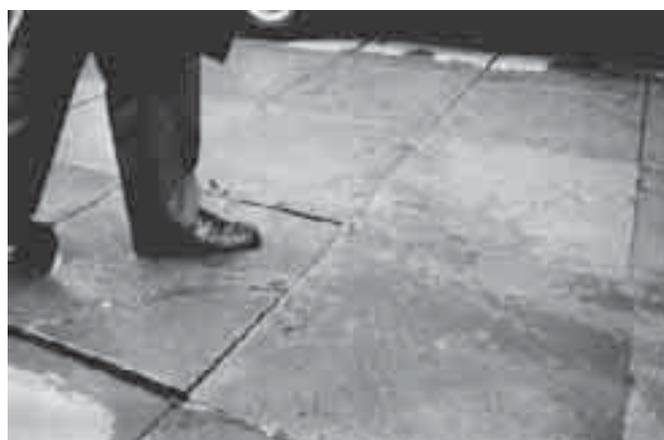
Rocking modules:

A paver, flag or sett which is not supported evenly will rock when loaded. The problem is exacerbated if the rocking pumps water and fines out from under the module, reducing the support further. This fault is usually only detectable if the module is walked on.

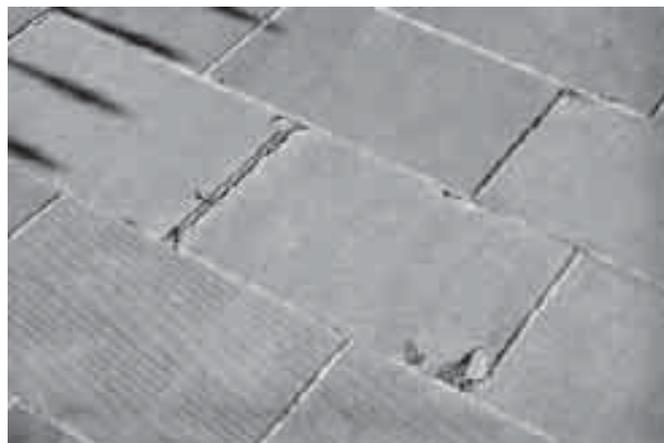
Spalling of arrises or surfaces:

Spalling of arrises can occur when modules rotate due to loading during construction or use, or lack of support, especially if the joint gap is small. Spalling occurs as adjacent modules exert pressure upon each other. Chips may be knocked off the top corners of flags or pavers when laying or during the life of the footway. This can detract from the visual appearance but rarely becomes a hazard.

Spalling of the surface, or loss of surface material, may occur if inappropriate natural materials are used and is unsightly rather than hazardous. It may be due to a manufacturing defect, impact loading, abrasion, weathering or possible chemical attack. York stone suffers from delamination which may result in an uneven surface.

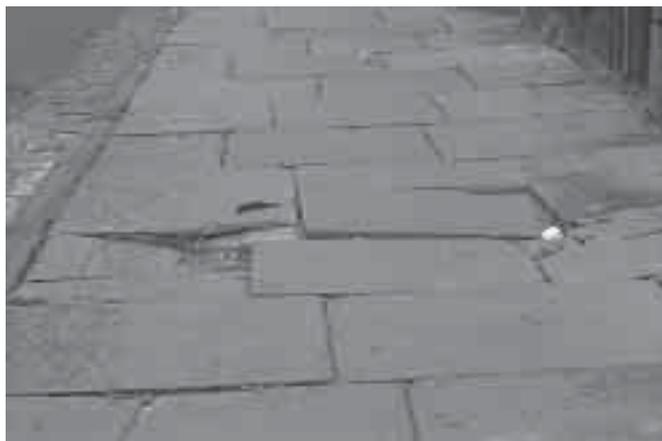
Trips:

Trips are caused where modules settle unevenly or crack. Where the difference in level is marked, trips present a hazard to pedestrians. This is more likely to be a problem with large flags.

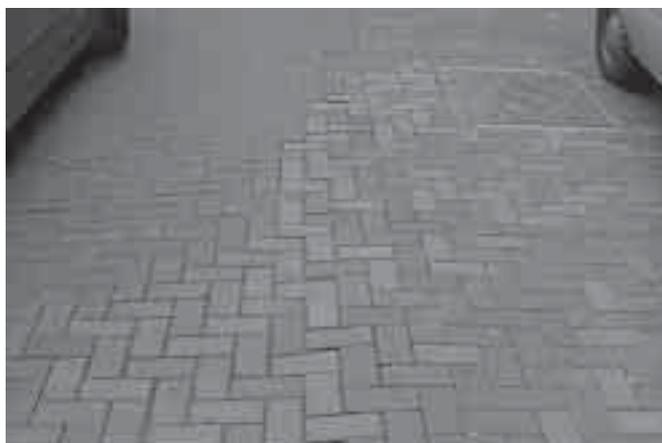
Unzipping:

Loss of interlock and movement of blocks or pavers may occur due to disturbance by excavation or to poor initial construction.

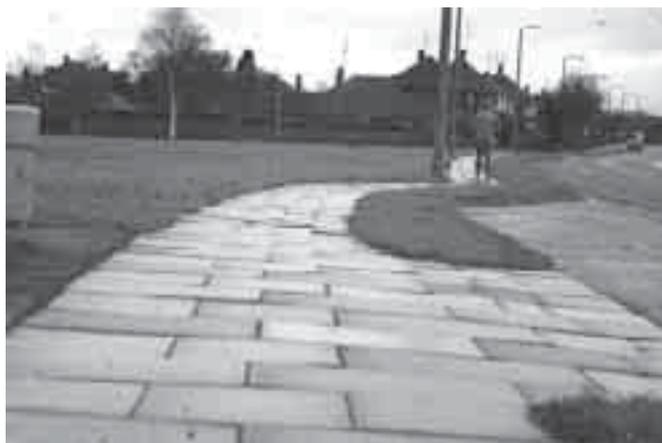
Widening of joints:

This may be indicative of ground movement, loss of jointing material or failure of footway edge constraint.

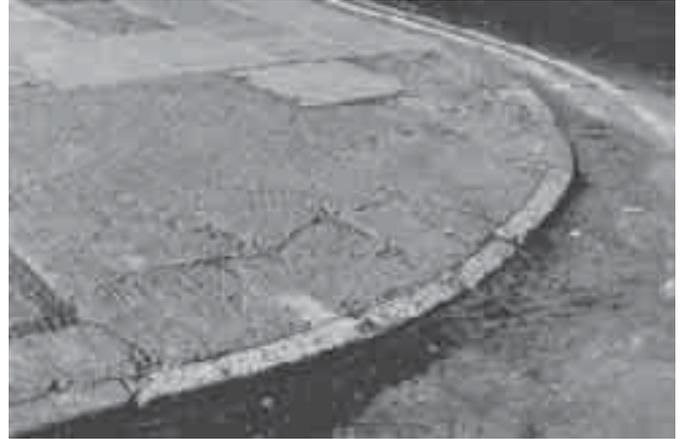
Cracking:

If large areas of concrete are laid without joints the concrete will crack as it cures. Cracks may also occur due to the concrete having insufficient tensile strength to support the stresses caused by loading and temperature changes. If the concrete has cracked sufficiently to impair its load spreading ability, depressions or ruts may result.

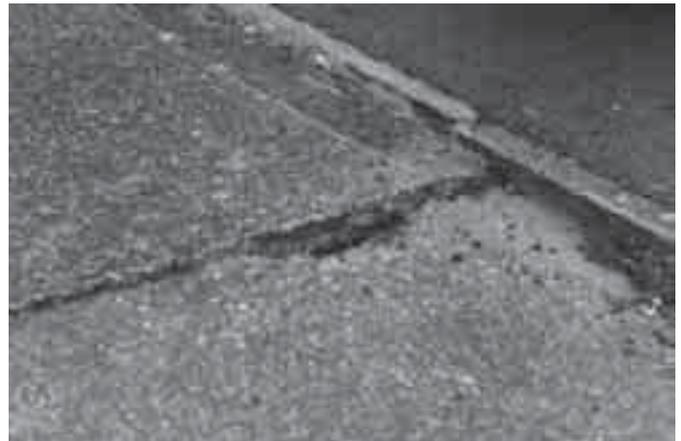
Damaged joints:

Damaged joints may occur as a result of movement of the concrete slabs due to loading or expansion. Spalling and cracking can result.

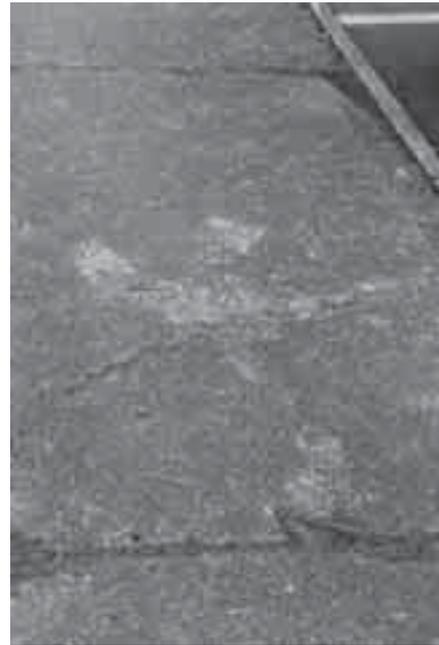
Surface damage:

The surface appearance can change and deteriorate due to weathering (sun, temperature changes, rain, snow, atmospheric pollution, freeze/thaw) which can result in cracks, and sometimes weed growth. Disruption caused by expansion of water on freezing can cause shallow surface scaling and delamination, leaving a rough surface. The effect is more pronounced for concretes with lower cement contents, because these have less strength and are more porous (interconnecting voids). However, air entrained concrete has excellent resistance to frost attack, since the discrete voids created by the admixture allow room for freezing water to expand without spalling the concrete. Chemical attack can lead to the surface aggregate becoming exposed or large areas of surface concrete being destroyed. Zones more prone to attack are near gullies where there may be a plentiful supply of contaminated water.

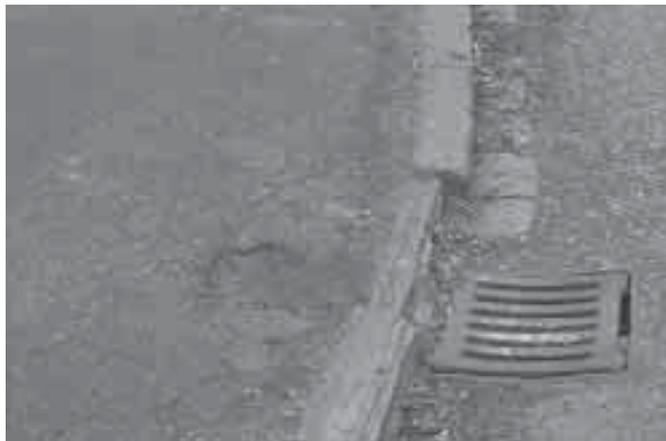
Broken or missing items: This may result in a loss of edge support to the footway. York stone kerbs may suffer from delamination

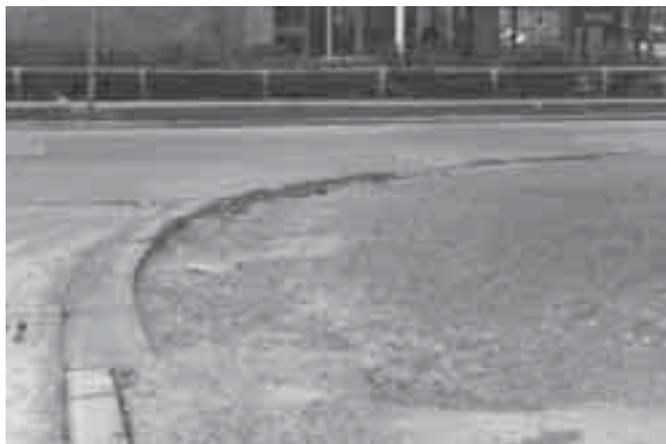
Horizontal or vertical steps:

If the kerb projects into the carriageway it may be dangerous for road users. Vertical steps may be a hazard for pedestrians.

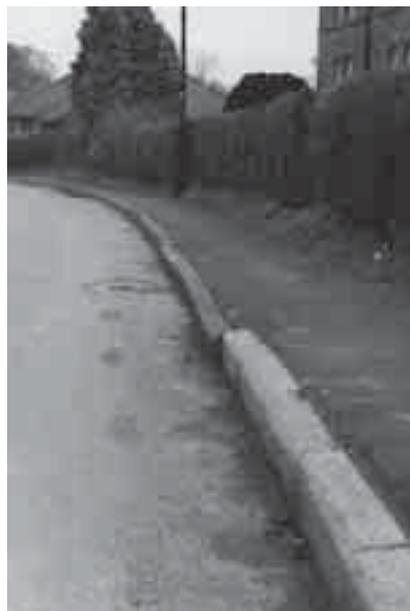
Poor alignment:

If preformed channels are part of the kerb, poor alignment can lead to drainage problems and water collecting in puddles. Poor kerb alignment may be a symptom of overrun, and may lead to ingress of water.

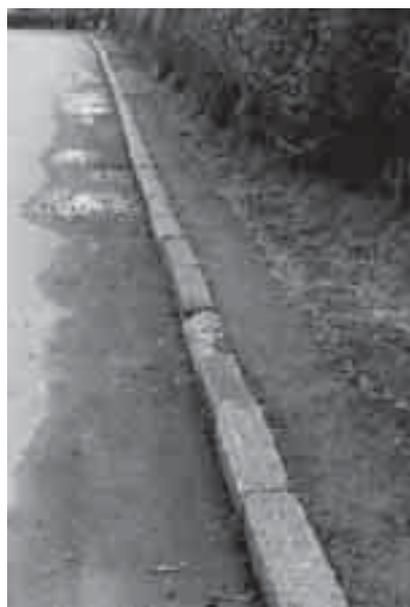
Spalling of arrises or faces:

Chips may be knocked off the top corners during the life of the footway. This can become a hazard depending on the extent of the damage. Spalling of the surface, or loss of surface material, may occur if inappropriate natural materials are used, and may become hazardous if vehicles mount or “knock” the kerb.

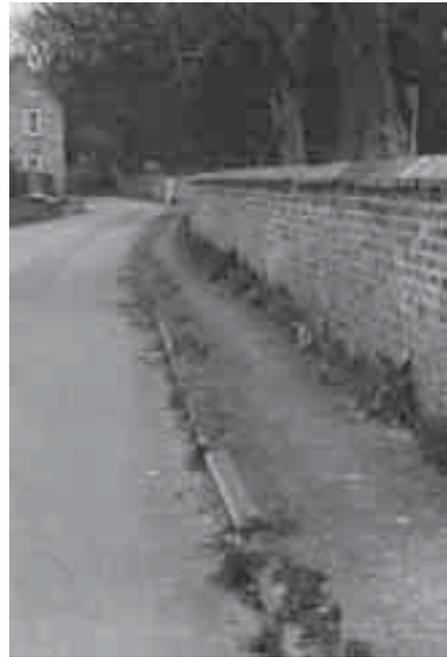
Vegetation growth:

Growth of vegetation along the edge of a footway or in drainage channels may prevent over edge run-off of water causing inconvenience to footway users.

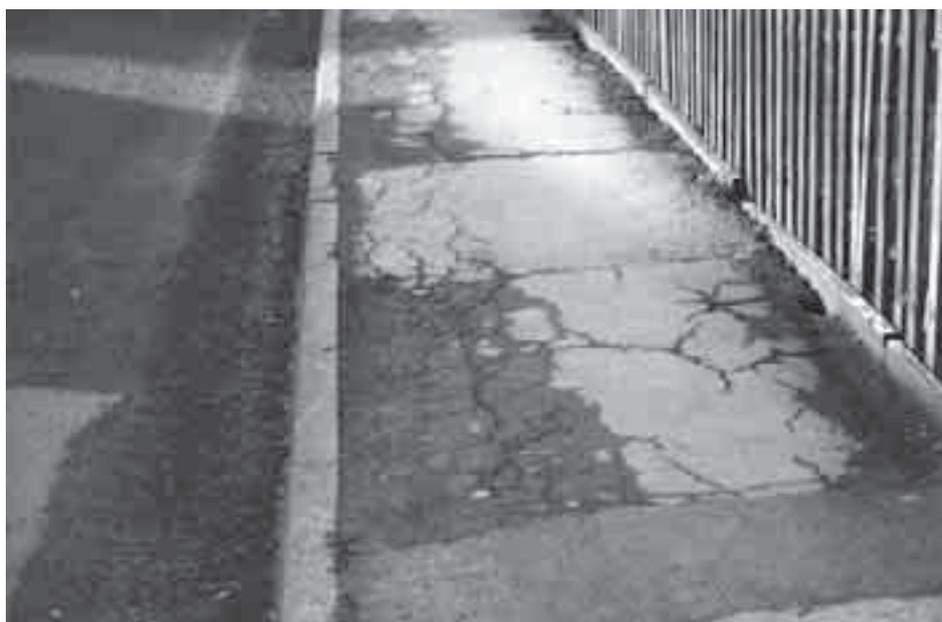
EXAMPLE 1

A narrow bituminous footway is adjacent to a relatively narrow carriageway which is on a bus route in a residential estate. The damage has occurred over the last 5 years, since the introduction of the bus route. The footway suffers overrun by buses as well as private cars and light delivery vehicles. The kerbs are less than 75mm in height and the back of the footway is poorly supported.

The footway should therefore be reconstructed according to DMRB 7.2.5.3 (Heavy-vehicle design). Consideration should be given to lifting the kerbs to help prevent future overrun. Replacement of the surfacing will also be required.

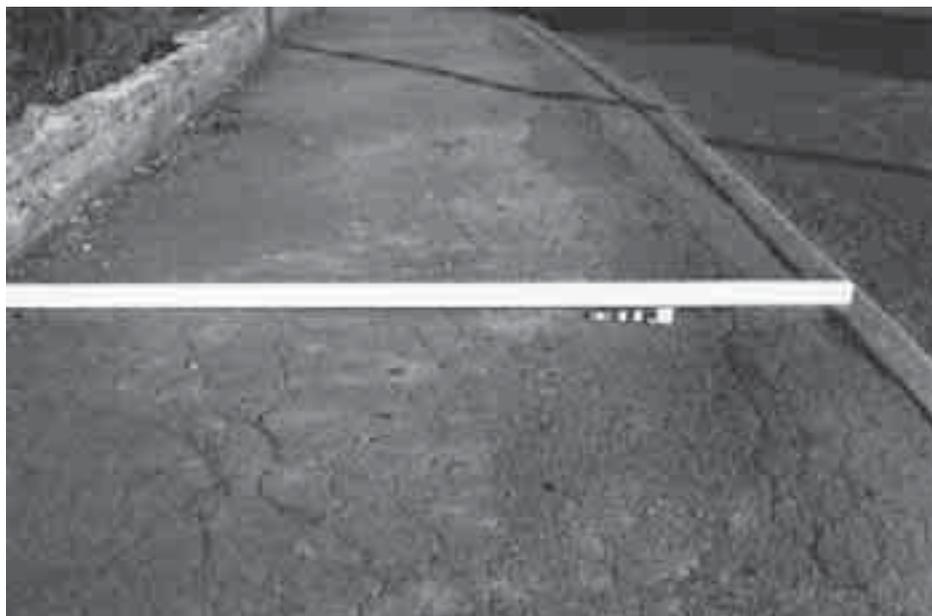
EXAMPLE 2

A bituminous footway is situated in a cul-de-sac in a residential area approximately 30 years old, and has received little past maintenance. It suffers overrun by private cars and delivery vehicles. The bituminous material shows signs of a combination of thermal and age induced cracking. There is a longitudinal rut, over 25mm deep, on the footway.

As the footway has received little maintenance over 30 years, and the deformation appears to have been progressive during that time, it is worth considering removing the deformation by replacing only the bituminous layers. However if the foundation is not sufficiently strong, the problem may recur (Chapter 4, Table 4.2).

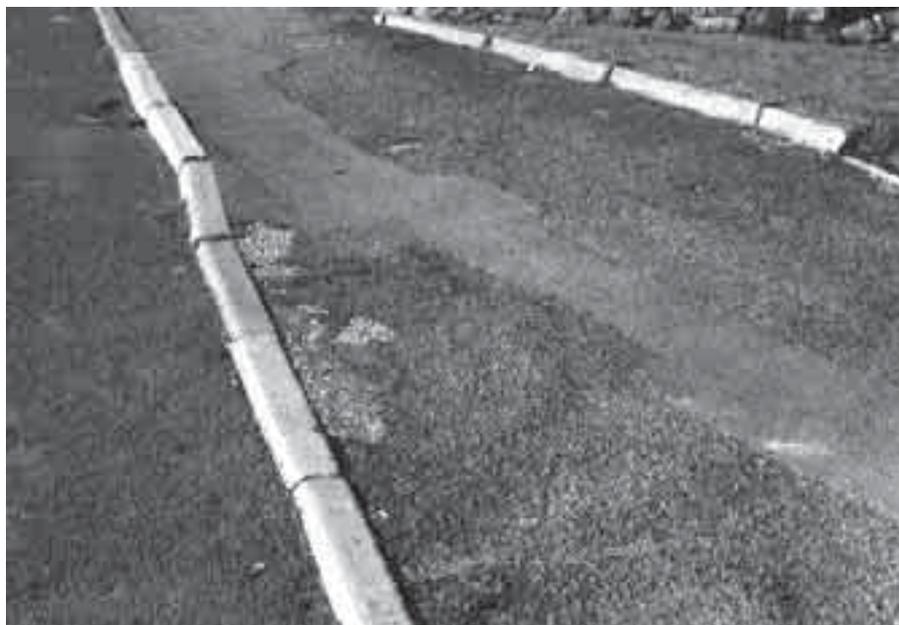
EXAMPLE 3

A bituminous footway in a residential area presents an uneven surface due to considerable loss of wearing course material. Some of the kerbs are slightly out of line due to undertakers' activities. There is no rutting.

Defects are not confined to isolated areas but, apart from the detail of kerb alignment, are confined to the wearing course.

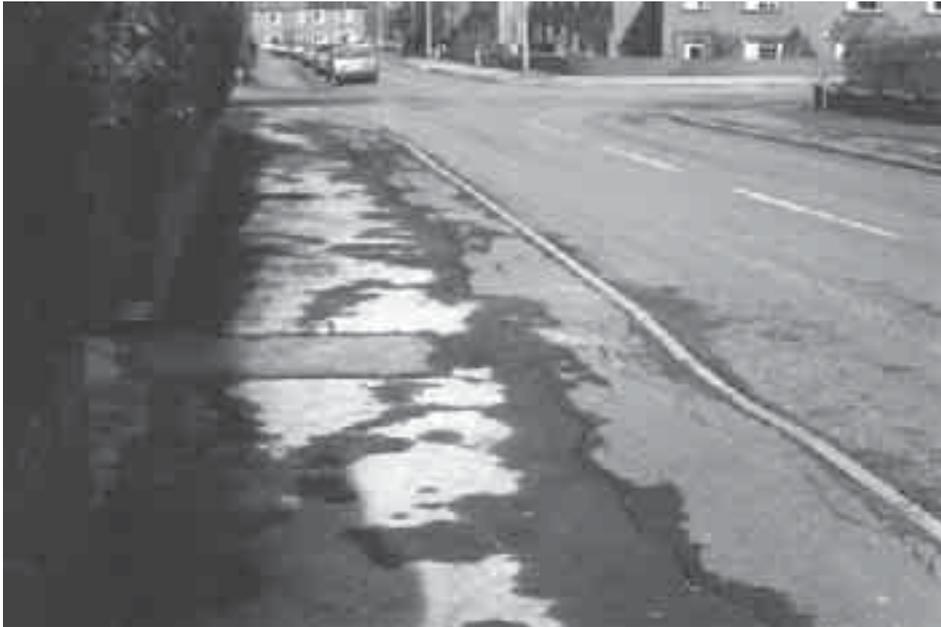
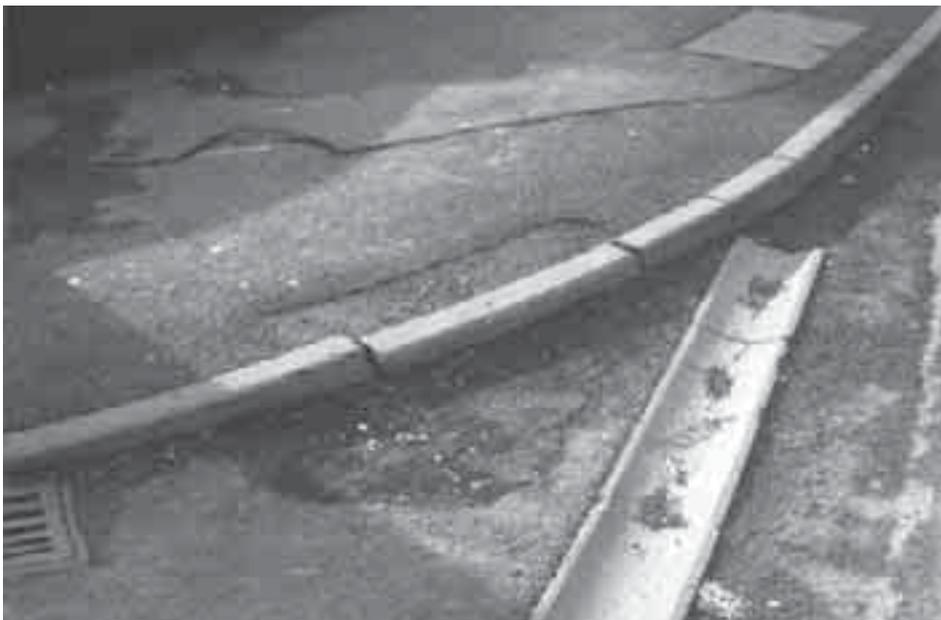
EXAMPLE 4

A bituminous footway in a late 1950's residential estate is in need of maintenance. The general view of the estate shows depression of kerbs due to a vehicular crossing and cracking in an old undertakers' reinstatement. The photograph of the corner shows that the kerb in the centre has been replaced in the past and it appears that the final patching at the back and front was not completed. The replacement kerb is shorter than the original and the kerb adjacent to the gully is tilting. In the upper part of the picture, overlaid patching following undertakers' activities has failed leaving a trip. There is no rutting.

Following Flowchart 1, there is no root growth, surface contamination or slip, but there is failure of edge restraint and the tilting and unsuitable kerbs should be replaced (Chapter 5, Clauses 5.67 - 5.69). The failed reinstatement is well over 2 years old and is not, therefore, in the guarantee period. There is no indication of foundation failure.

Defects appear to be confined to the wearing course. The worst defects are in isolated areas.

Defects could be treated with more overlay patching (Chapter 5, Clauses 5.19 - 5.21, 5.35 - 5.37). However, the appearance of the footway would be enhanced if it were resurfaced rather than receiving further patching.

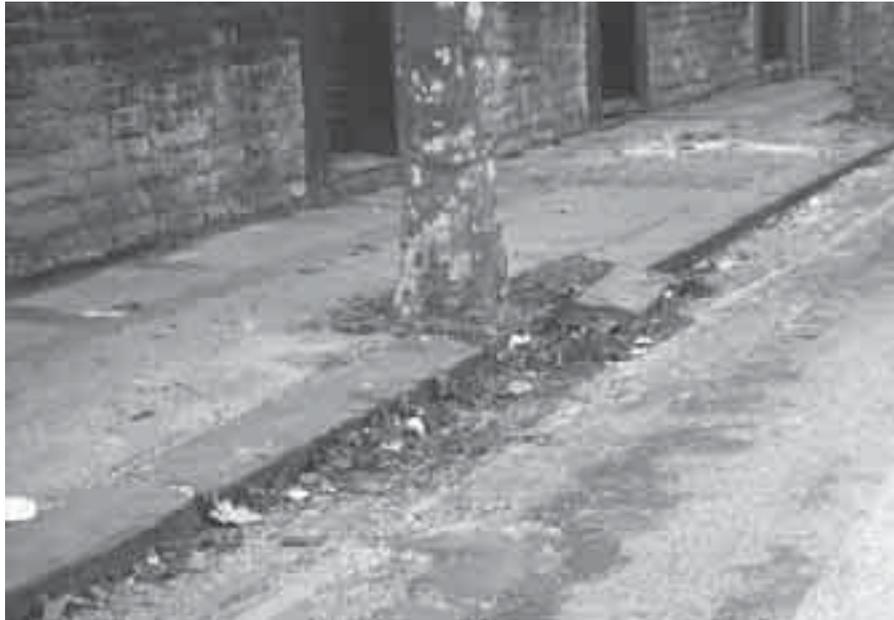
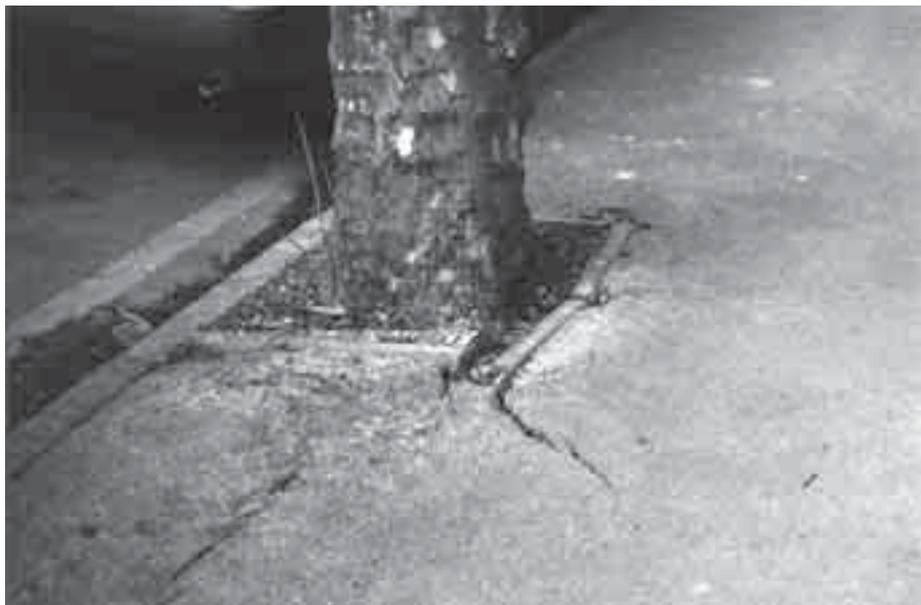
EXAMPLE 5

The photographs show the footway on both sides of the road in an urban residential area with terraced houses. It appears to have been originally surfaced in stone flags which have been replaced with bituminous construction. The stone kerb is believed to be original. The kerb has been displaced because of growth of tree roots which have also caused cracking of the bituminous surface.

The displaced kerb is a safety hazard and should be removed until it can be replaced (Chapter 5, Clauses 5.8 - 5.16).

Following Flowchart 1, root growth and subsequent failure of edge restraint and cracking are the only problems.

The tree roots should be pruned, if possible, to minimise future problems. The displaced kerb can be shortened to fit around the roots and narrower edging can be used immediately adjacent to the tree. The concrete edging forming a box around the tree can be replaced leaving more room for root growth, providing that the footway remains sufficiently wide for pedestrians. The bituminous footway needs relaying where it has become uneven (Table 4.1 and Chapter 5, Clauses 5.55 - 5.60).

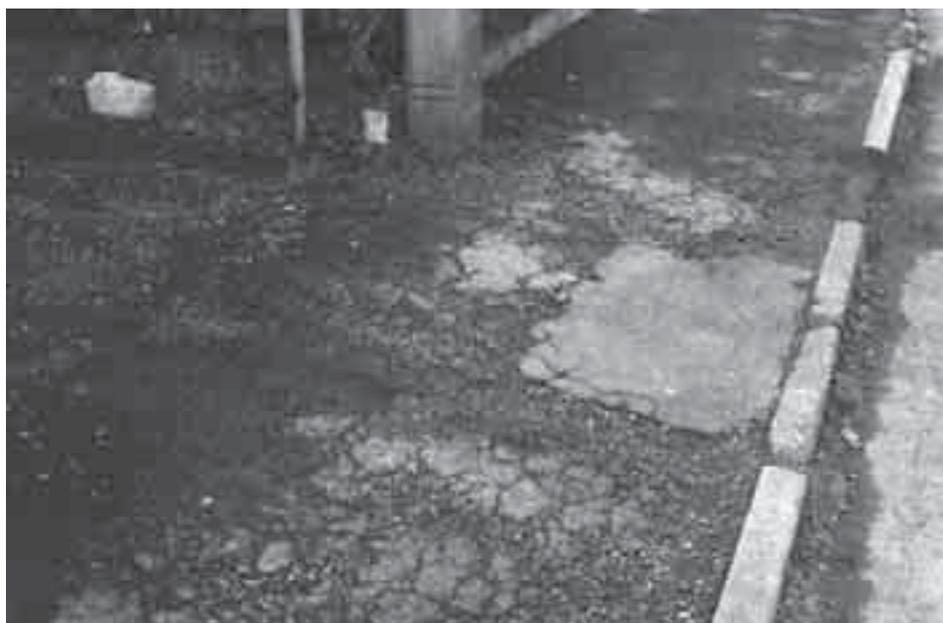
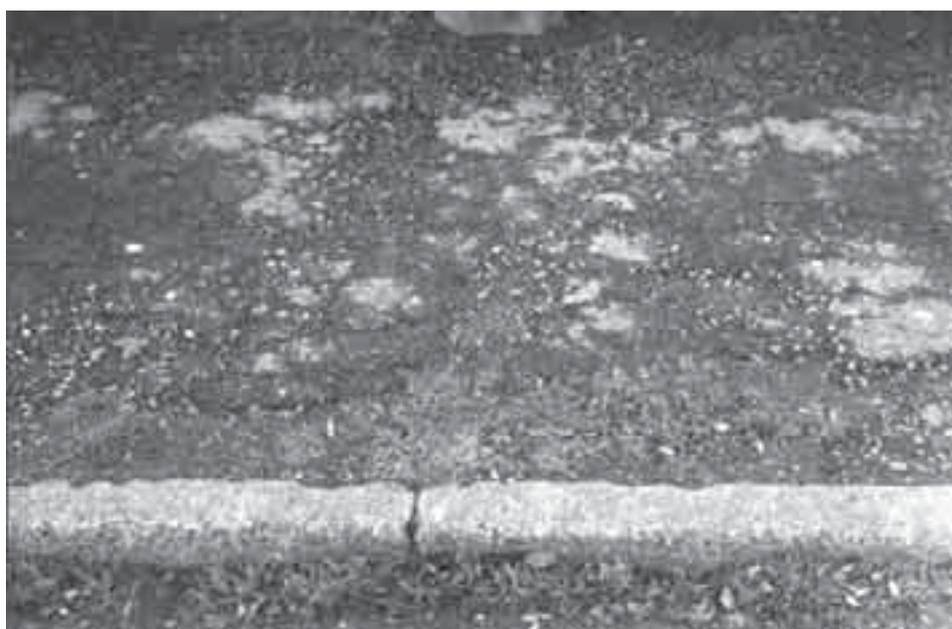
EXAMPLE 6

A footway in a residential street some 40 years old has not received any maintenance since its construction. The surfacing is worn and uneven with some loose material, significant loss of wearing course material, cracking and weed growth. Missing kerbs have been patched with bituminous material.

Following Flowchart 1, the surface should be replaced and the edge restraint reconstructed. Foundation failure is not indicated.

The deterioration is general, not confined to isolated areas or to the wearing course. The footway is too degraded for slurry surfacing to be used. The footway is not subject to HGV overrun and retread has not previously been used, so it is one possibility.
