**VOLUME 7 PAVEMENT DESIGN AND
MAINTENANCE**
**SECTION 4 PAVEMENT
MAINTENANCE
METHODS**

HD 40/01

FOOTWAY MAINTENANCE

This part provides guidance on footway maintenance. It provides advice on inspection of footways, the likely causes of defects and the possible treatment options that are available.

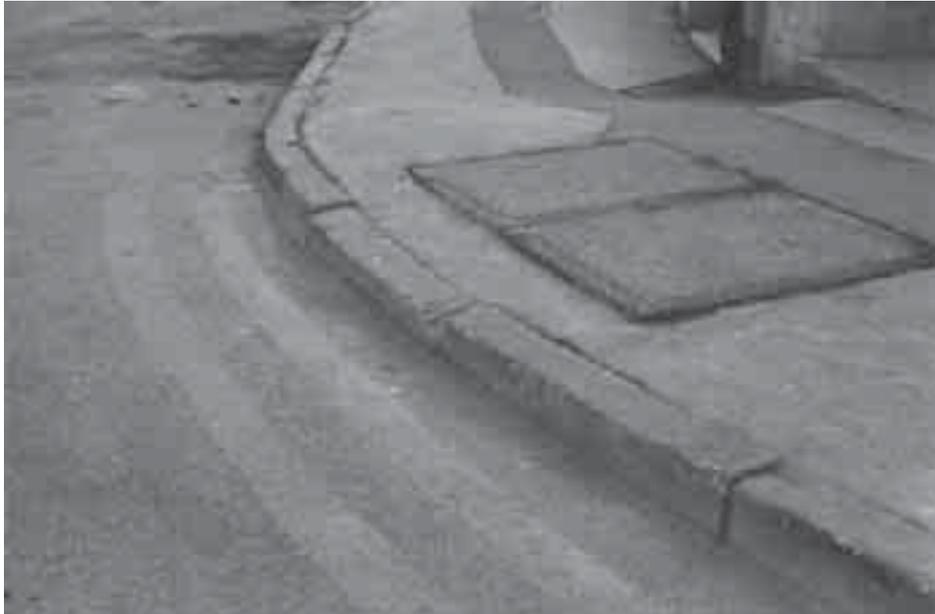
EXAMPLE 7

A footway in a small market town suffers from overrun, especially from heavy delivery vehicles, which has caused the kerbs to sink. This has allowed the formation of a trip adjacent to an undertaker's cover.

Following Flowchart 1, the kerb should be replaced. Foundation failure is indicated as the kerb has sunk and rotated and the footway behind the kerb is depressed.

The footway should be strengthened locally to prevent further deterioration due to overrun. When the kerb is being realigned the sub-base under the corner of the footway could be replaced with concrete to give additional strength (Chapter 5, Clauses 5.67 - 5.69). This could be brought to the surface level or an inlaid patch of bituminous material could be applied over the concrete (Chapter 5, Clauses 5.20 - 5.21).

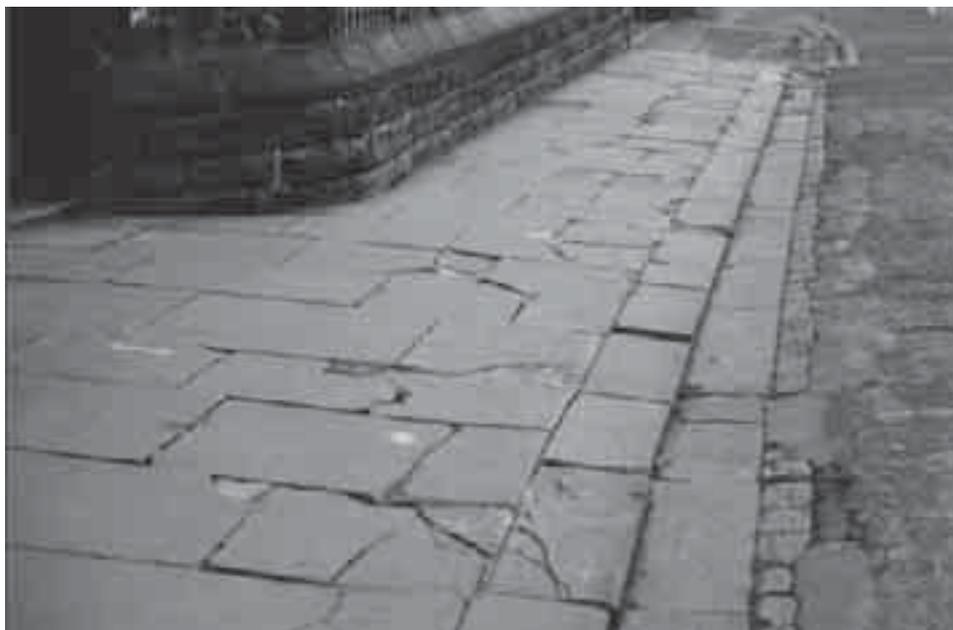
EXAMPLE 8

A flagged footway on a 100 year old urban street is in a bad state of repair. The footway is surfaced with large natural stone flags. Most kerbside flags are cracked and the kerbs have sunk. A combination of overrun by delivery vehicles and laying of undertaker's apparatus, with inadequate backfill to the trench before the flags were relaid, has caused breaking and spalling of the flags.

Safety hazards such as significant trips or rocking flags need to be dealt with as a matter of urgency. Modules can be replaced, temporarily, with bituminous material (Table 4.3 and Chapter 5, Clause 5.9).

The footway should be reconstructed following the recommendations of DMRB 7.2.5.3 (Heavy-vehicle design).

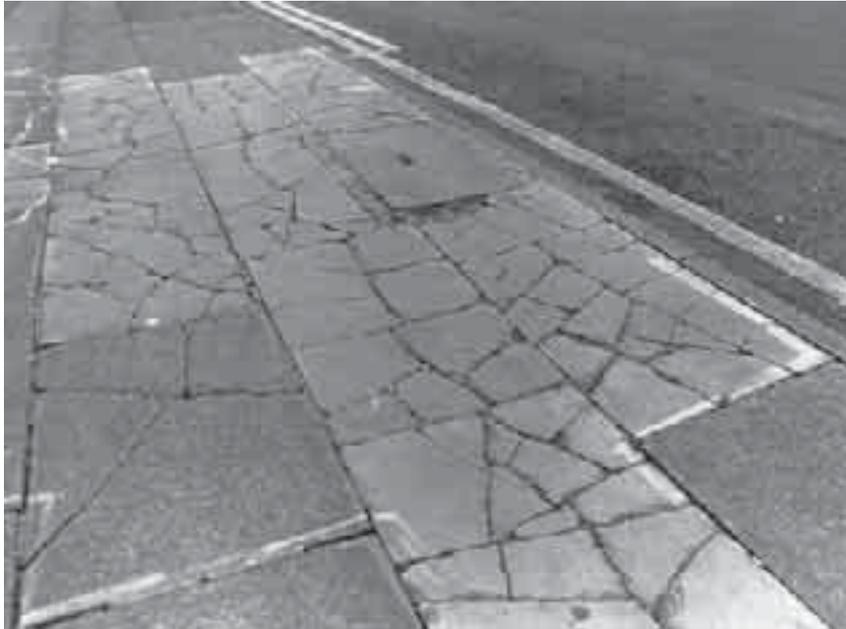
EXAMPLE 9

A flagged footway is adjacent to a public house. Damage has been caused by delivery vehicles, more particularly due to the impact loading caused by the off-loading of barrels.

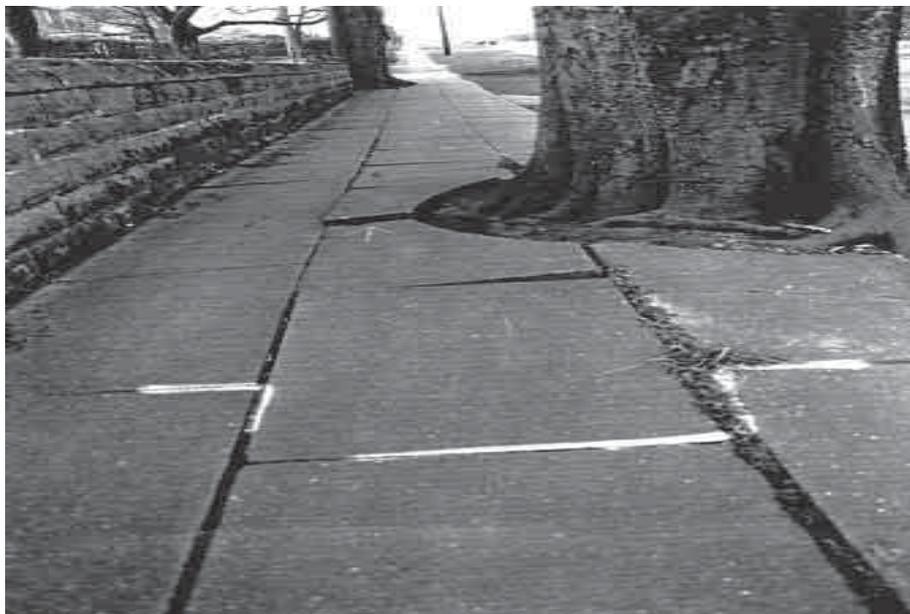
EXAMPLE 10

A flagged footway in a suburban street requires attention because of trips around mature trees. The footway is otherwise in a good state of repair.

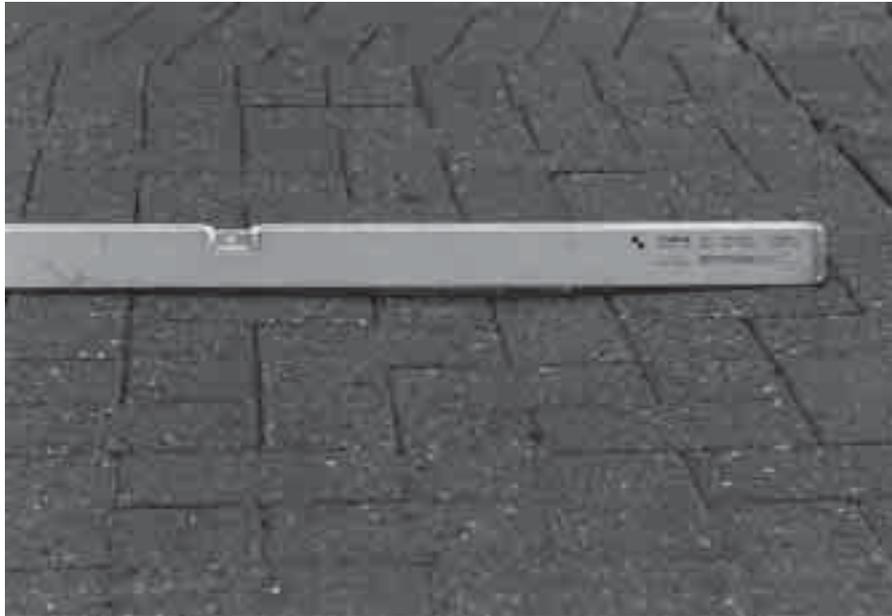
EXAMPLE 11

A footway in a shopping centre is surfaced in concrete blocks. It has a depression along the line of an undertaker's reinstatement that was carried out three years ago.

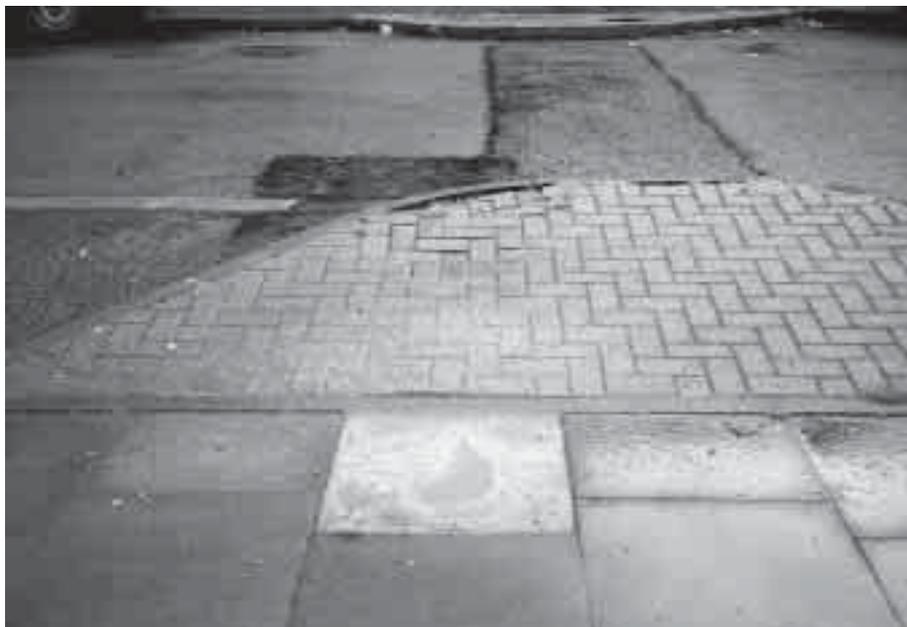
EXAMPLE 12

A footway has been built out into the road as part of traffic calming measures. A gap has now opened between the concrete blocks and the kerb and the surface of the pavers has become uneven. An adjacent reinstatement indicates that the problem may be due to the pavers having not been properly replaced on completion of the reinstatement.
