Highway Structures & Bridges
Inspection & Assessment

CS 460

Management of corrugated steel buried structures

This document details the management requirements for corrugated steel buried structures.

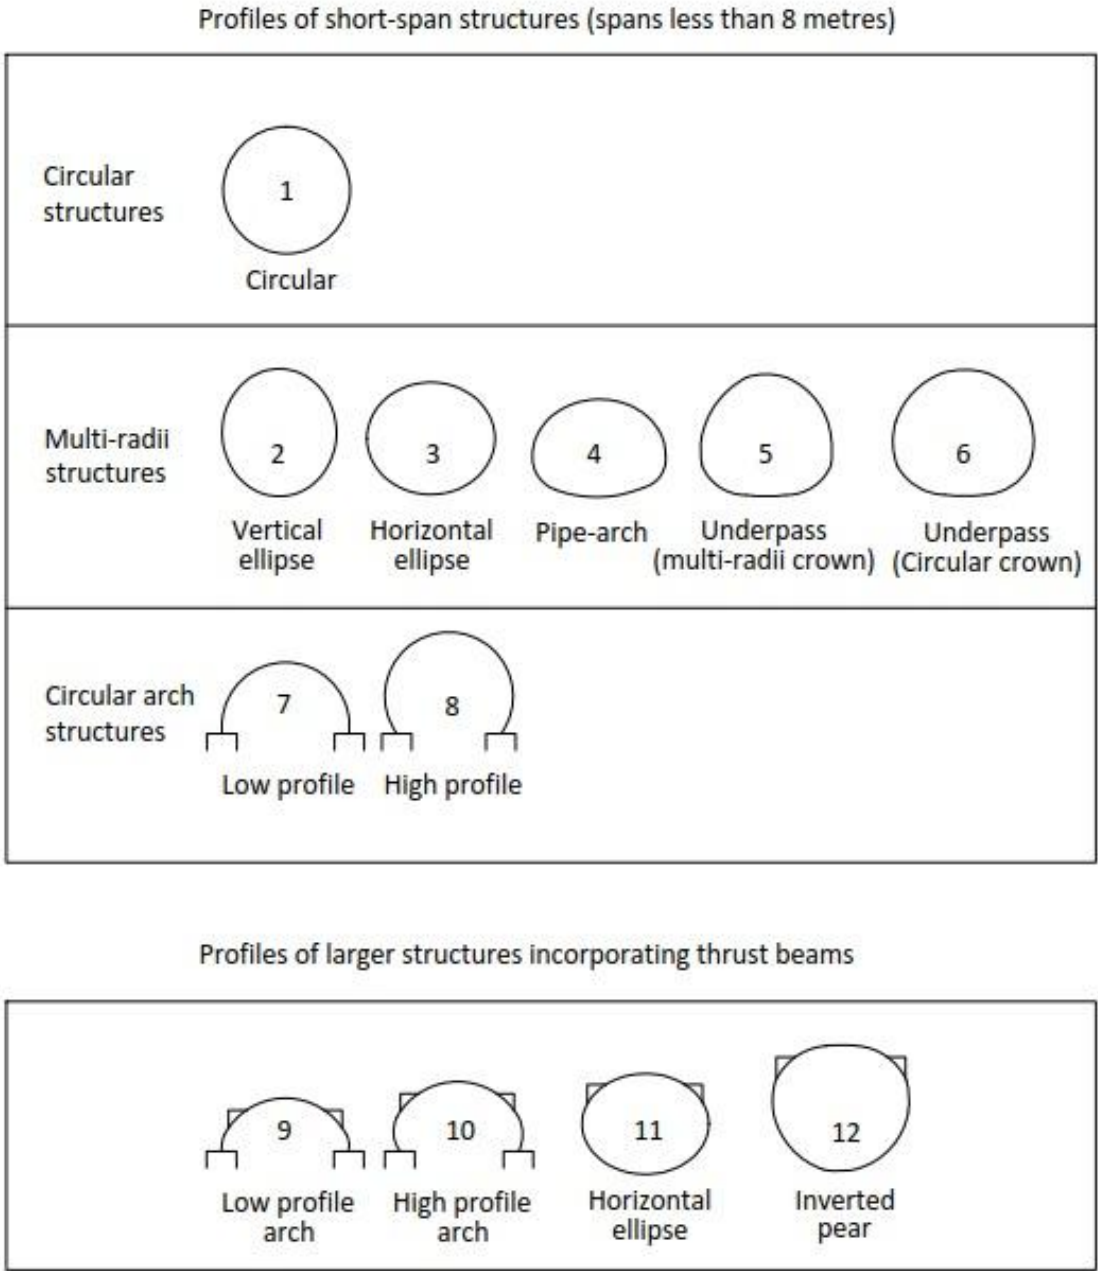
Figure A.1 Typical profiles of CSBS commonly installed in the UK

Corrugation size mm (Imperial units)	Approximate range of spans metres (Imperial units)	Thickness range of steel plate mm (Gauge size)	Shape (see Figure A1)
Riveted - prefabricated 20 ft (6.0 m) standard lengths			
68 x 13* (2 2/3 in. x 2 in.)	0.9 - 1.8 (36 in. - 72)	1.5, 1.9, 2.7, 3.4, 4.2 (16, 14, 12, 10, 8 gauge)	1 & 4
Spirally corrugated lock seam - normally supplied in 6.0 m lengths			
68 x 13	0.9 - 1.2	1.5, 2.0, 2.5, 3.0, 3.5	1
100 x 20	0.9 - 3.0	1.5, 2.0, 2.5, 3.0, 3.5	1
125 x 25	1.2 - 3.6	1.5, 2.0, 2.5, 3.0, 3.5	1
Bolted			
68 x 13	0.9 - 2.0	1.5, 2.0, 2.7, 3.5	1 & 4
100 x 20	0.9 - 3.0	1.5, 2.0, 2.5, 3.0, 3.5	1 & 4
100 x 22	0.9 - 3.6	1.5, 2.0, 2.5, 3.0, 3.5	1 & 4
152 x 32	1.2 - 3.5	2.0, 3.0, 4.0	1 & 4
152 x 51* (6 in. x 2 in.)	1.5 - 7.0 (5 ft - 24 ft)	2.7, 3.5, 4.2, 4.7, 5.5, 6.2, 7.0, (12, 10, 8, 7, 5, 3, 1 gauge)	1 - 7, 9 - 12
200 x 55	3.5 - 12.0	2.75, 3.25, 4.0, 4.75, 5.5, 6.25, 7.0, 7.75, 8.0	1 - 12

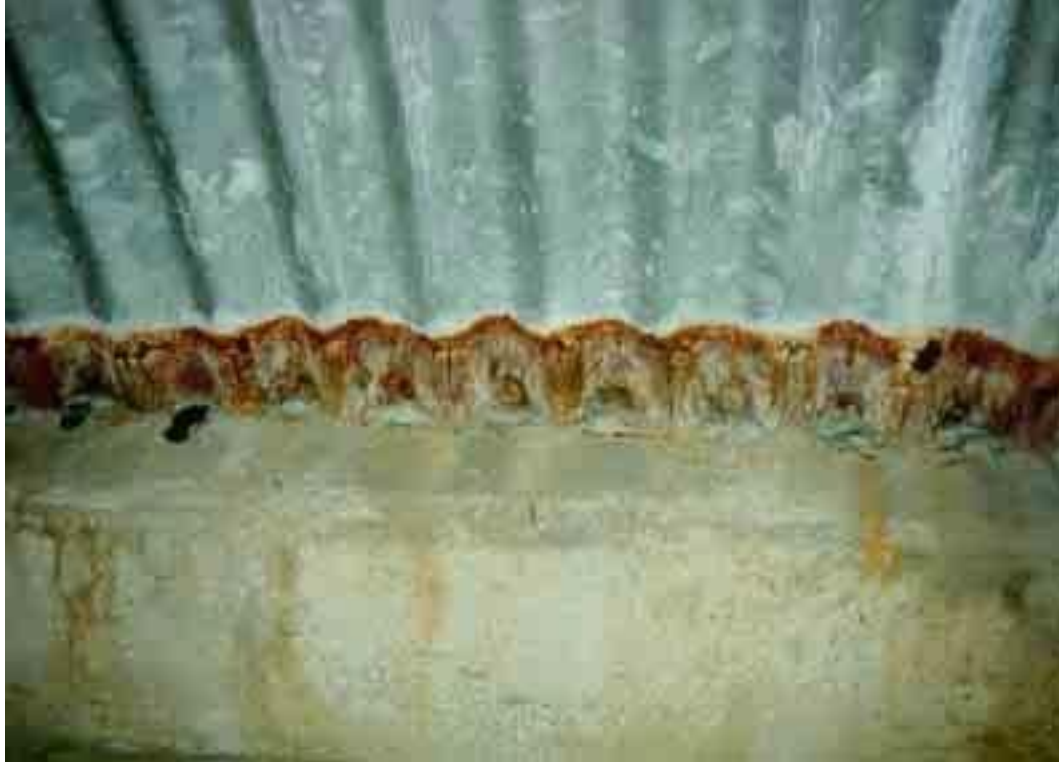
Figure B.9 Deterioration at the arch seating of a plain galvanised arch structure due to seepage and ponding of water containing de-icing salts

Figure B9 shows the deterioration in a 25-year-old plain galvanised arch structure. Water laden with deicing salts has percolated into the structure below the edges of the carriageway. Corrosion is most noticeable around bolt holes and plate edges in the crown and also where it has ponded in the seating channel of the arch. The rest of the structure is in good condition.
