Design Manual for Roads and Bridges

CS 460

Management of corrugated steel buried structures

This document details the management requirements for corrugated steel buried structures.

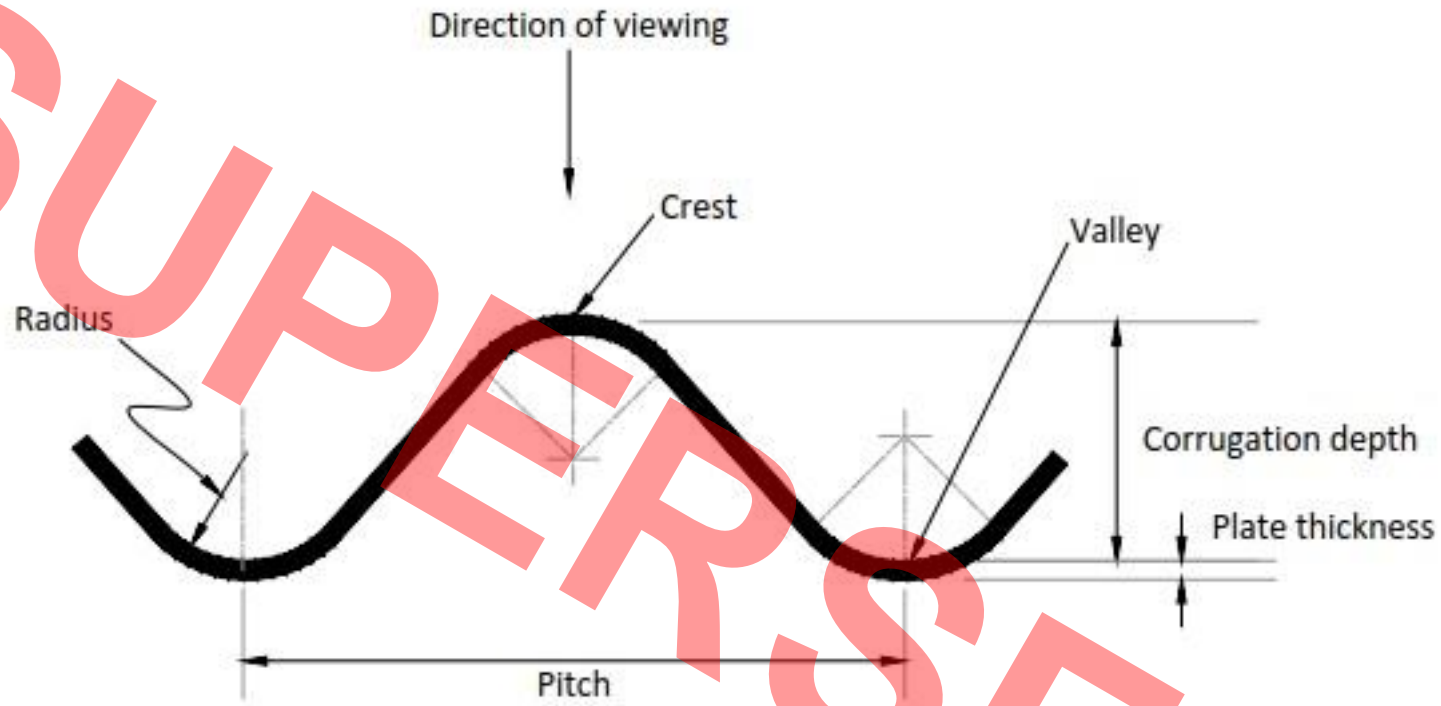
Figure A.5 Terminology relating to the corrugation profile

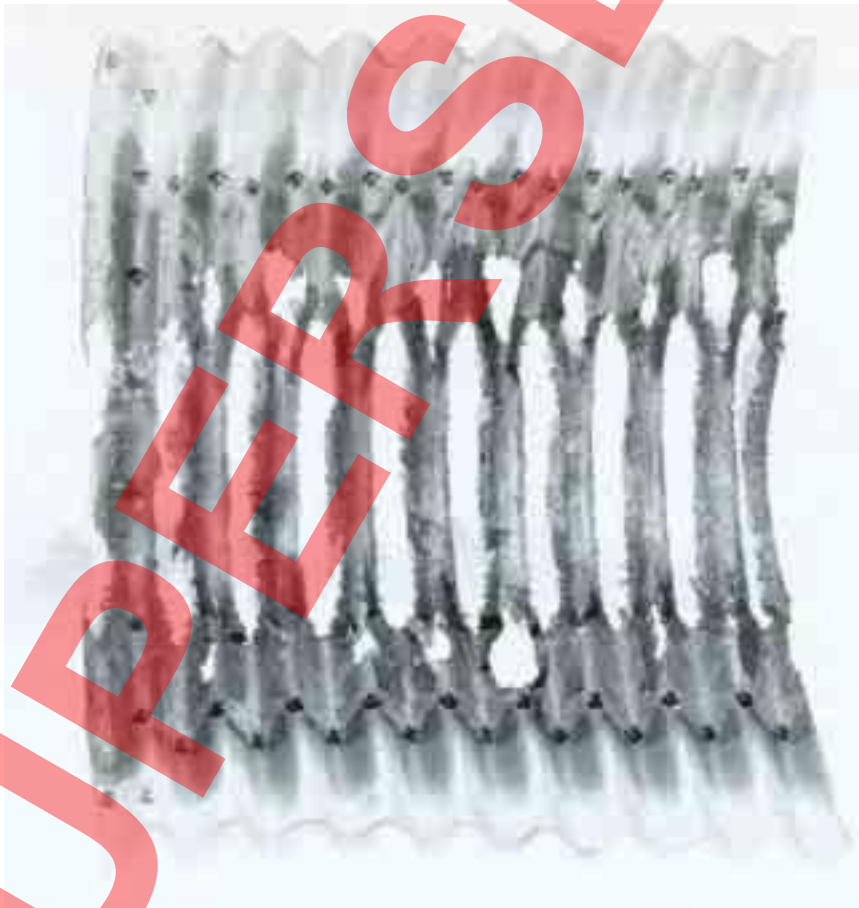
Figure B.1 Example of extreme corrosion in the invert of a structure subject to scour (this 30 year old structure was not provided with a paving or bitumen coating)

Figure B1 shows the deterioration in the invert of a 1.8 m-diameter CSBS. This structure was subsequently replaced with a larger diameter helically wound corrugated-steel pipe incorporating a reinforced concrete paving. If the deterioration had been less severe it might have been possible to install a reinforced concrete structural paving.

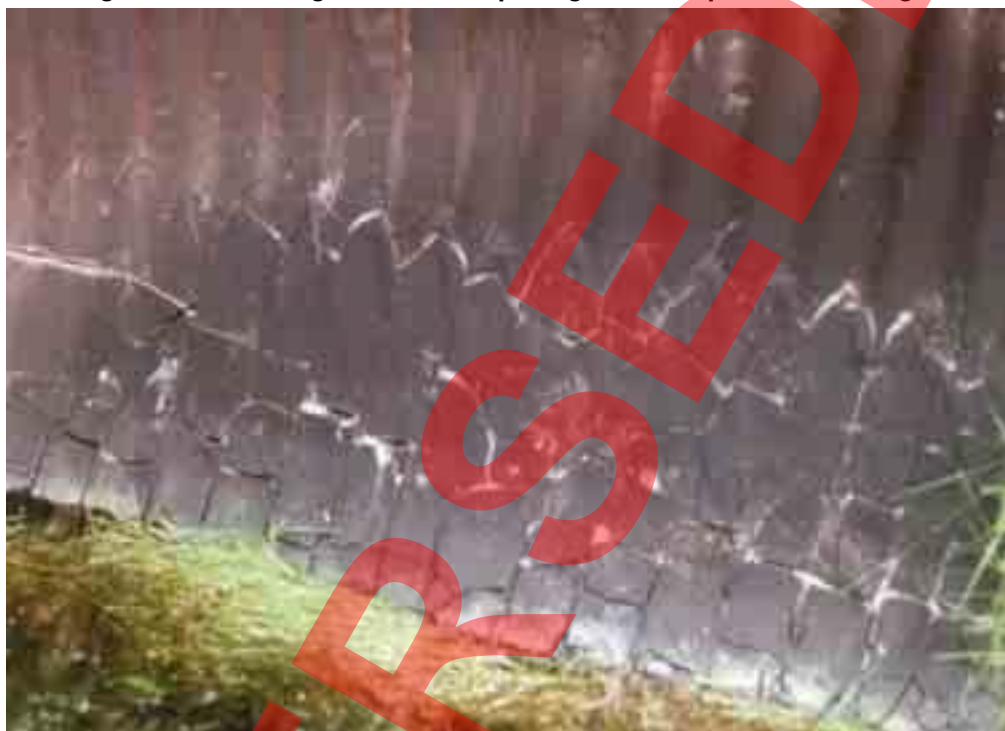
Figure B.5 Cracking in a bitumen paving due to exposure to sunlight

Bitumen pavings are generally hard wearing and resistant to scour by waterborne debris. The most common form of deterioration of bitumen pavings takes the form of cracking as the bitumen hardens with age and loses its more volatile constituents. This is usually most evident at the ends of the structure (particularly those with bevelled ends) exposed to direct sunlight and potentially turbulent water flows. Figure B5 shows an example of the form of deterioration.

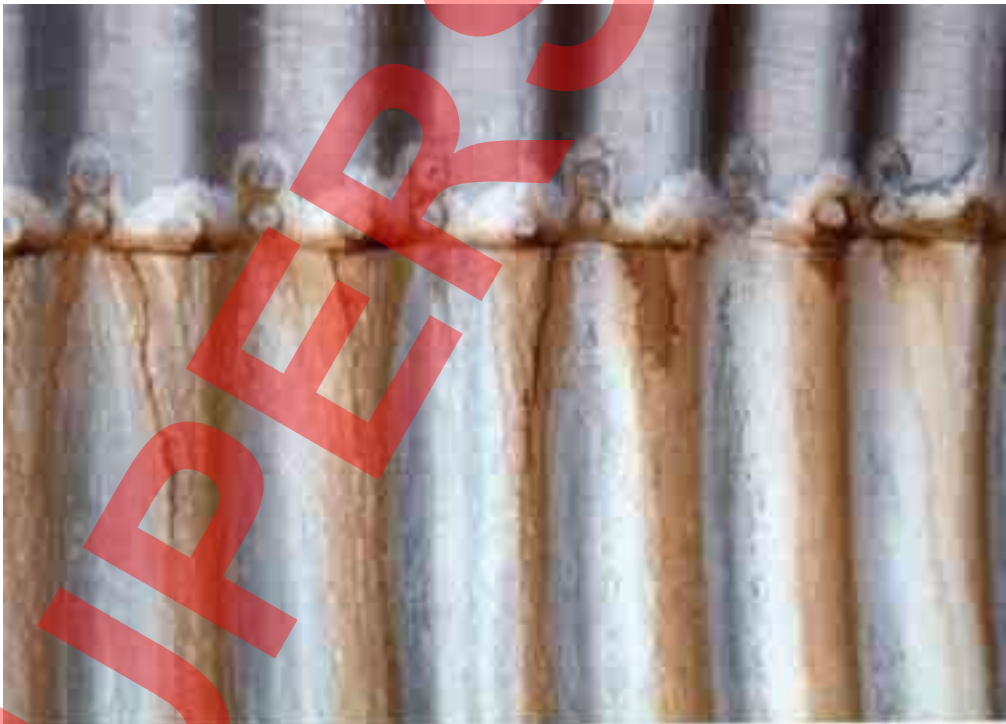
Figure B.8 Deterioration to side plates in a plain galvanised bolted segmental CSBS caused by seepage below the edge of the carriageway

Figure B8 shows the interior of a 35-year old plain galvanised bolted segmental CSBS where deterioration is particularly severe below the edges of the carriageways. Excavation and exposure of the outside of the structure at this point showed that the exterior had suffered no corrosion. On the soil side, the thickness of the remaining zinc was about 60% of its nominal original thickness despite the fact that no external secondary coat had been used.

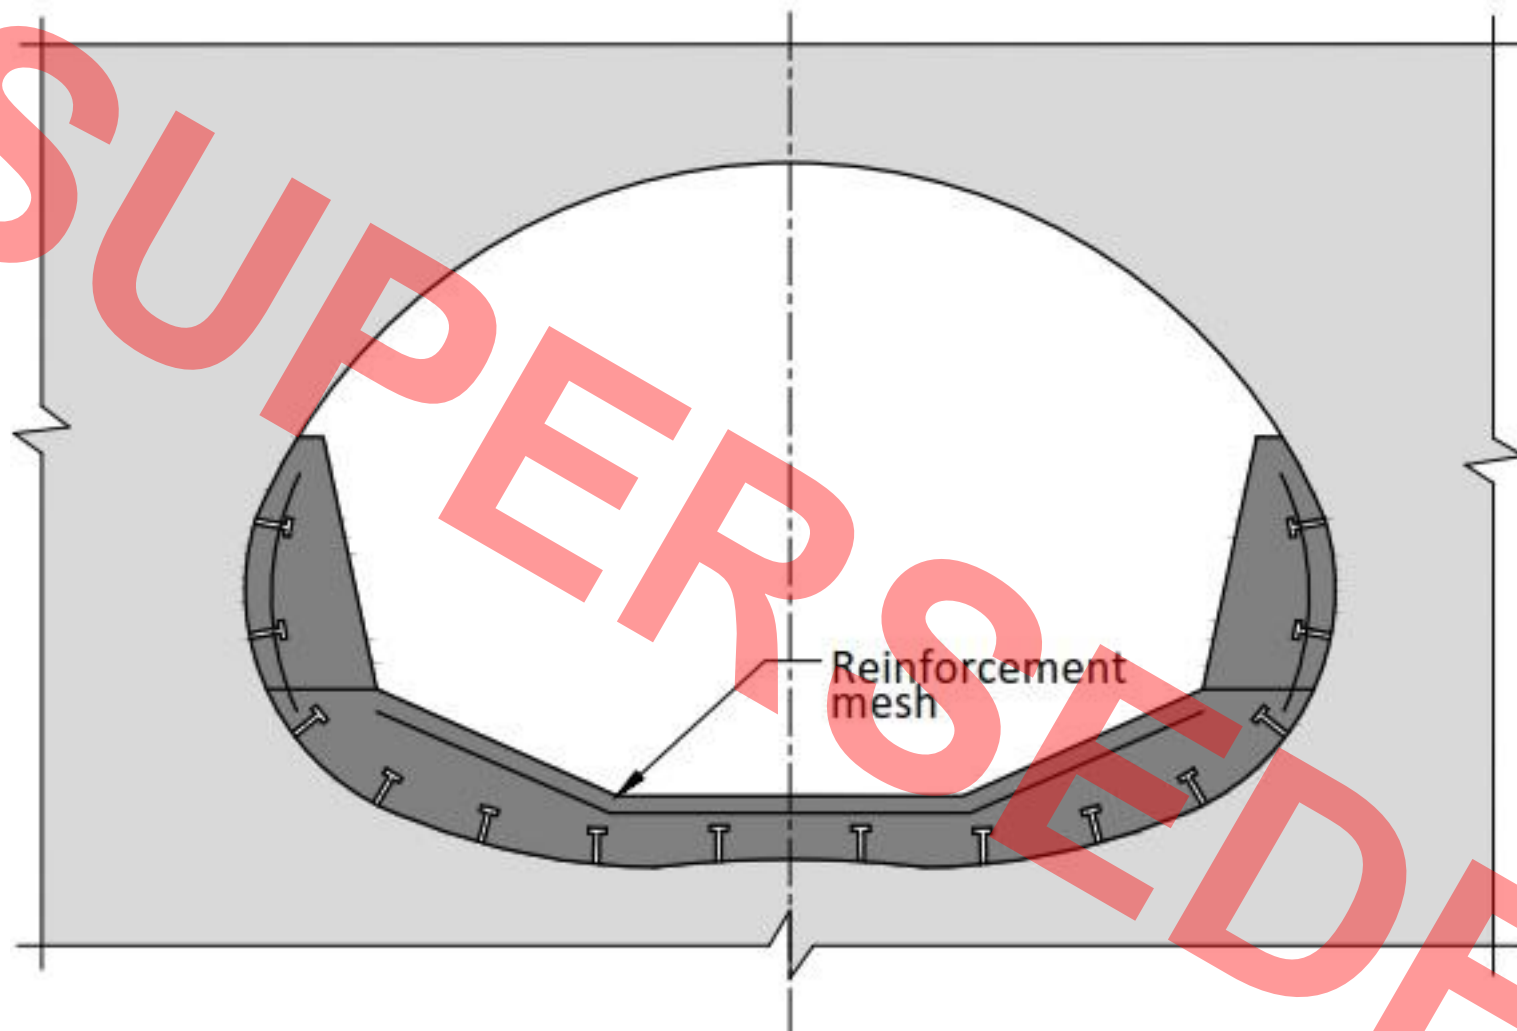
Figure B.12 Reinforced concrete paving (after Abdel-Sayed et al, 1993)

A possible solution to increase the stability is the provision of a structural paving. Details of various arrangement for structural pavings are shown in Figures B11 to B14, and as indicated in Alexander et al 1994 [Ref 14.] and in 'Invert replacement of corrugated metal structural plate pipe' Ikerd 1984 [Ref 11.].

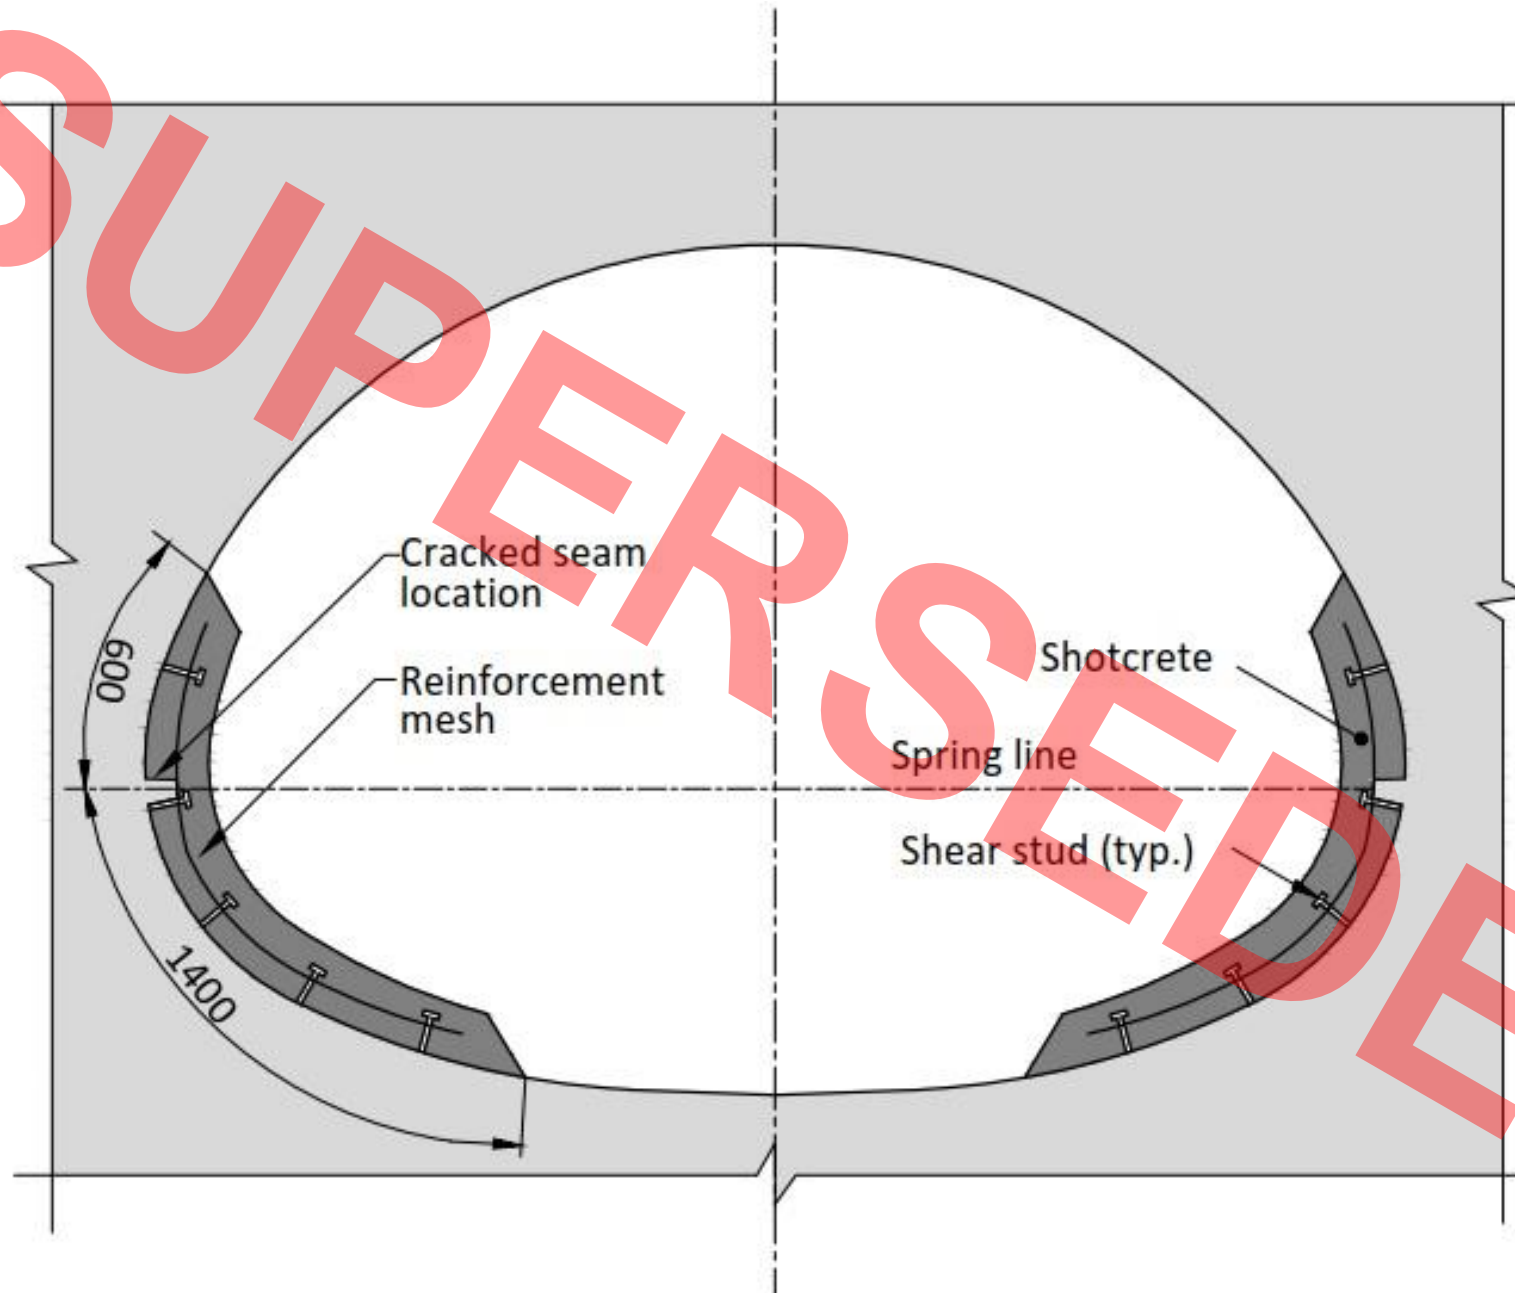
Figure B.13 Shotcrete reinforced concrete paving (after Abdel-Sayed et al, 1993)

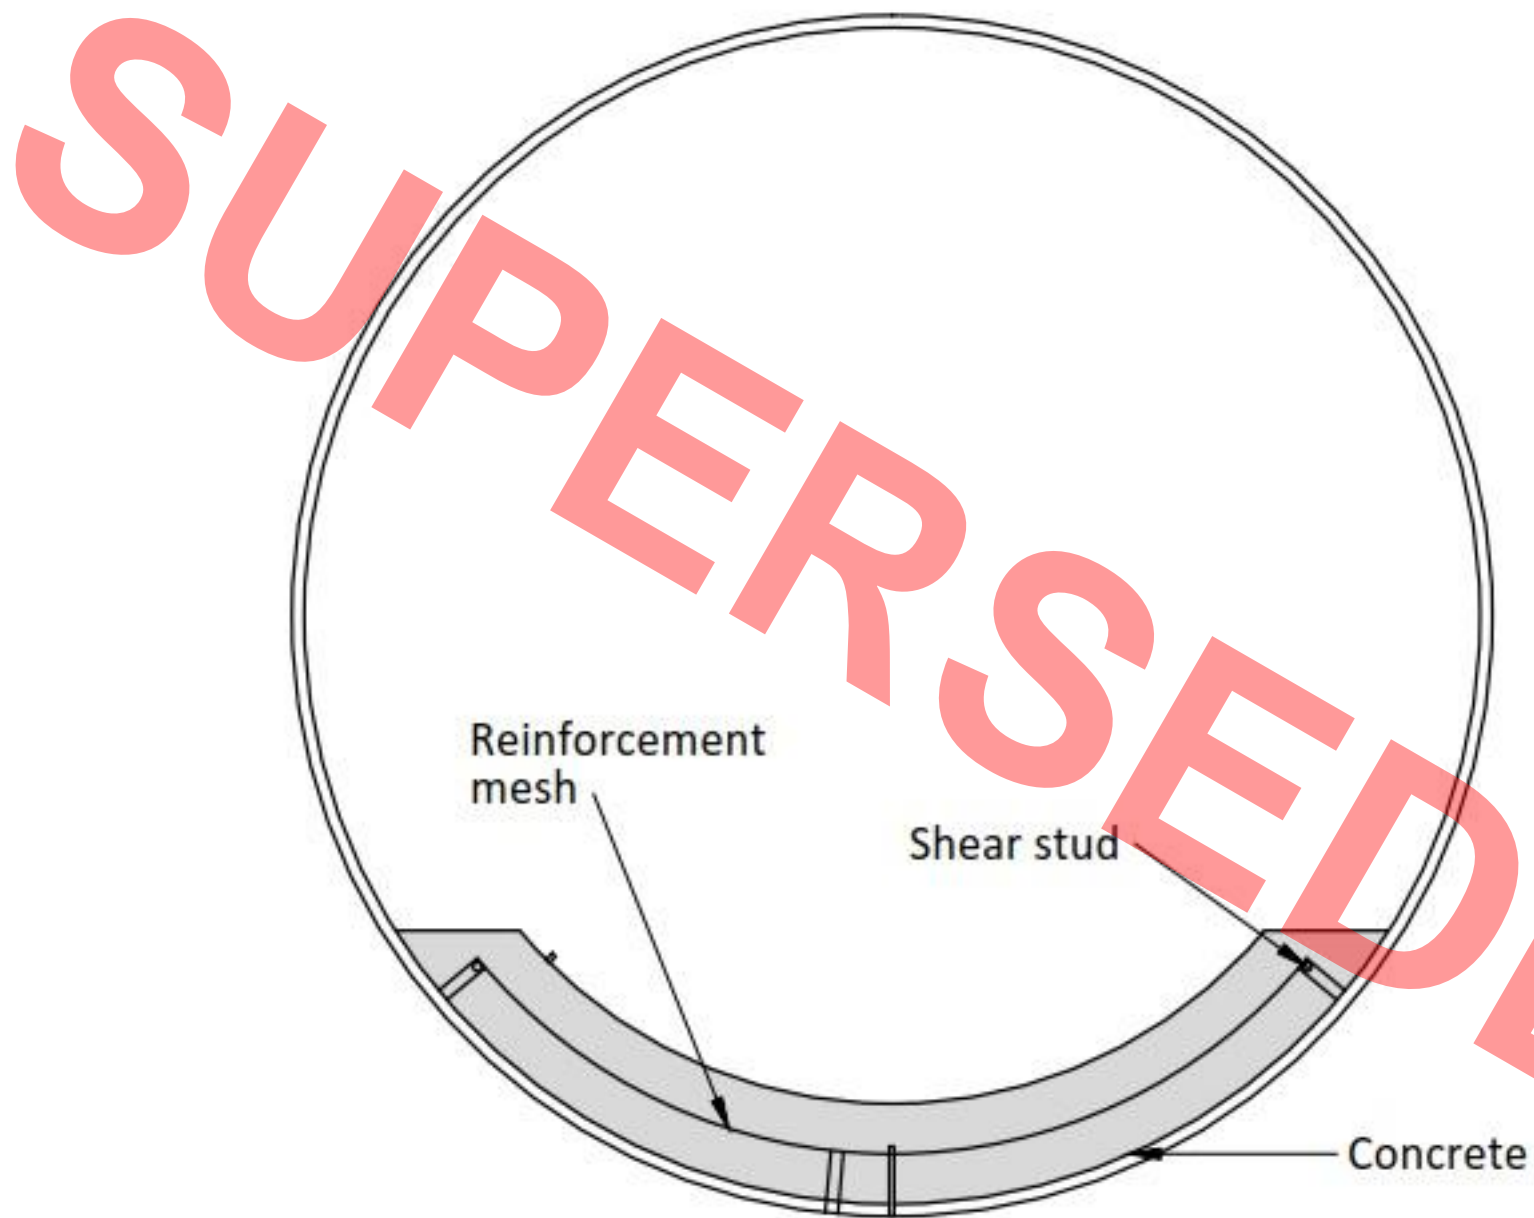
Figure B.15 Reinforced concrete paving as used in Hawaii (after Alexander et al, 1994)
