Highway Structures & Bridges
Inspection & Assessment

CS 460

Management of corrugated steel buried structures

Summary

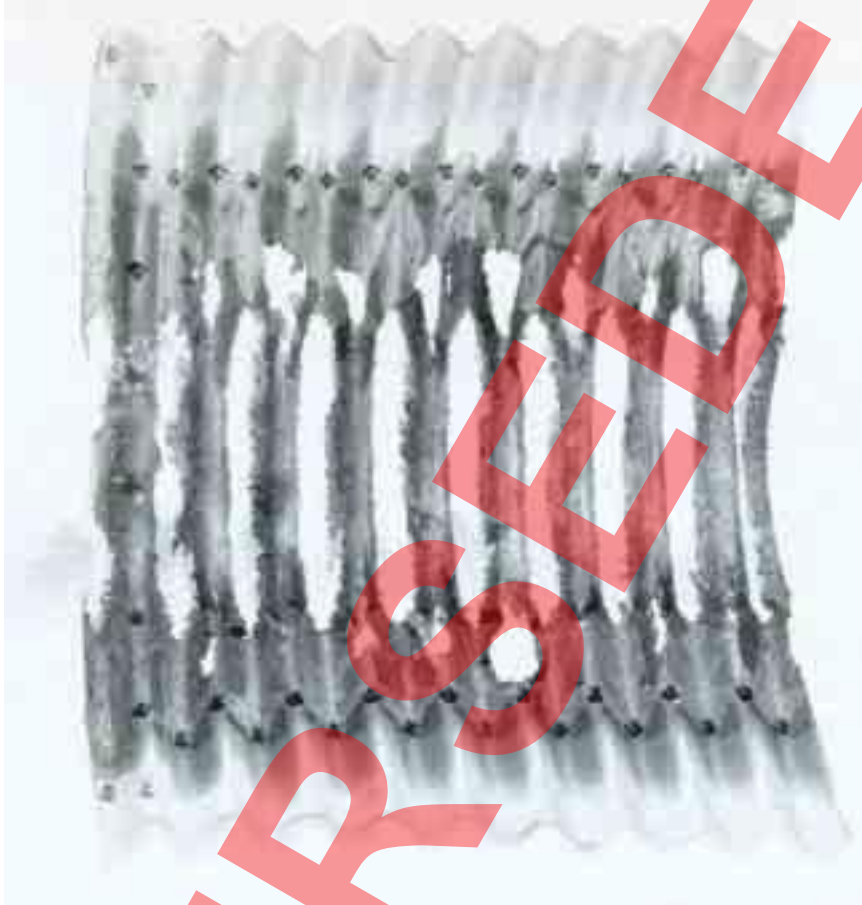
Figure B.1 Example of extreme corrosion in the invert of a structure subject to scour (this 30 year old structure was not provided with a paving or bitumen coating)

Figure B1 shows the deterioration in the invert of a 1.8 m diameter CSBS. This structure was subsequently replaced with a larger diameter helically wound corrugated steel pipe incorporating a reinforced concrete paving. If the deterioration had been less severe it might have been possible to install a reinforced concrete structural paving.
