Highway Structures & Bridges  
Inspection & Assessment

# CS 460

## Management of corrugated steel buried structures

This document details the management requirements for corrugated steel buried structures.

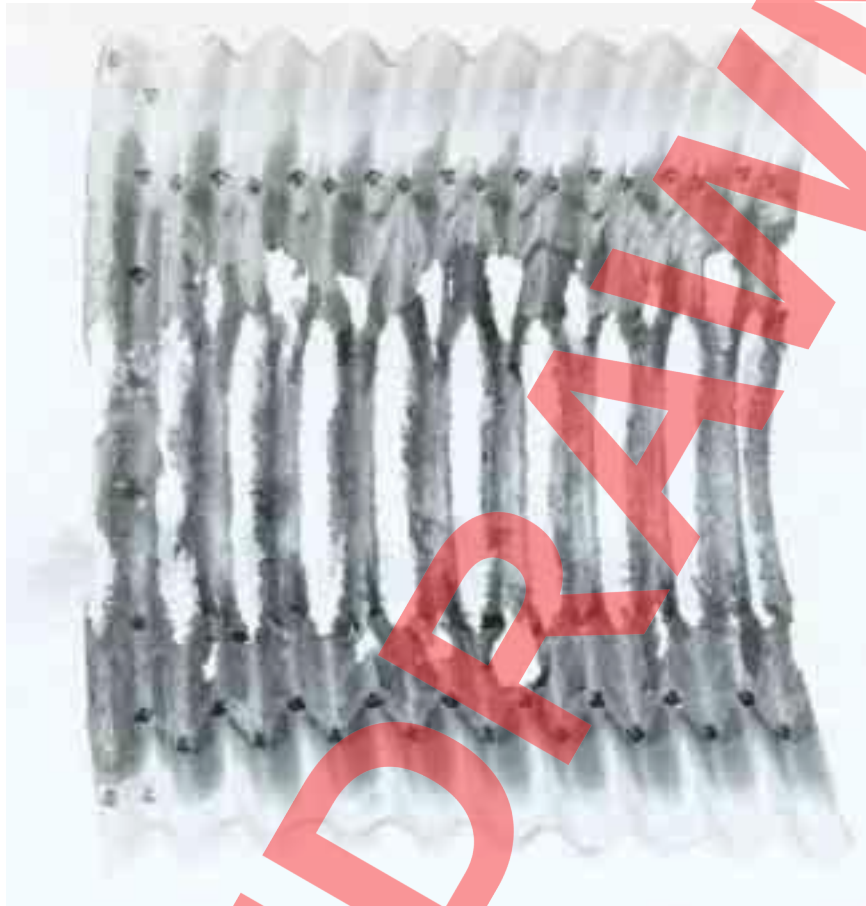
**Figure B.1 Example of extreme corrosion in the invert of a structure subject to scour  
(this 30 year old structure was not provided with a paving or bitumen coating)**

Figure B1 shows the deterioration in the invert of a 1.8 m diameter CSBS. This structure was subsequently replaced with a larger diameter helically wound corrugated steel pipe incorporating a reinforced concrete paving. If the deterioration had been less severe it might have been possible to install a reinforced concrete structural paving.

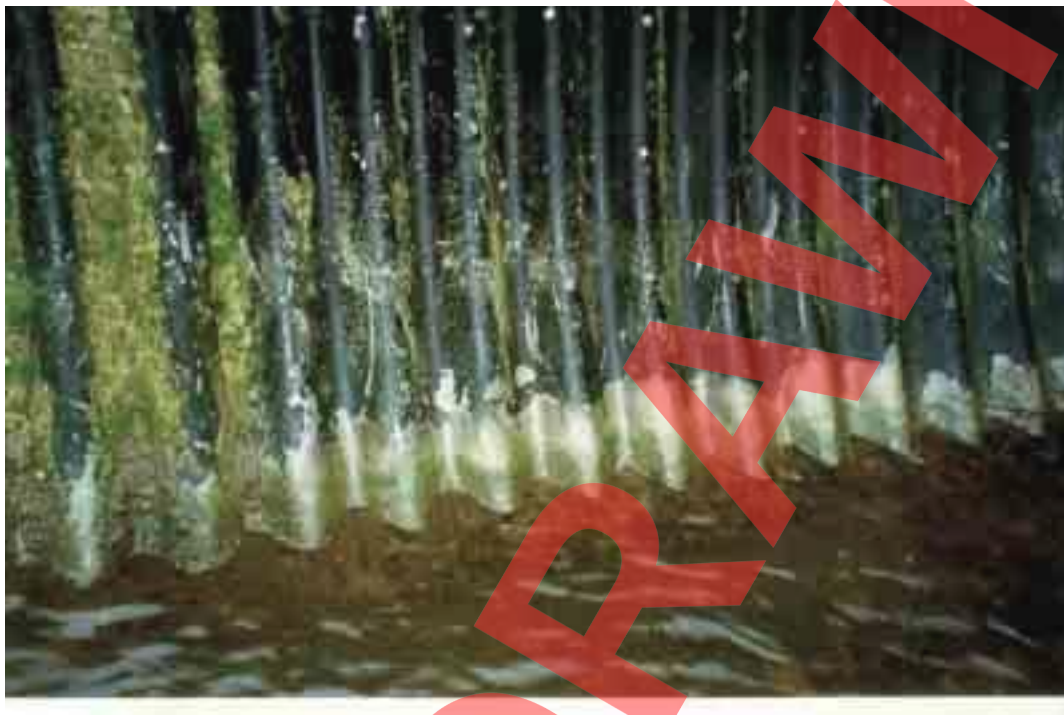
**Figure B.2 Deterioration of bitumen coating along the wet/dry line in low flow condition**

Figure B2 shows typical deterioration of a bitumen coating caused by frequent cycles of wetting and drying. Figure B3 shows the deterioration of the bitumen coatings above the paving in a pipe arch structure due to overtopping through turbulent flow. In Figure B3 the bitumen coating was in good condition elsewhere in the structure.

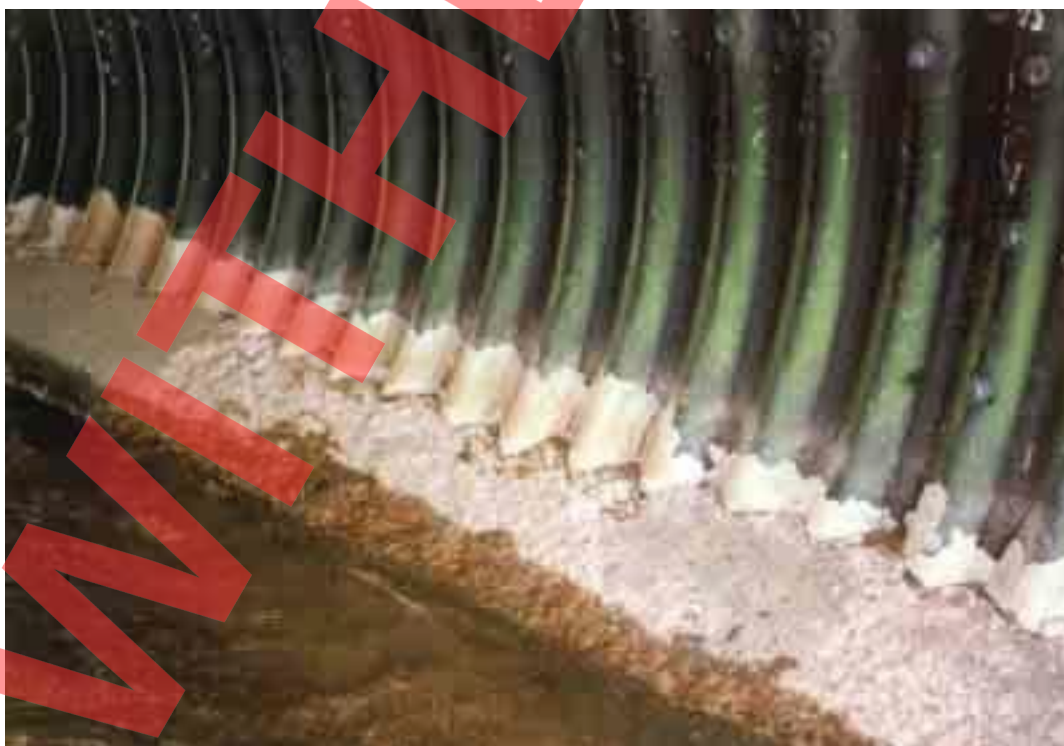
**Figure B.3 Damaged bitumen coating caused by overtopping of paving during turbulent flow**

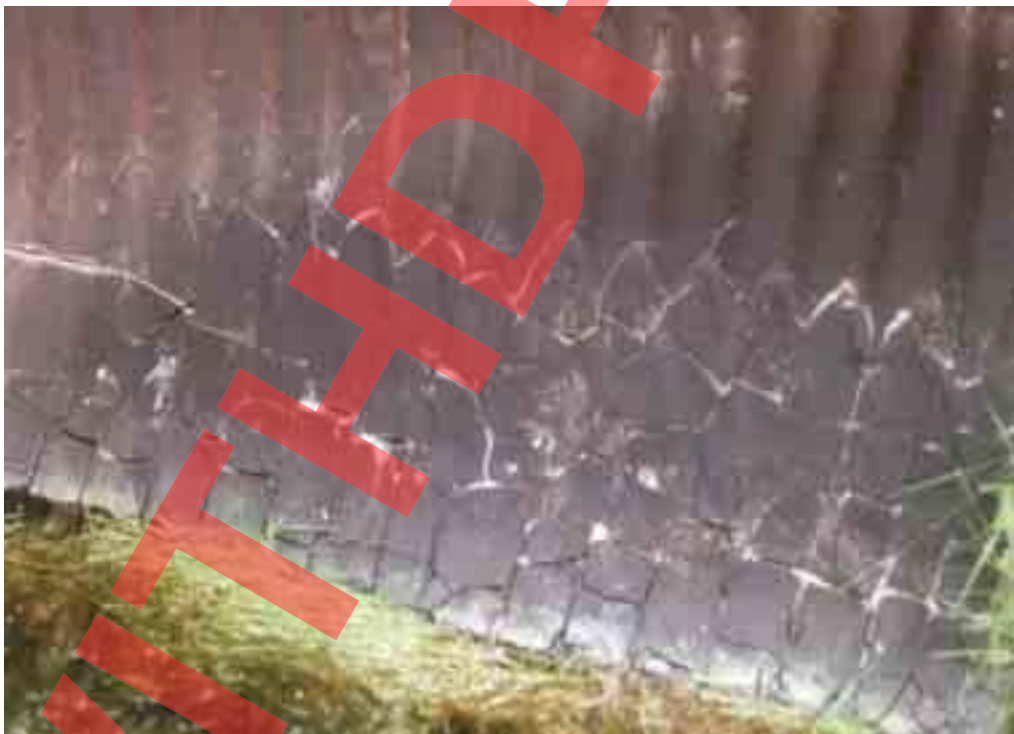
Figure B.5 Cracking in a bitumen paving due to exposure to sunlight

Bitumen pavings are generally hard wearing and resistant to scour by water-borne debris. The most common form of deterioration of bitumen pavings takes the form of cracking as the bitumen hardens with age and loses its more volatile constituents. This is usually most evident at the ends of the structure (particularly those with bevelled ends) exposed to direct sunlight and potentially turbulent water flows. Figure B5 shows an example of the form of deterioration.

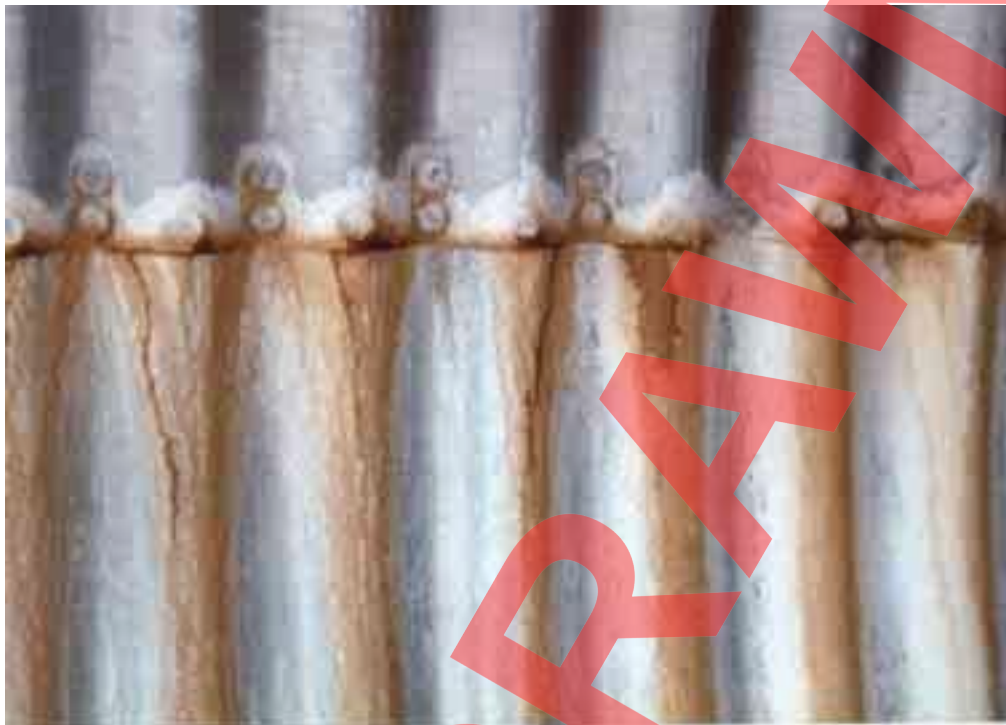
**Figure B.8 Deterioration to side plates in a plain galvanised bolted segmental CSBS caused by seepage below the edge of the carriageway**

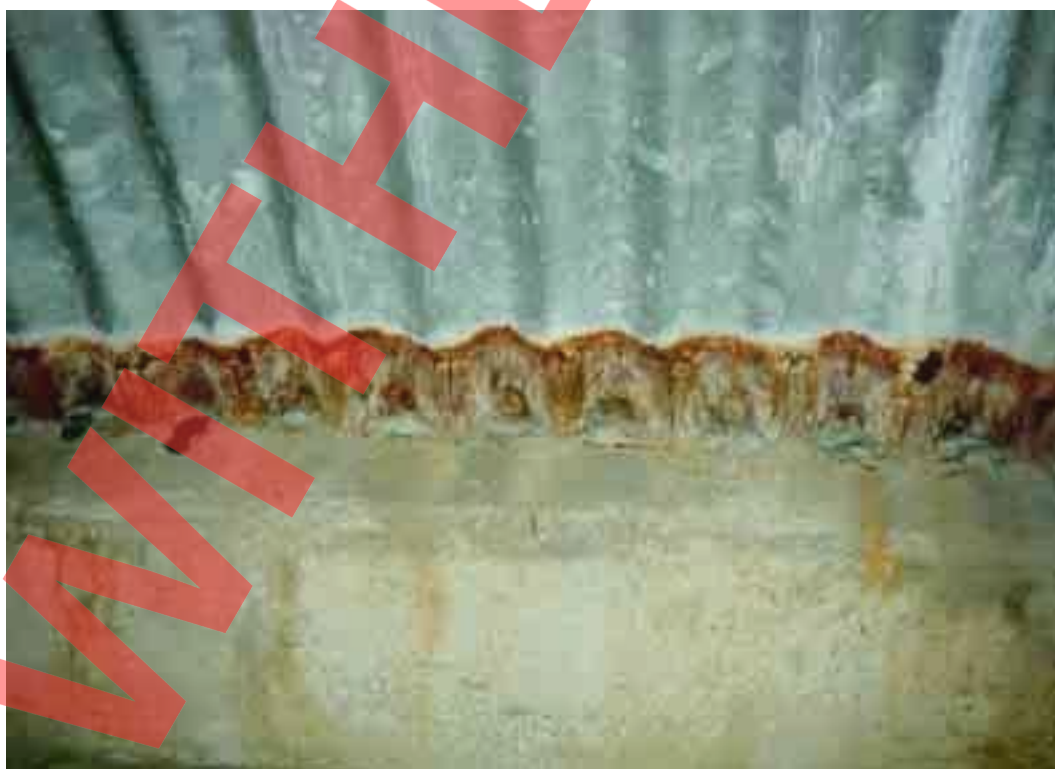
**Figure B.9 Deterioration at the arch seating of a plain galvanised arch structure due to seepage and ponding of water containing de-icing salts**

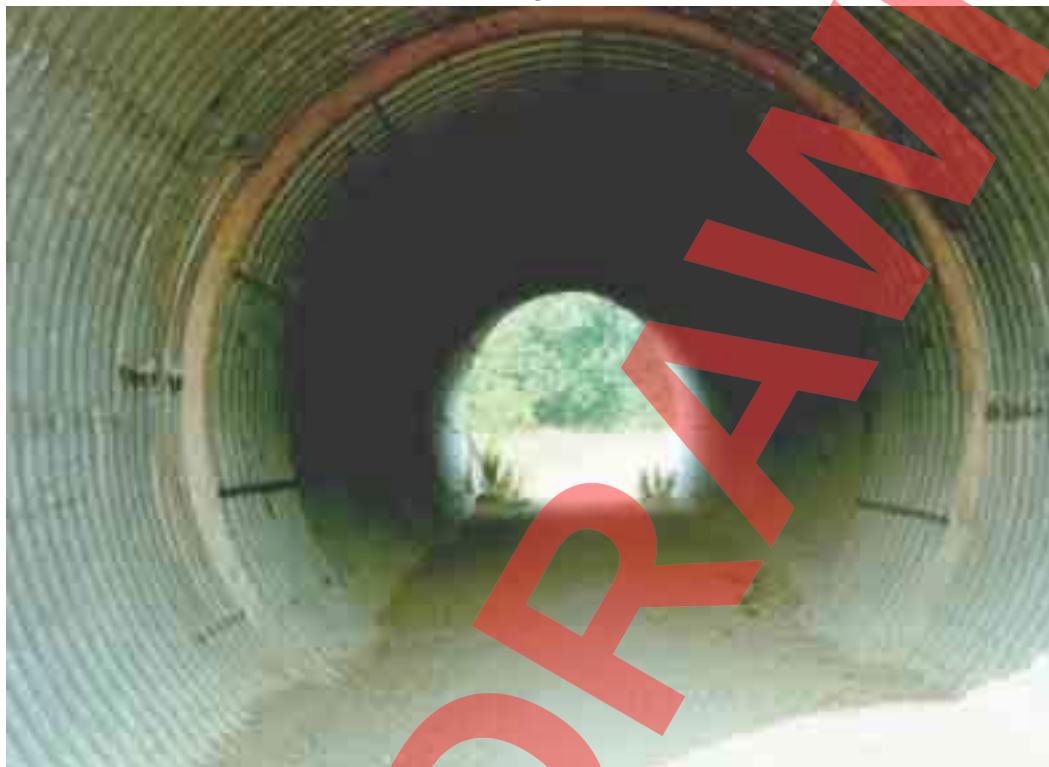
**Figure B.10 Use of liner plates to repair a bolted segmental CSBS showing deterioration below the edge of the carriageway due to seepage of water containing de-icing salts**
