Highway Structures & Bridges
Inspection & Assessment

CS 460

Management of corrugated steel buried structures

Summary

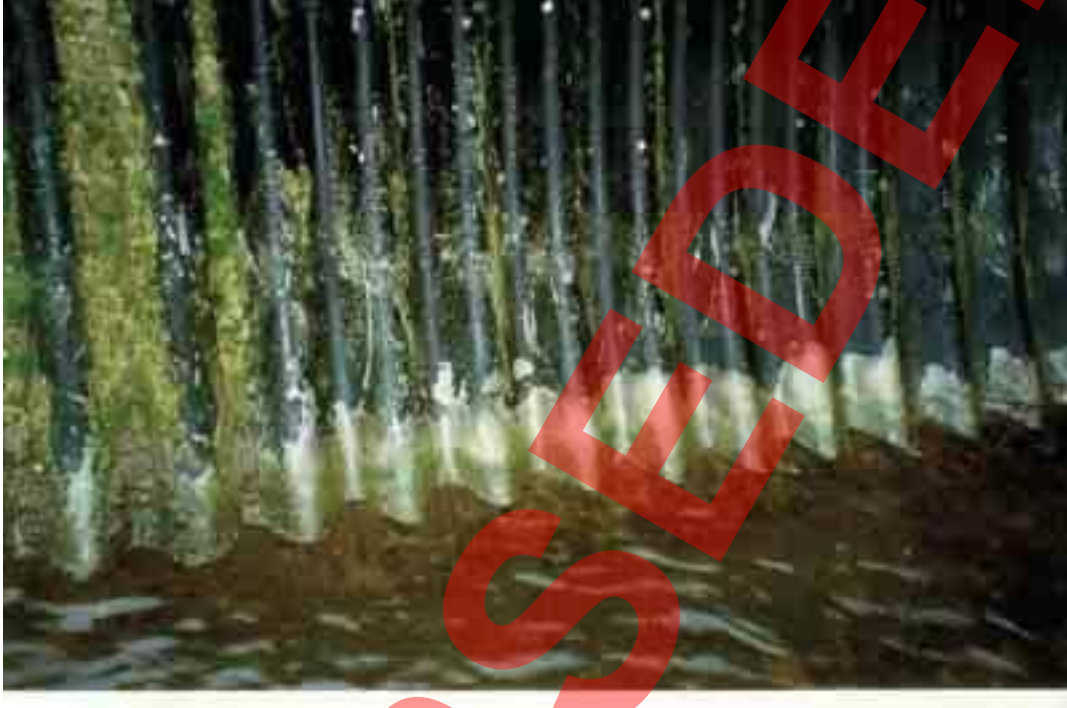
Figure B.2 Deterioration of bitumen coating along the wet/dry line in low flow condition

Figure B2 shows typical deterioration of a bitumen coating caused by frequent cycles of wetting and drying. Figure B3 shows the deterioration of the bitumen coatings above the paving in a pipe arch structure due to overtopping through turbulent flow. In Figure B3 the bitumen coating was in good condition elsewhere in the structure.

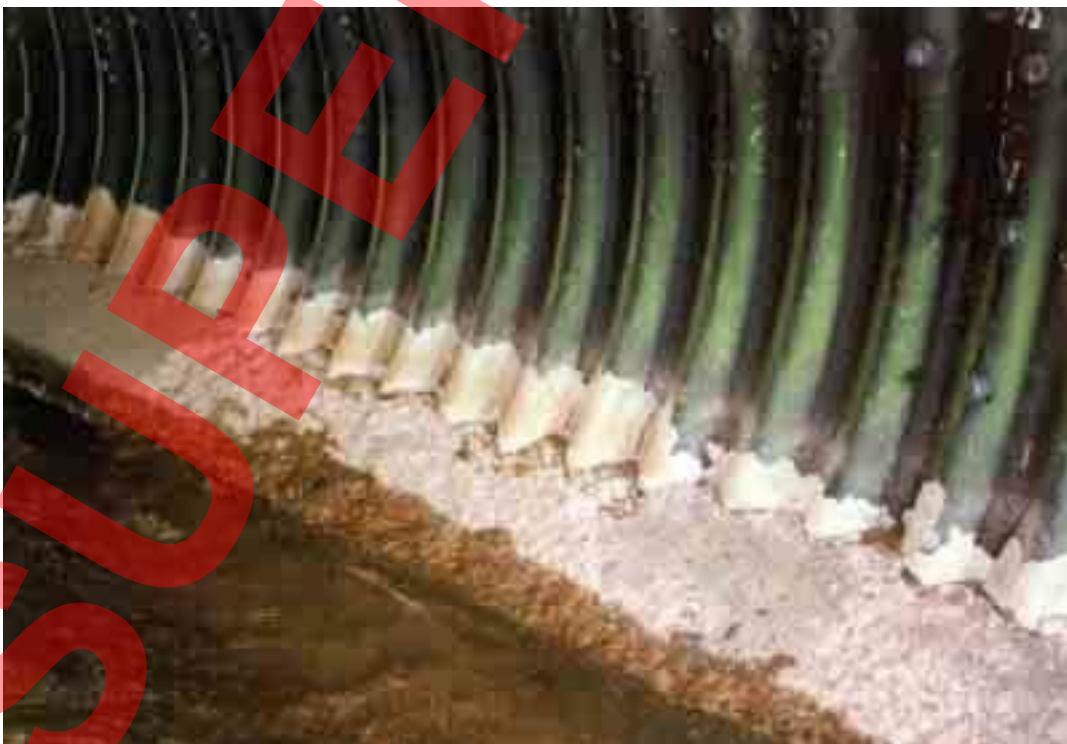
Figure B.3 Damaged bitumen coating caused by overtopping of paving during turbulent flow

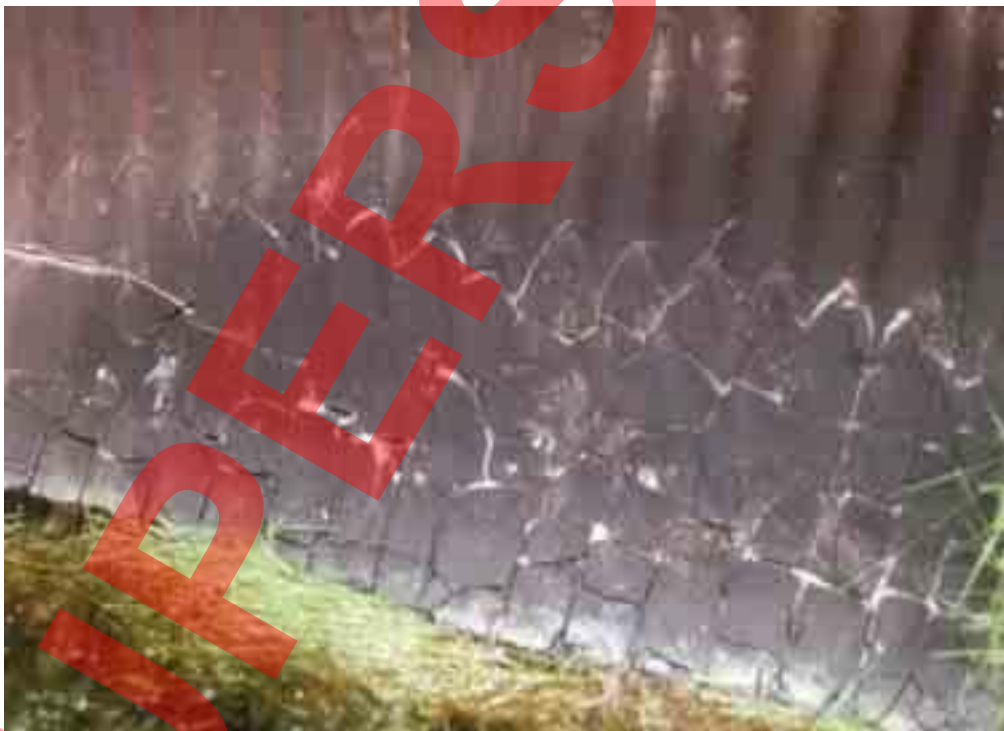
Figure B.5 Cracking in a bitumen paving due to exposure to sunlight

Bitumen pavings are generally hard wearing and resistant to scour by water-borne debris. The most common form of deterioration of bitumen pavings takes the form of cracking as the bitumen hardens with age and loses its more volatile constituents. This is usually most evident at the ends of the structure (particularly those with bevelled ends) exposed to direct sunlight and potentially turbulent water flows. Figure B5 shows an example of the form of deterioration.

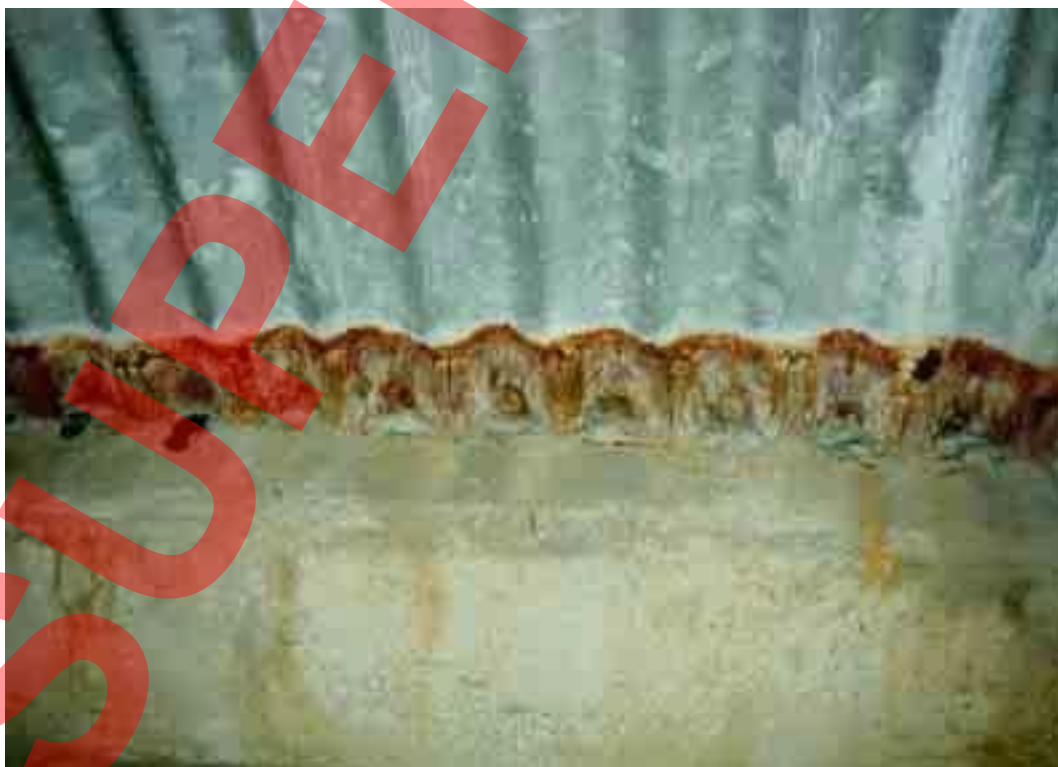
Figure B.9 Deterioration at the arch seating of a plain galvanised arch structure due to seepage and ponding of water containing de-icing salts

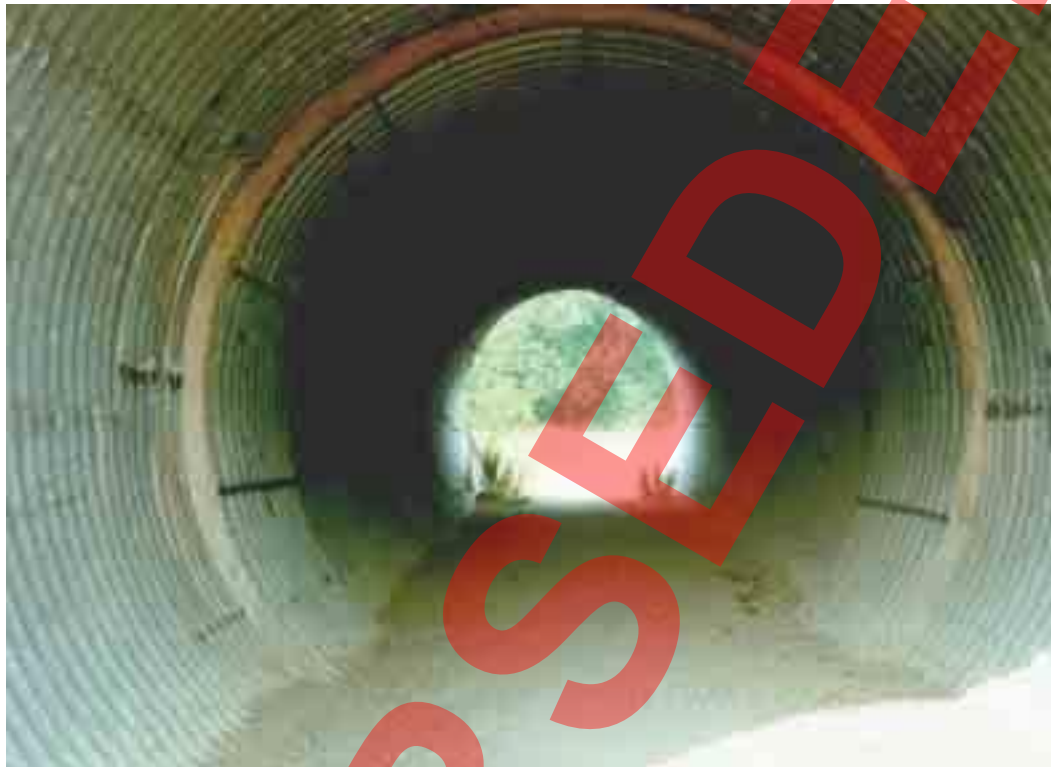
Figure B.10 Use of liner plates to repair a bolted segmental CSBS showing deterioration below the edge of the carriageway due to seepage of water containing de-icing salts
