# CS 460

## Management of corrugated steel buried structures

This document details the management requirements for corrugated steel buried structures.

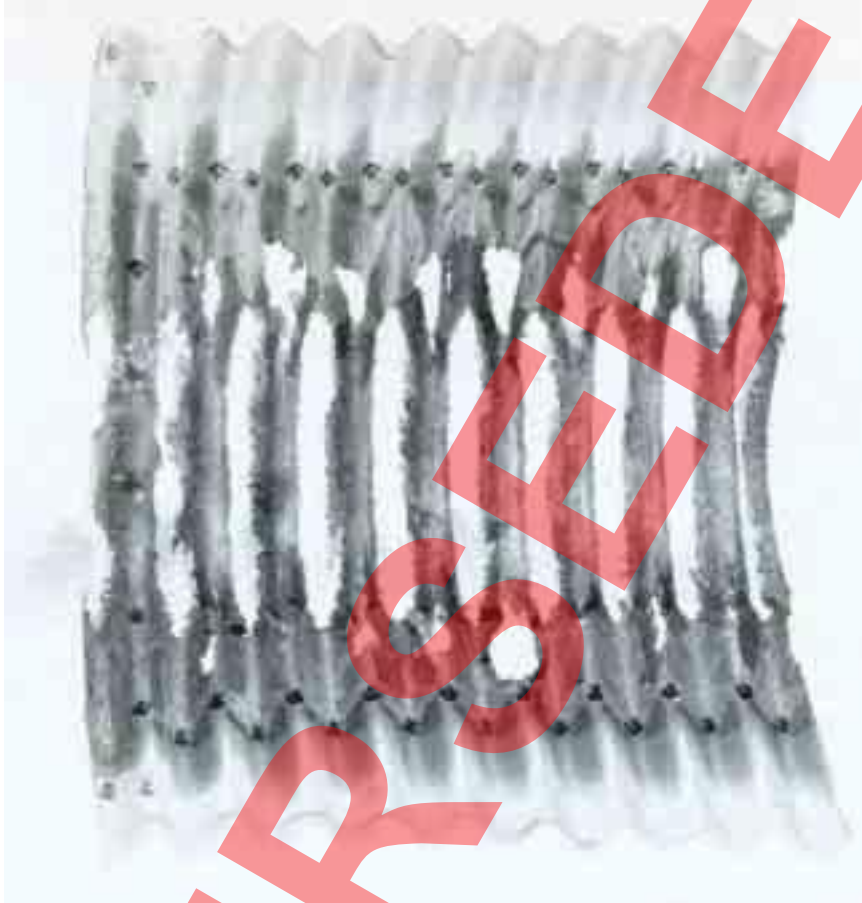
**Figure B.1 Example of extreme corrosion in the invert of a structure subject to scour (this 30 year old structure was not provided with a paving or bitumen coating)**

Figure B1 shows the deterioration in the invert of a 1.8 m diameter CSBS. This structure was subsequently replaced with a larger diameter helically wound corrugated steel pipe incorporating a reinforced concrete paving. If the deterioration had been less severe it might have been possible to install a reinforced concrete structural paving.

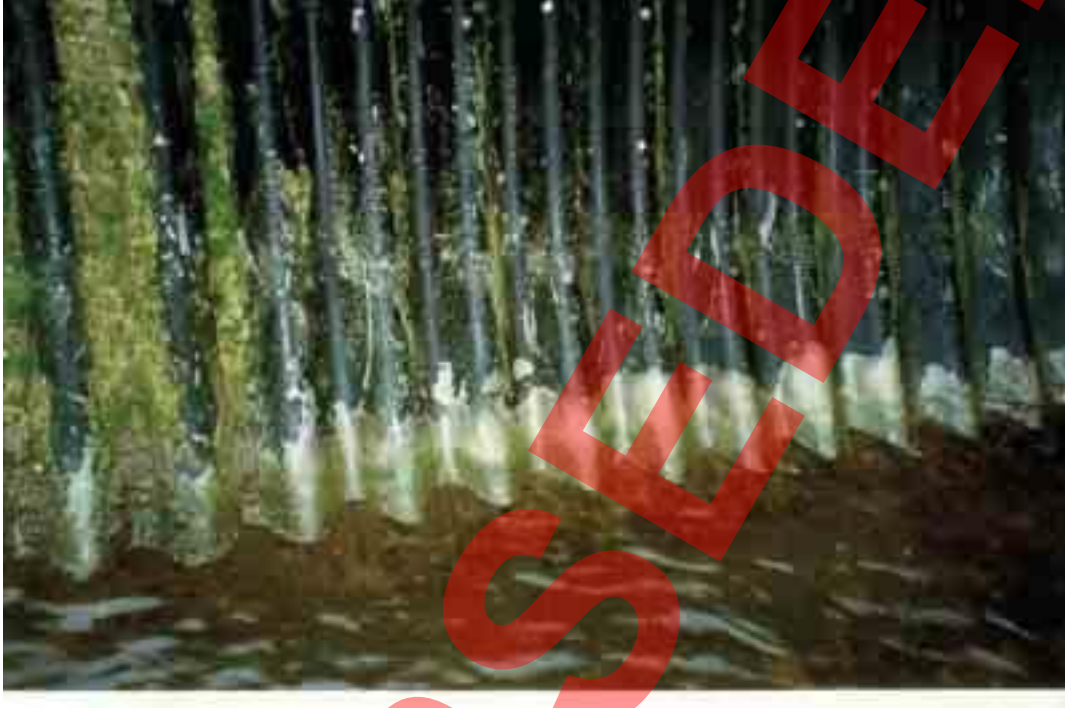
**Figure B.2 Deterioration of bitumen coating along the wet/dry line in low flow condition**

Figure B2 shows typical deterioration of a bitumen coating caused by frequent cycles of wetting and drying. Figure B3 shows the deterioration of the bitumen coatings above the paving in a pipe arch structure due to overtopping through turbulent flow. In Figure B3 the bitumen coating was in good condition elsewhere in the structure.

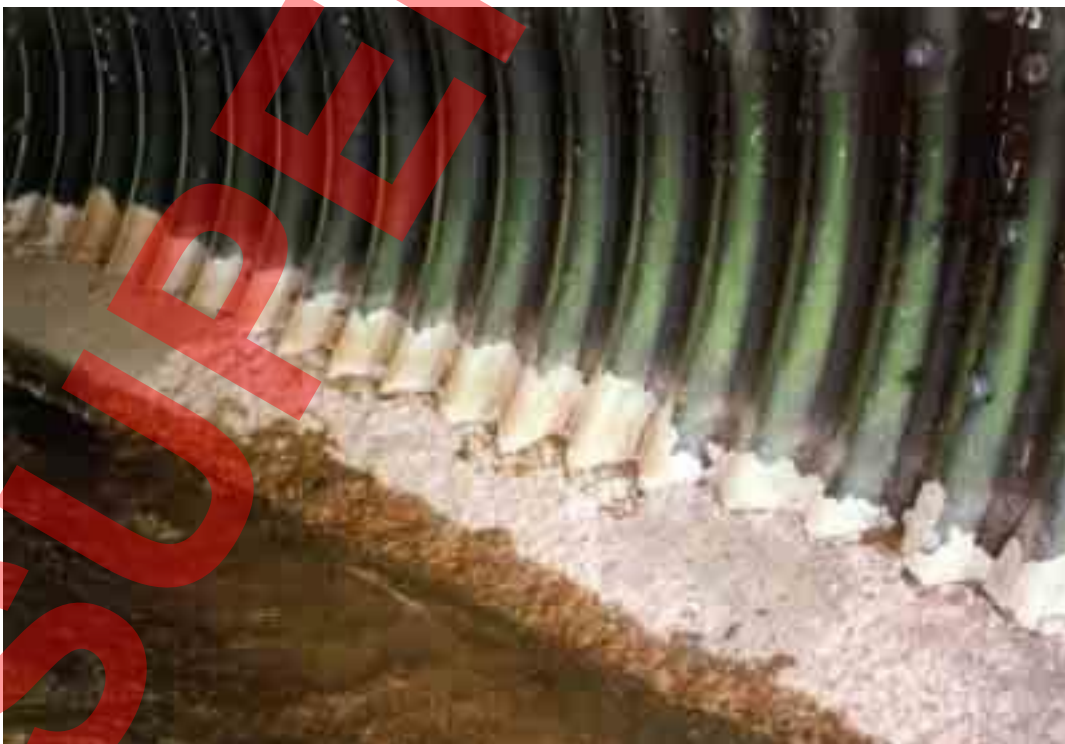
**Figure B.3 Damaged bitumen coating caused by overtopping of paving during turbulent flow**

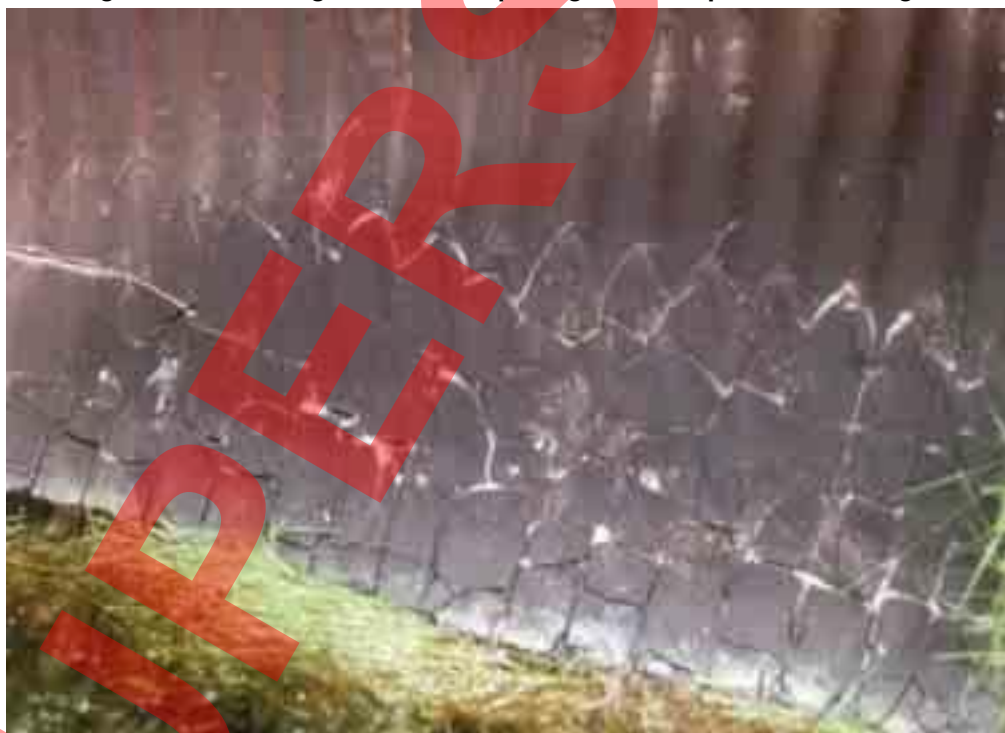
Figure B.5 Cracking in a bitumen paving due to exposure to sunlight

Bitumen pavings are generally hard wearing and resistant to scour by water-borne debris. The most common form of deterioration of bitumen pavings takes the form of cracking as the bitumen hardens with age and loses its more volatile constituents. This is usually most evident at the ends of the structure (particularly those with bevelled ends) exposed to direct sunlight and potentially turbulent water flows. Figure B5 shows an example of the form of deterioration.

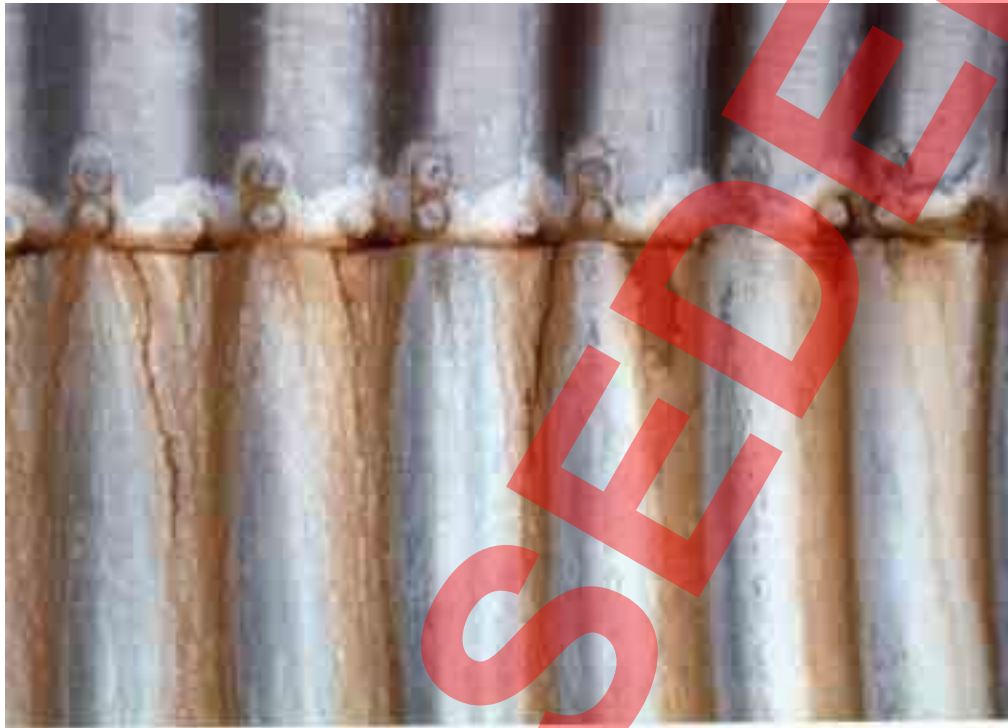
**Figure B.8 Deterioration to side plates in a plain galvanised bolted segmental CSBS caused by seepage below the edge of the carriageway**

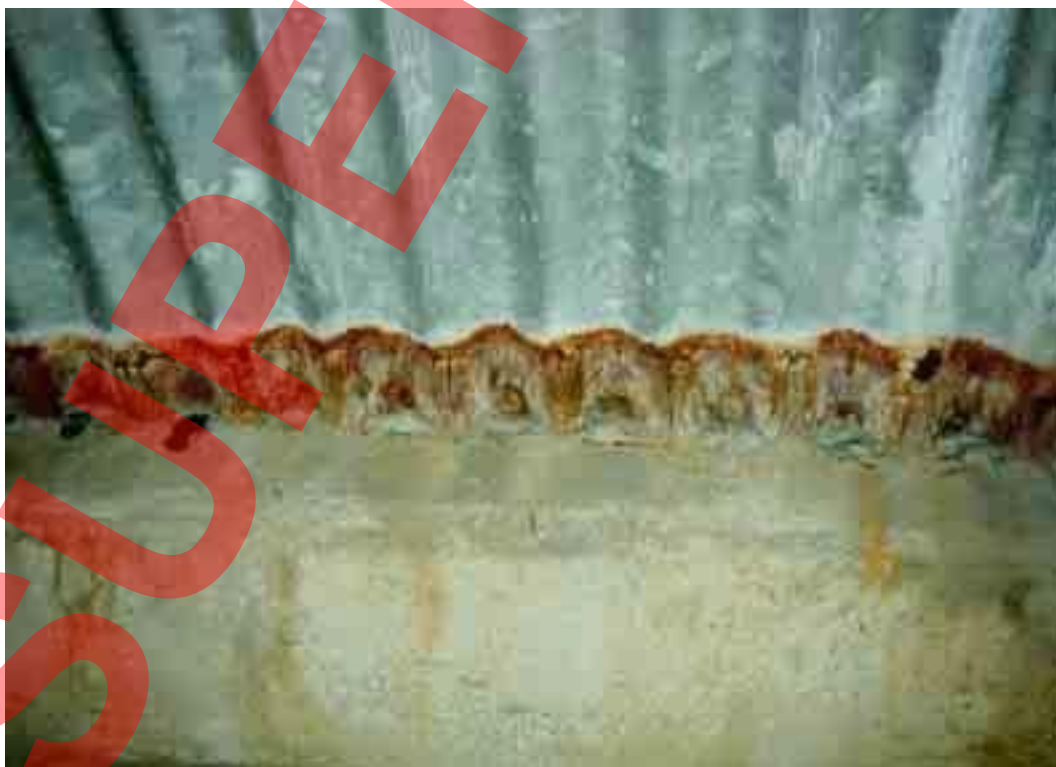
**Figure B.9 Deterioration at the arch seating of a plain galvanised arch structure due to seepage and ponding of water containing de-icing salts**

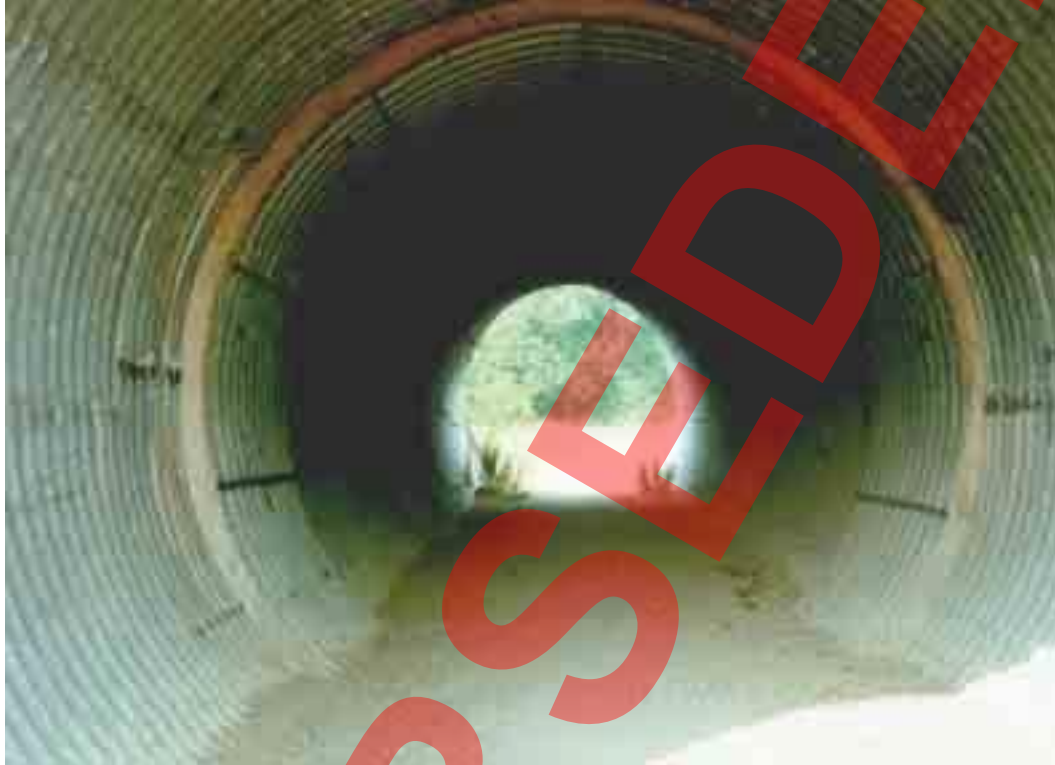
**Figure B.10 Use of liner plates to repair a bolted segmental CSBS showing deterioration below the edge of the carriageway due to seepage of water containing de-icing salts**
