**VOLUME 3 INSPECTION AND
MAINTENANCE
SECTION 2 MAINTENANCE**

BD 54/15

**MANAGEMENT OF POST-TENSIONED
CONCRETE BRIDGES**

This standard provides the requirements and guidance for the management of post-tensioned concrete bridges. It implements a risk based approach to management and includes advice on Special Inspections, monitoring, repairs and strengthening.

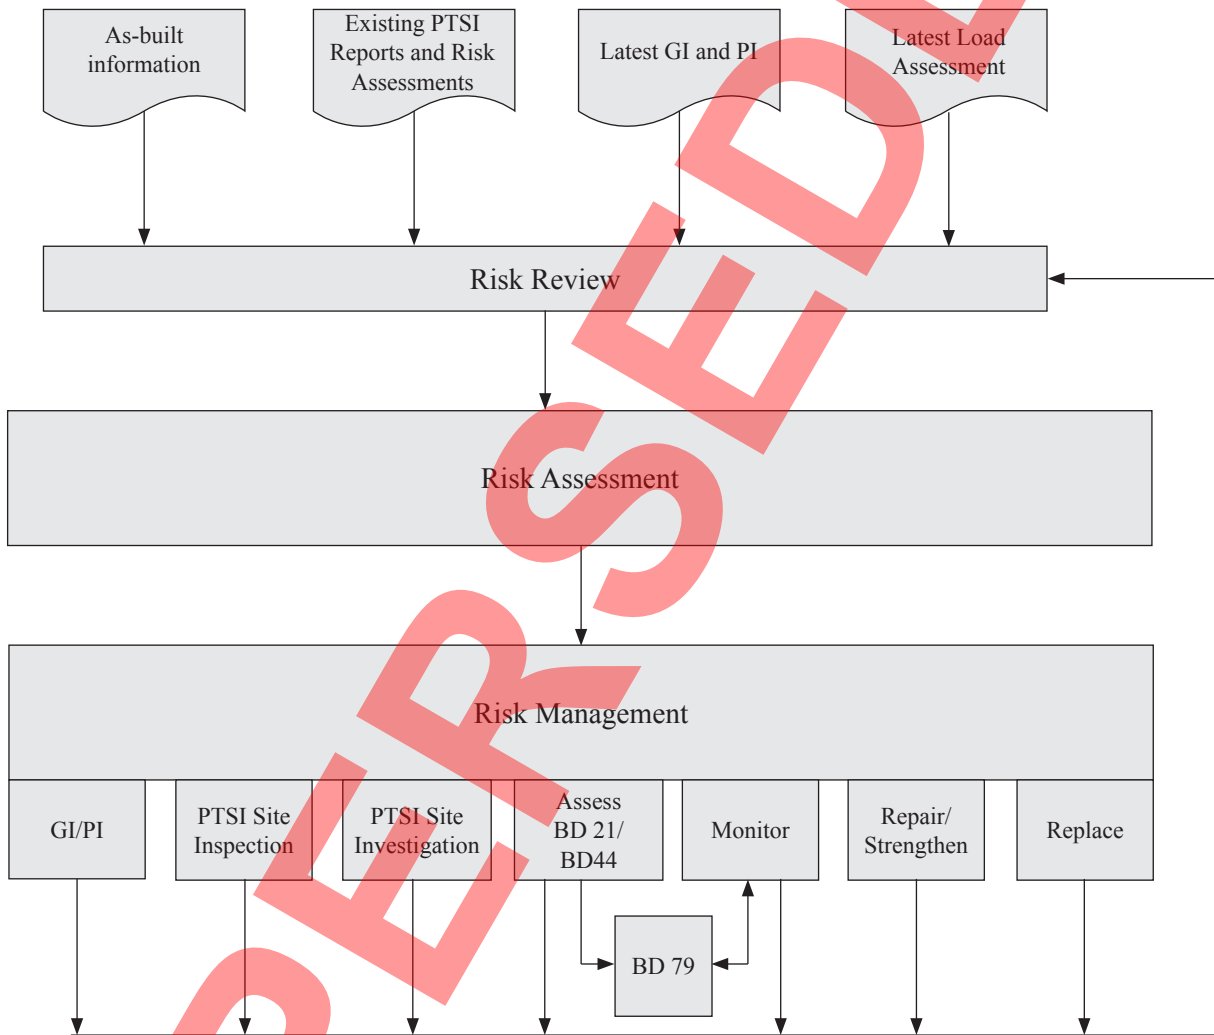
Figure 2.1 – Overview of the Risk Review, Risk Assessment & Risk Management System

2.1 An ongoing system of Risk Review, Risk Assessment and Risk Management will be used to provide assurance on the safety of the stock of post-tensioned concrete bridges. The overall process is illustrated by the flowchart in figure 2.1. The process starts with a Risk Review.

- 2.18 The report should advise on the adequacy of any previous risk assessment and make a recommendation on the need for further risk assessment. The report should identify whether there is sufficient information available to undertake or update a risk assessment and the adequacy of any previous investigations at critical sections. Where the available information is not considered sufficient to carry out a viable risk assessment, for example missing information on material properties, section geometry, the prestressing system and reinforcement details at critical sections, recommendations on the action needed to collect the necessary information should be provided in the Risk Review Report. This is likely to involve use of the risk management tools identified in figure 2.1, typically a PTSI Site Inspection followed by a PTSI Site Investigation.

- 4.2 The risk management measures will typically be derived from the Risk Assessment and should be included in the Risk Assessment Report. Figure 2.1 shows some typical risk management measures. Routine Principal and General Inspections will apply to all bridges and these alone are likely to be sufficient for low risk bridges. Additional measures could include Special Inspections, PTSI, load assessment, monitoring, repair, strengthening and in extreme cases replacement of elements, decks or whole structures. Guidance on Principal and General Inspections can be found in BD 63 Inspection of Highway Structures (DMRB 3.1.4). Guidance on PTSI can be found in chapters 5, 6 and 7 of this standard. Refer to BD 21 and BD 44 for the requirements and guidance for load assessment. Guidance on monitoring is in chapter 8, repair in chapter 9 and strengthening in chapter 10 of this standard.

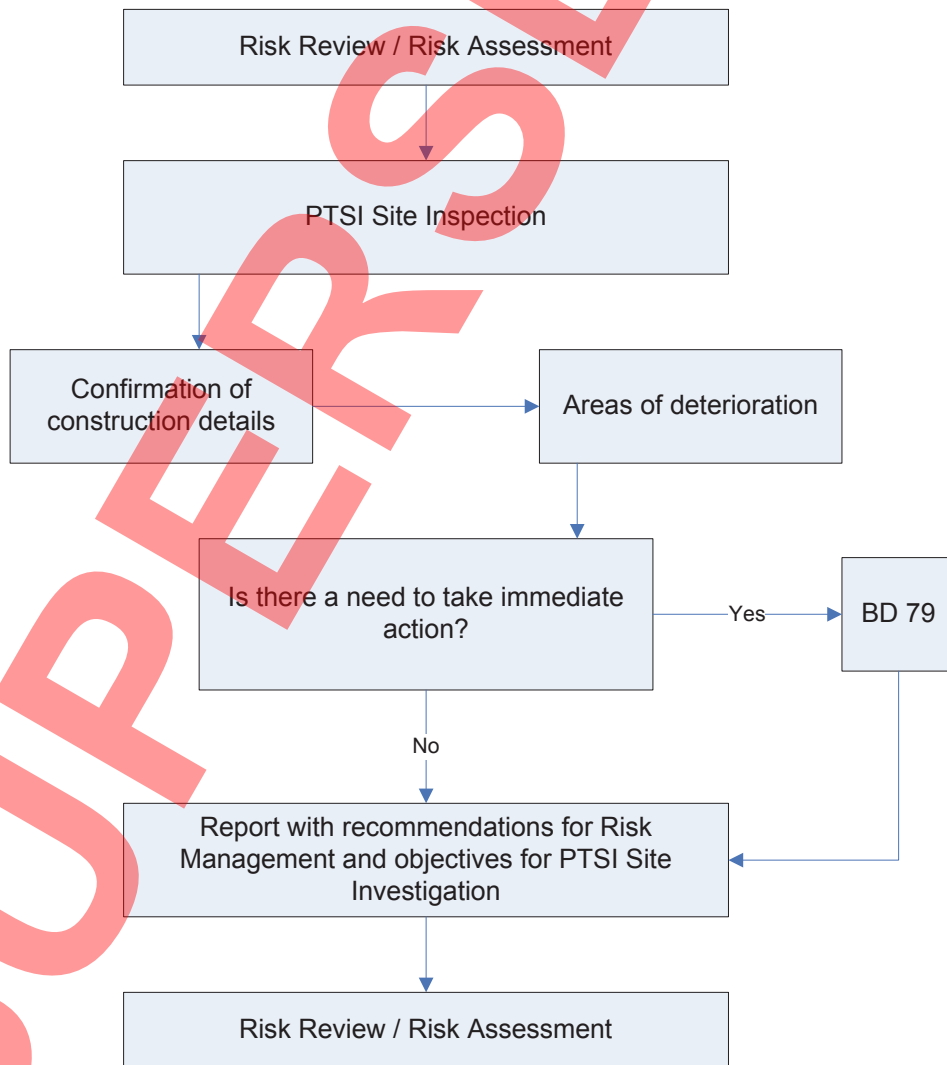
Figure 6.1 – Basic steps for a PTSI Site Inspection

6.2 The basic steps relevant to the PTSI Site Inspection are illustrated in Figure 6.1. The Site Inspection is completed by a report, which reviews the findings and makes recommendations for consideration in a further Risk Assessment. If necessary the report should define the work to be carried out and the technical plan for the PTSI Site Investigation.

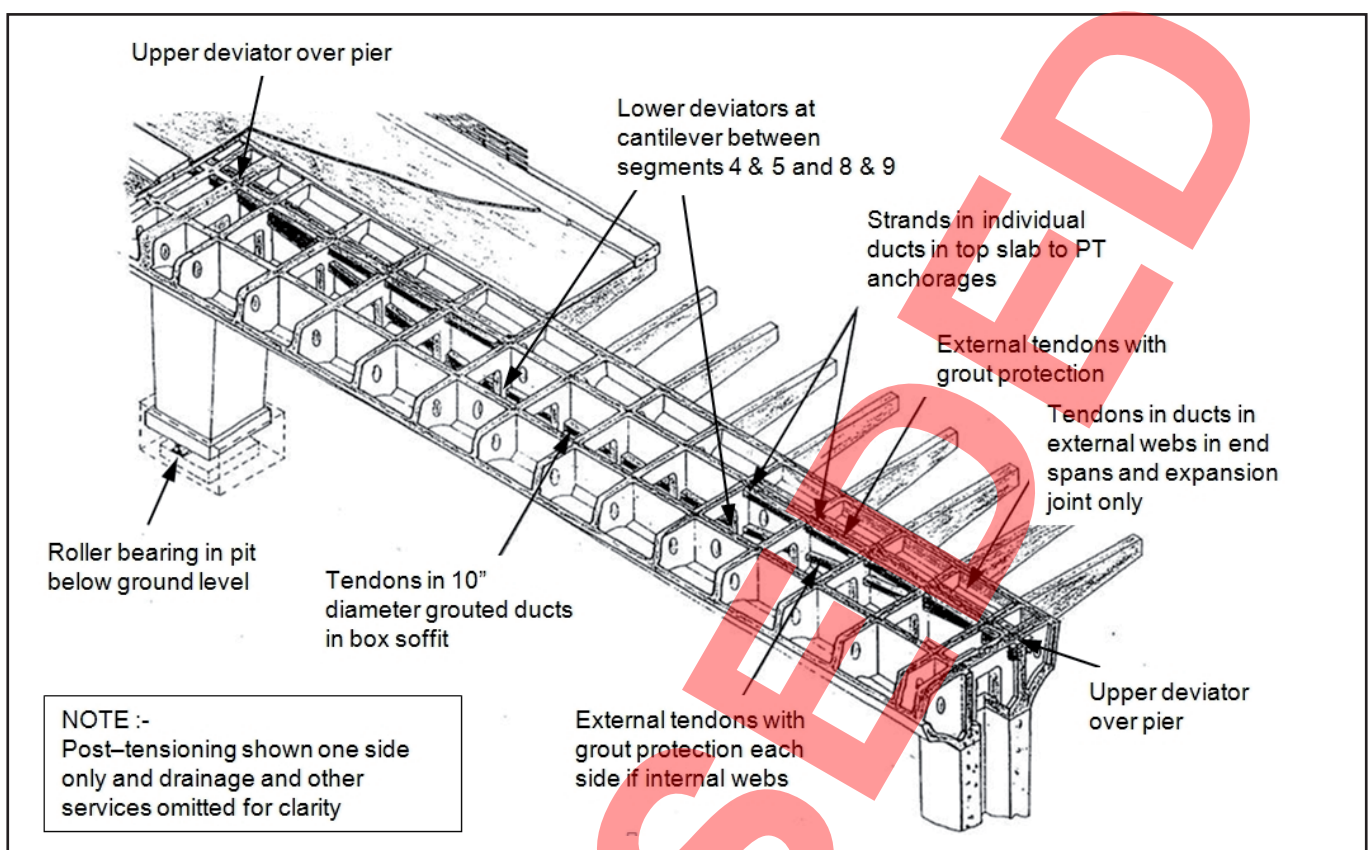
Figure B5.5.1 – Sectional view of post-tensioning layout in a typical span

There are four tendons, one either side of (but external to) the inner webs. At mid-span, the tendons run in 254mm grouted ducts in the bottom slab of the spine beam. At 7.62m either side of mid-span, the strands are directed upwards via saddles to run externally along the webs, protected by a grout casing tied into the webs by reinforcement. Each tendon has minimum ultimate strength of 83.9 tonnes and comprises 16 No. 29mm strands of nineteen wires.

The tendons are arranged in overlapping groups, each passing through two spans and anchored at both ends in the top flanges of the beam on the far side of the extreme piers of the pairs of spans affected giving 50% more pre-stress at the piers than at mid-span.
