**VOLUME 3 INSPECTION AND
SECTION 2 MAINTENANCE**

BD 54/15

**MANAGEMENT OF POST-TENSIONED
CONCRETE BRIDGES**

This standard provides the requirements and guidance for the management of post-tensioned concrete bridges. It implements a risk based approach to management and includes advice on Special Inspections, monitoring, repairs and strengthening.

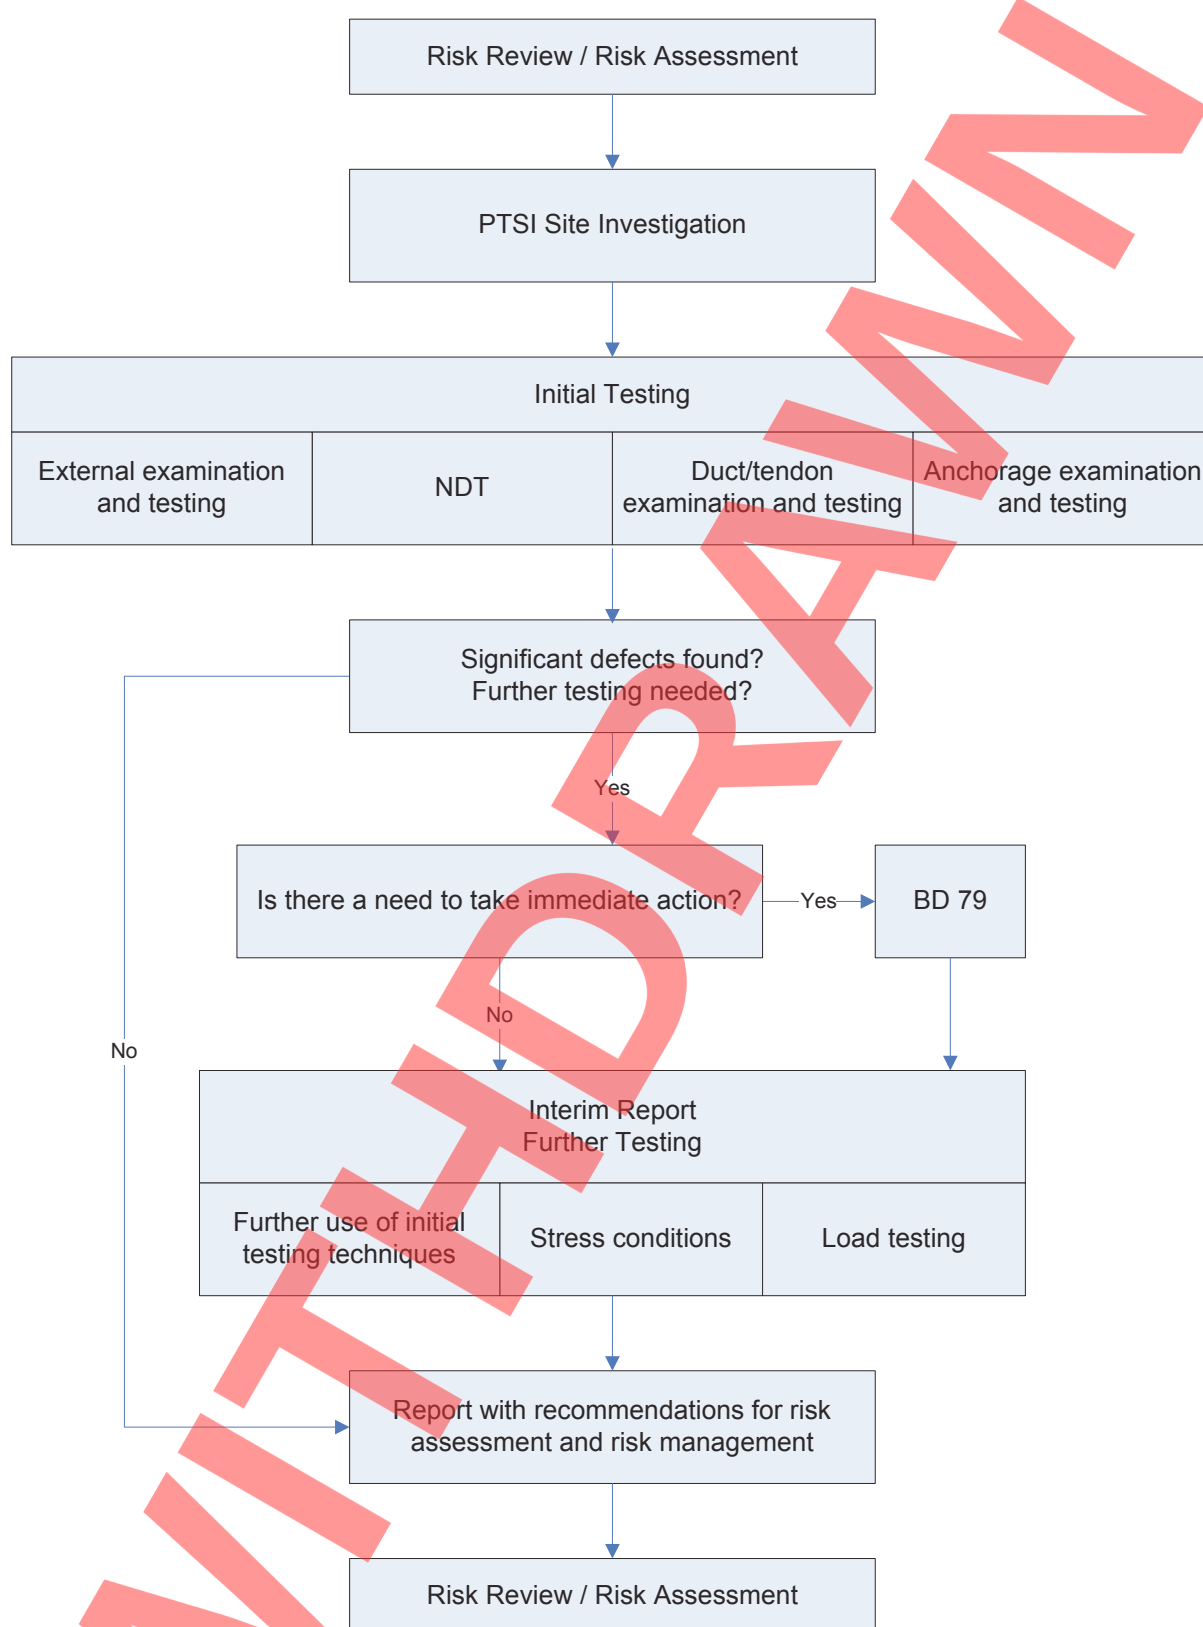
Figure 7.1 – Basic steps for a PTSI Site Investigation

- 7.1 The general procedure for a Site Investigation is illustrated in Figure 7.1. In many cases, it may be sufficient to carry out only the initial testing tasks. Where problems are encountered and additional testing is considered necessary, then further investigation should be undertaken.

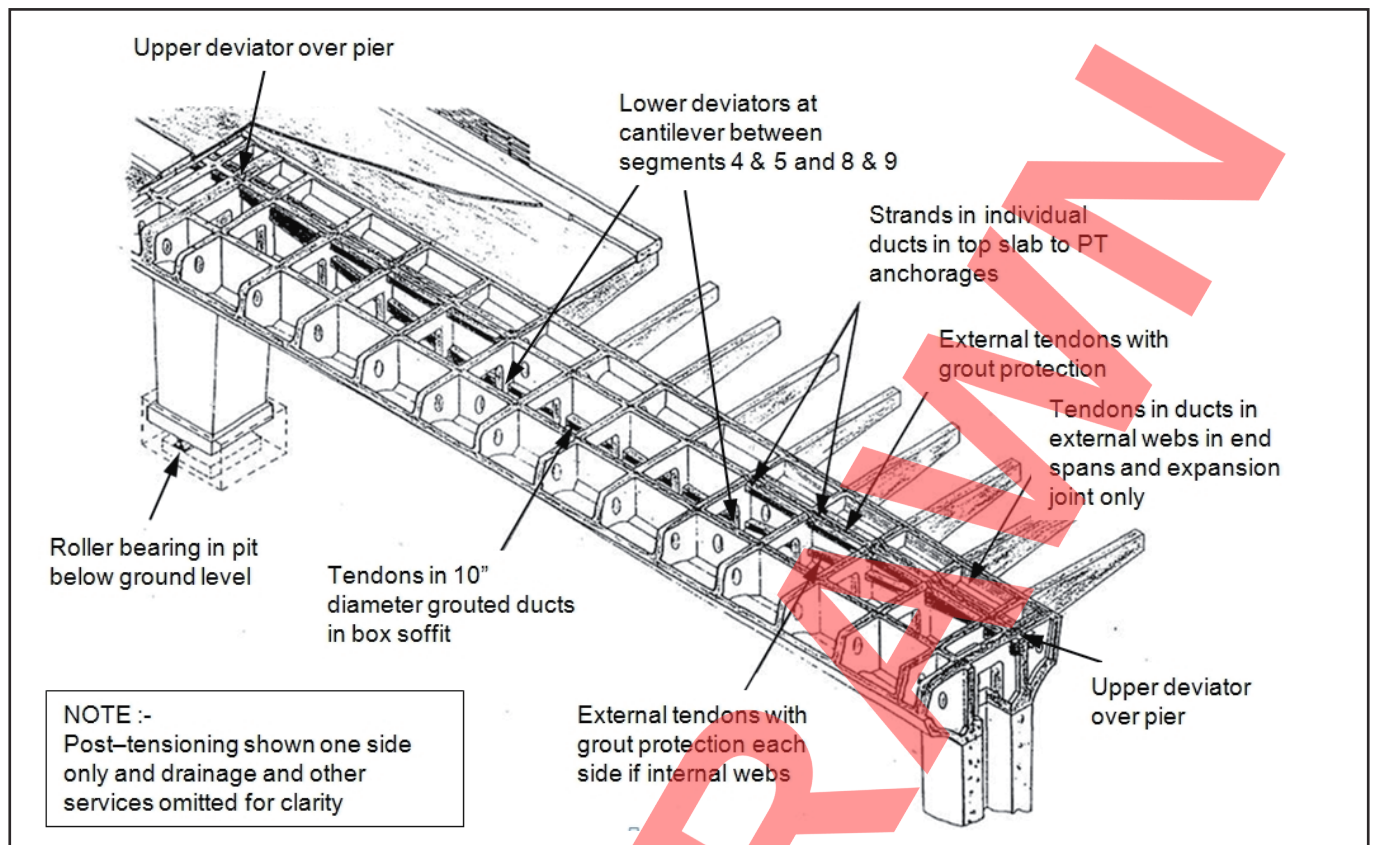
Figure B5.5.1 – Sectional view of post-tensioning layout in a typical span

There are four tendons, one either side of (but external to) the inner webs. At mid-span, the tendons run in 254mm grouted ducts in the bottom slab of the spine beam. At 7.62m either side of mid-span, the strands are directed upwards via saddles to run externally along the webs, protected by a grout casing tied into the webs by reinforcement. Each tendon has minimum ultimate strength of 83.9 tonnes and comprises 16 No. 29mm strands of nineteen wires.

The tendons are arranged in overlapping groups, each passing through two spans and anchored at both ends in the top flanges of the beam on the far side of the extreme piers of the pairs of spans affected giving 50% more pre-stress at the piers than at mid-span.
