**BD 54/15**

**MANAGEMENT OF POST-TENSIONED  
CONCRETE BRIDGES**

This standard provides the requirements and guidance for the management of post-tensioned concrete bridges. It implements a risk based approach to management and includes advice on Special Inspections, monitoring, repairs and strengthening.

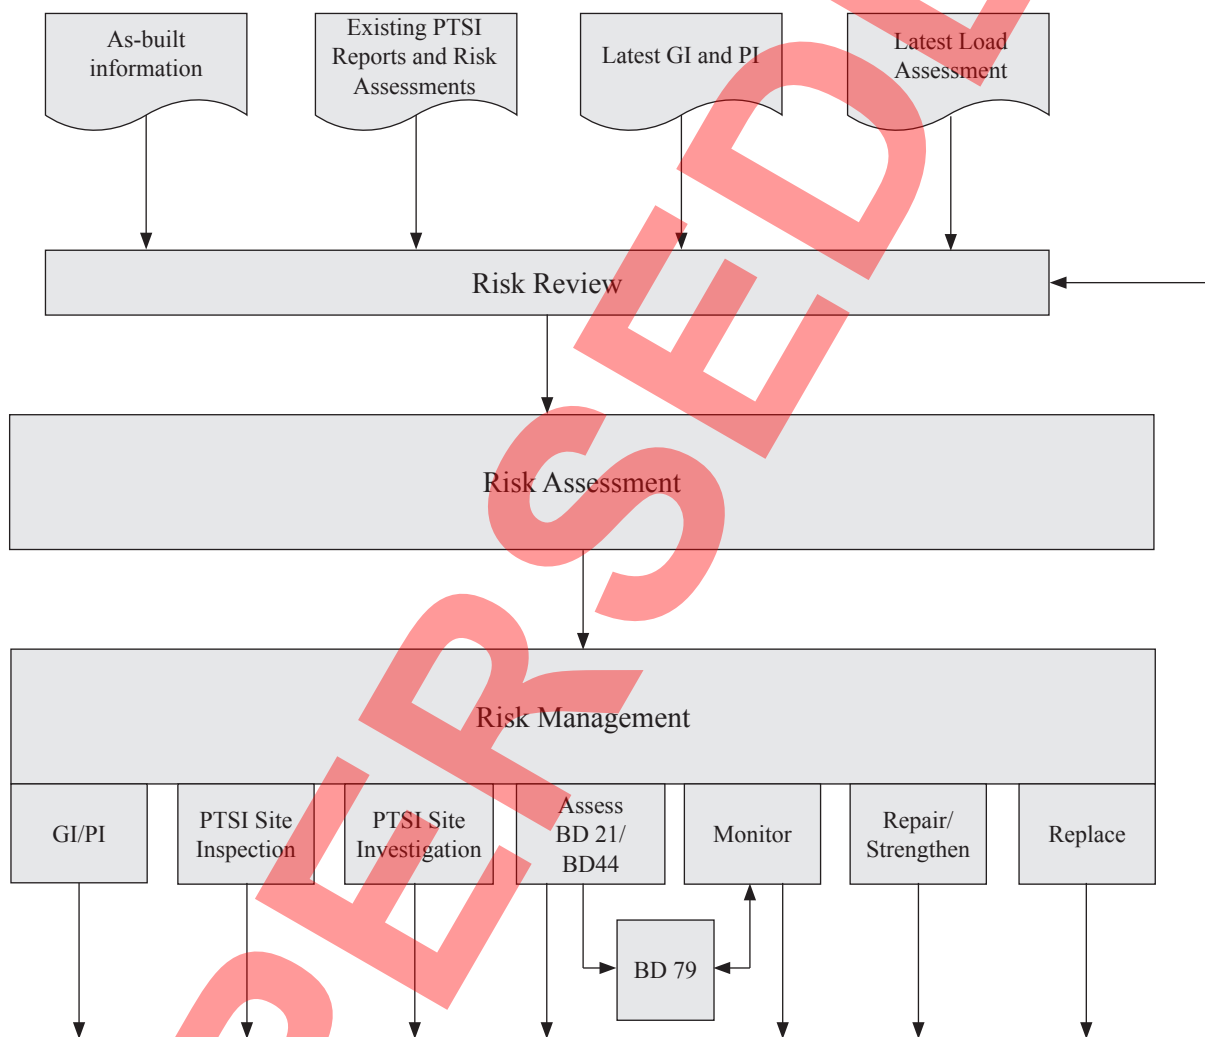
2.1 An ongoing system of Risk Review, Risk Assessment and Risk Management will be used to provide assurance on the safety of the stock of post-tensioned concrete bridges. The overall process is illustrated by the flowchart in figure 2.1. The process starts with a Risk Review.

Figure 2.1 – Overview of the Risk Review, Risk Assessment & Risk Management System

- 2.18 The report should advise on the adequacy of any previous risk assessment and make a recommendation on the need for further risk assessment. The report should identify whether there is sufficient information available to undertake or update a risk assessment and the adequacy of any previous investigations at critical sections. Where the available information is not considered sufficient to carry out a viable risk assessment, for example missing information on material properties, section geometry, the prestressing system and reinforcement details at critical sections, recommendations on the action needed to collect the necessary information should be provided in the Risk Review Report. This is likely to involve use of the risk management tools identified in figure 2.1, typically a PTSI Site Inspection followed by a PTSI Site Investigation.

- 4.2 The risk management measures will typically be derived from the Risk Assessment and should be included in the Risk Assessment Report. Figure 2.1 shows some typical risk management measures. Routine Principal and General Inspections will apply to all bridges and these alone are likely to be sufficient for low risk bridges. Additional measures could include Special Inspections, PTSI, load assessment, monitoring, repair, strengthening and in extreme cases replacement of elements, decks or whole structures. Guidance on Principal and General Inspections can be found in BD 63 Inspection of Highway Structures (DMRB 3.1.4). Guidance on PTSI can be found in chapters 5, 6 and 7 of this standard. Refer to BD 21 and BD 44 for the requirements and guidance for load assessment. Guidance on monitoring is in chapter 8, repair in chapter 9 and strengthening in chapter 10 of this standard.

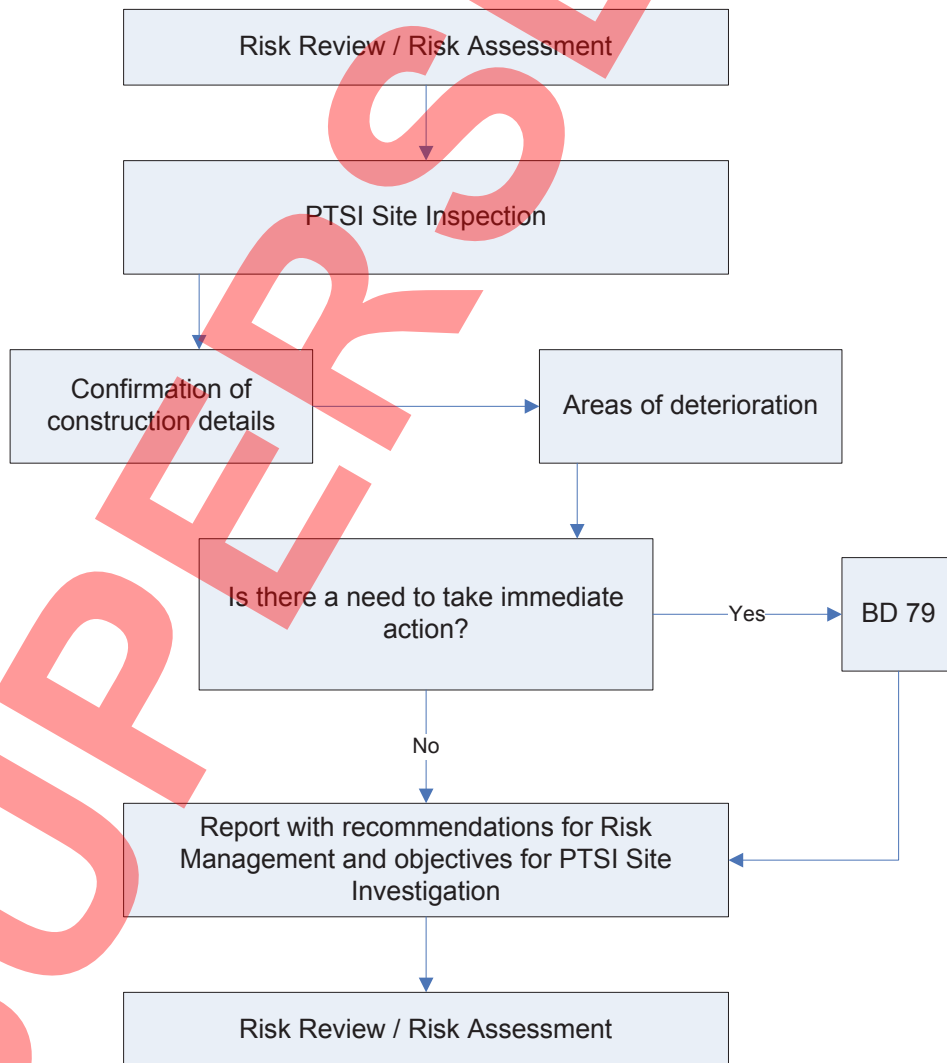
6.2 The basic steps relevant to the PTSI Site Inspection are illustrated in Figure 6.1. The Site Inspection is completed by a report, which reviews the findings and makes recommendations for consideration in a further Risk Assessment. If necessary the report should define the work to be carried out and the technical plan for the PTSI Site Investigation.

Figure 6.1 – Basic steps for a PTSI Site Inspection

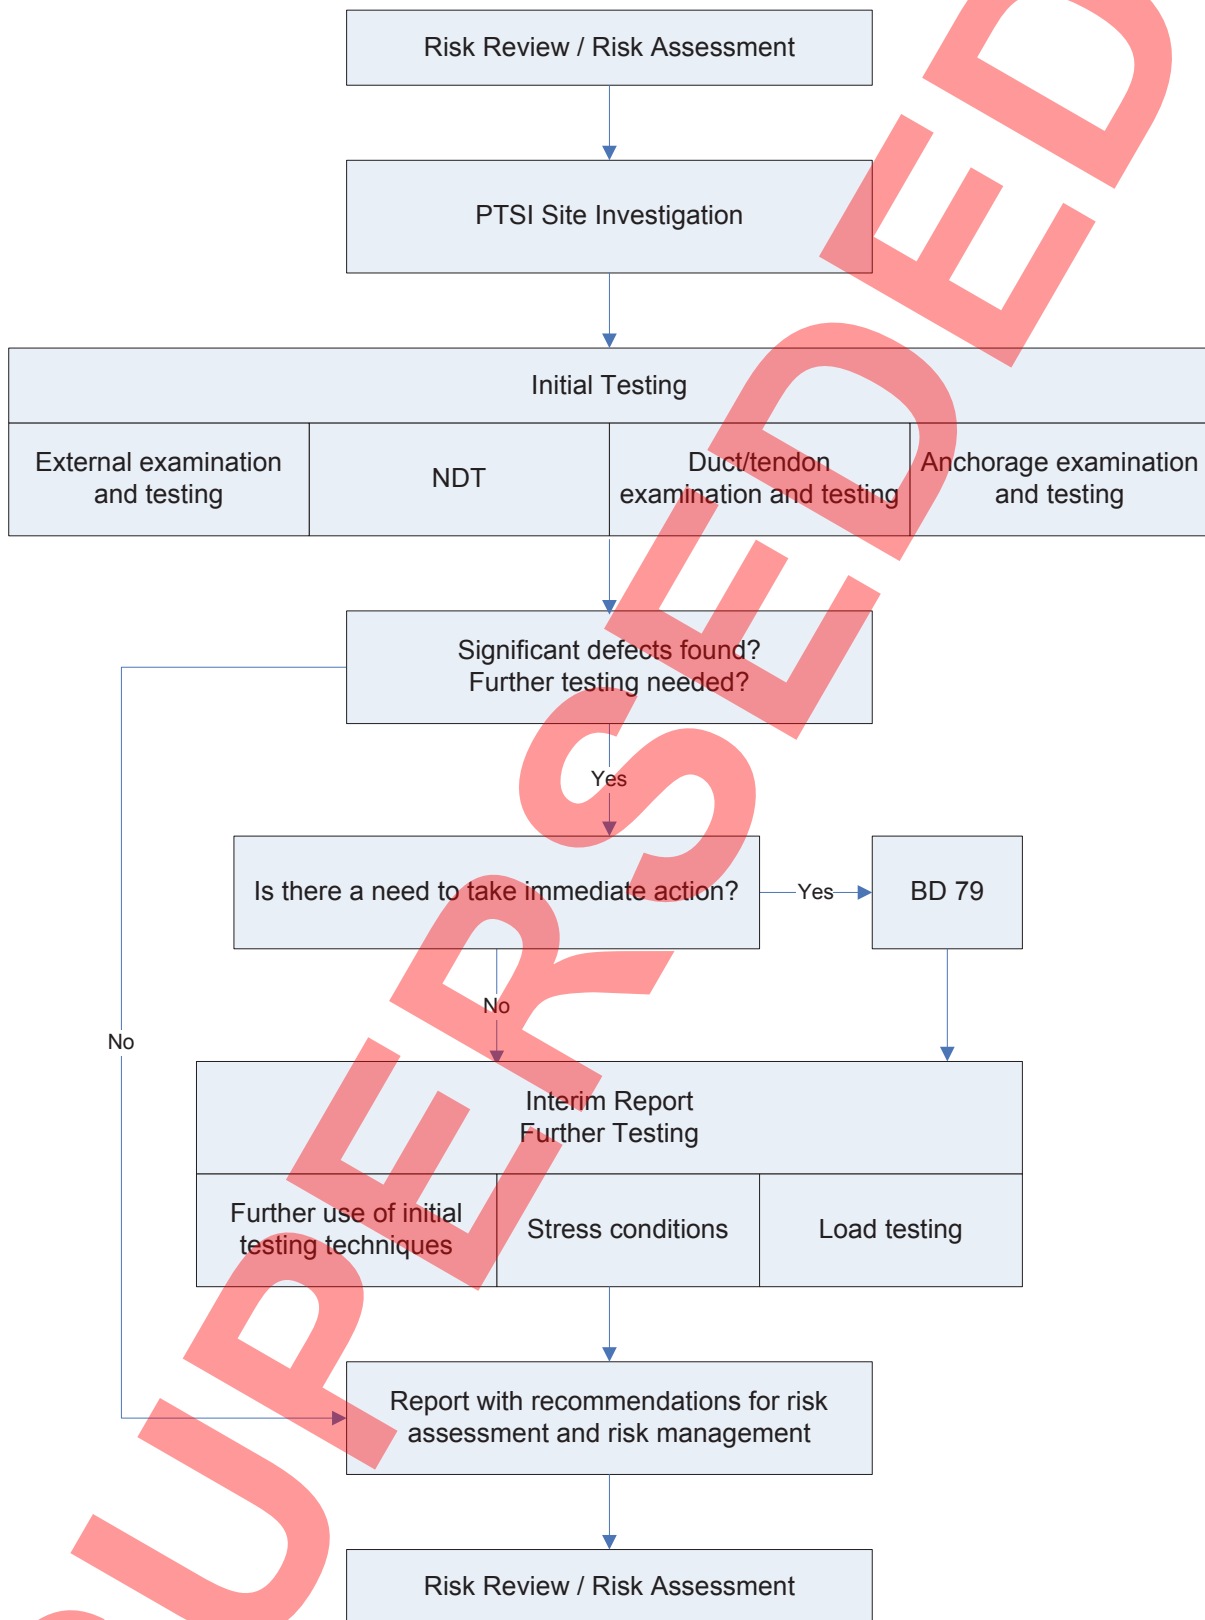
- 7.1 The general procedure for a Site Investigation is illustrated in Figure 7.1. In many cases, it may be sufficient to carry out only the initial testing tasks. Where problems are encountered and additional testing is considered necessary, then further investigation should be undertaken.

Figure 7.1 – Basic steps for a PTSI Site Investigation

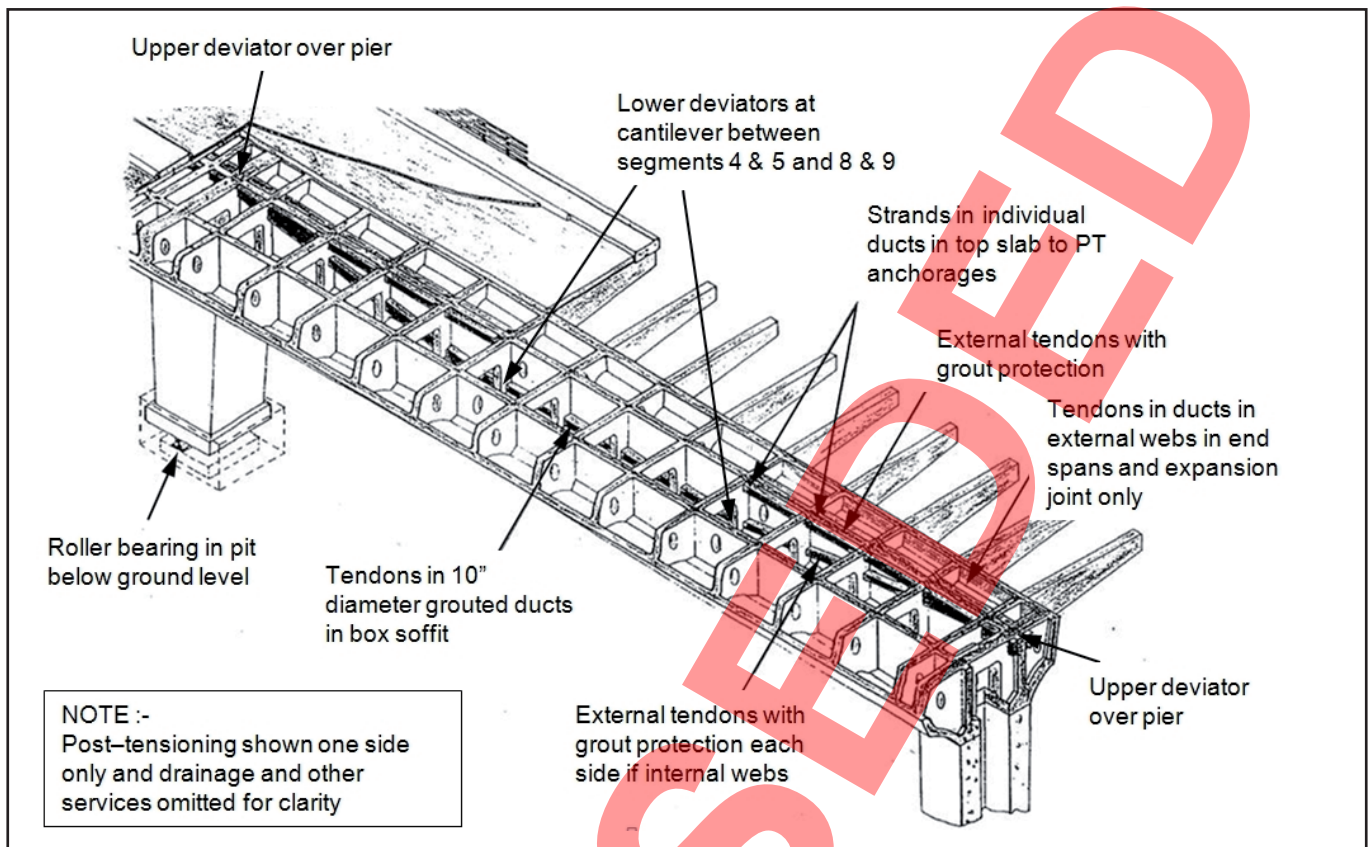
There are four tendons, one either side of (but external to) the inner webs. At mid-span, the tendons run in 254mm grouted ducts in the bottom slab of the spine beam. At 7.62m either side of mid-span, the strands are directed upwards via saddles to run externally along the webs, protected by a grout casing tied into the webs by reinforcement. Each tendon has minimum ultimate strength of 83.9 tonnes and comprises 16 No. 29mm strands of nineteen wires.

The tendons are arranged in overlapping groups, each passing through two spans and anchored at both ends in the top flanges of the beam on the far side of the extreme piers of the pairs of spans affected giving 50% more pre-stress at the piers than at mid-span.

**Figure B5.5.1 – Sectional view of post-tensioning layout in a typical span**
