**BD 54/15**

**MANAGEMENT OF POST-TENSIONED  
CONCRETE BRIDGES**

**SUMMARY**

This standard provides the requirements and guidance for the management of post-tensioned concrete bridges. It implements a risk based approach to management and includes advice on Special Inspections, monitoring, repairs and strengthening.

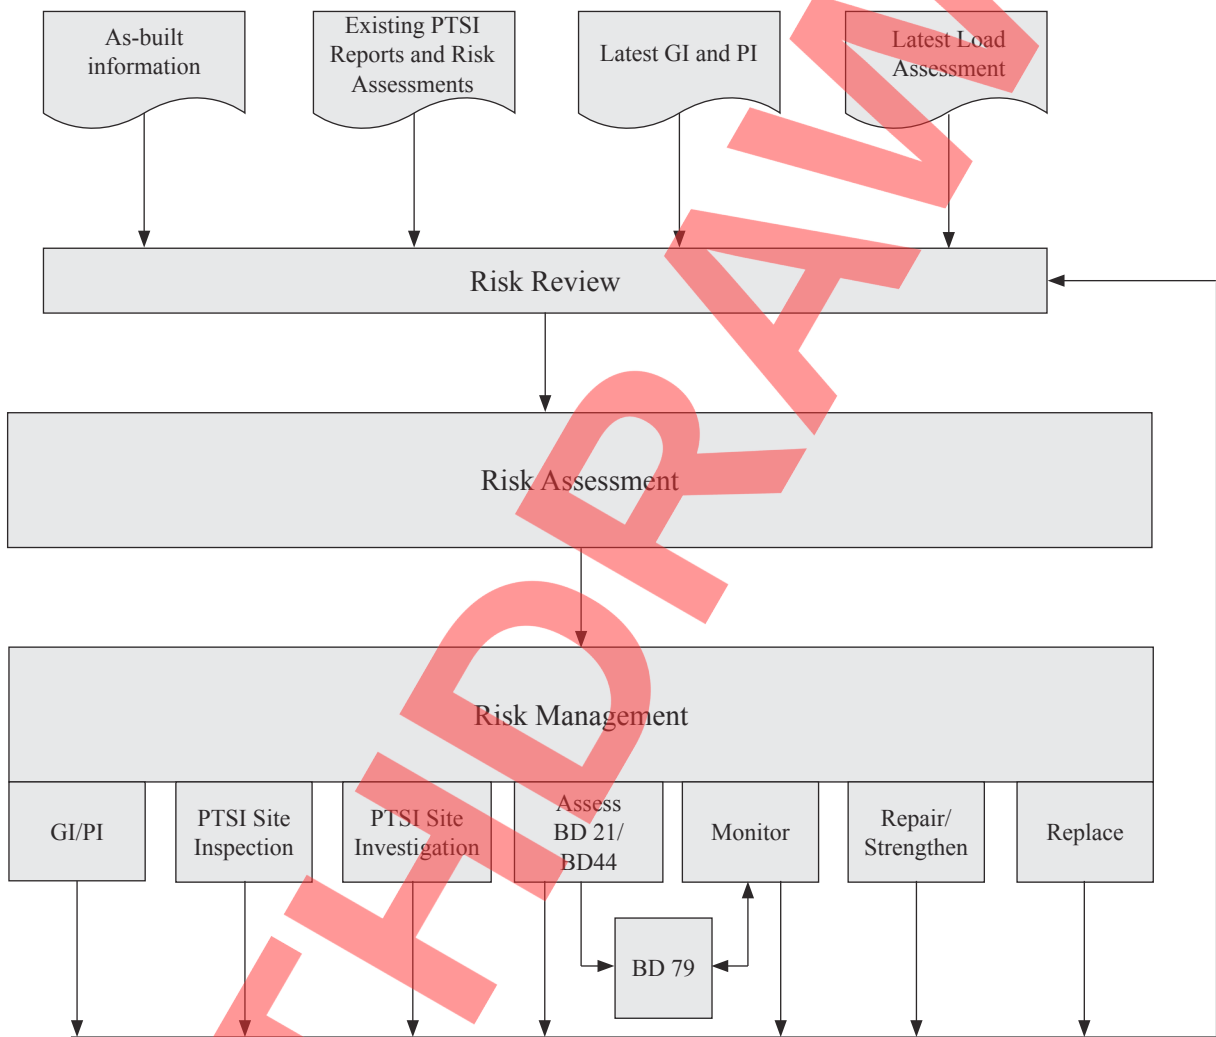
2.1 An ongoing system of Risk Review, Risk Assessment and Risk Management will be used to provide assurance on the safety of the stock of post-tensioned concrete bridges. The overall process is illustrated by the flowchart in figure 2.1. The process starts with a Risk Review.

Figure 2.1 – Overview of the Risk Review, Risk Assessment & Risk Management System

- 2.18 The report should advise on the adequacy of any previous risk assessment and make a recommendation on the need for further risk assessment. The report should identify whether there is sufficient information available to undertake or update a risk assessment and the adequacy of any previous investigations at critical sections. Where the available information is not considered sufficient to carry out a viable risk assessment, for example missing information on material properties, section geometry, the prestressing system and reinforcement details at critical sections, recommendations on the action needed to collect the necessary information should be provided in the Risk Review Report. This is likely to involve use of the risk management tools identified in figure 2.1, typically a PTSI Site Inspection followed by a PTSI Site Investigation.

- 4.2 The risk management measures will typically be derived from the Risk Assessment and should be included in the Risk Assessment Report. Figure 2.1 shows some typical risk management measures. Routine Principal and General Inspections will apply to all bridges and these alone are likely to be sufficient for low risk bridges. Additional measures could include Special Inspections, PTSI, load assessment, monitoring, repair, strengthening and in extreme cases replacement of elements, decks or whole structures. Guidance on Principal and General Inspections can be found in BD 63 Inspection of Highway Structures (DMRB 3.1.4). Guidance on PTSI can be found in chapters 5, 6 and 7 of this standard. Refer to BD 21 and BD 44 for the requirements and guidance for load assessment. Guidance on monitoring is in chapter 8, repair in chapter 9 and strengthening in chapter 10 of this standard.

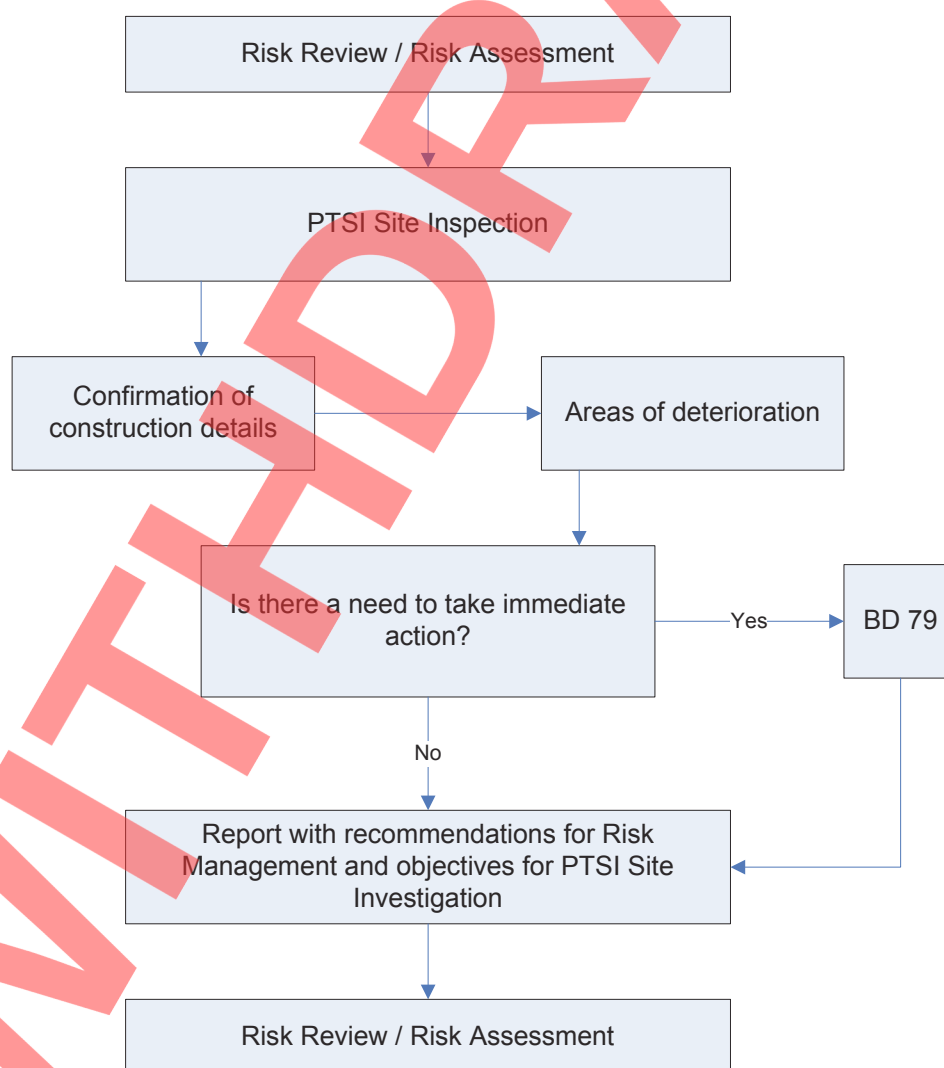
6.2 The basic steps relevant to the PTSI Site Inspection are illustrated in Figure 6.1. The Site Inspection is completed by a report, which reviews the findings and makes recommendations for consideration in a further Risk Assessment. If necessary the report should define the work to be carried out and the technical plan for the PTSI Site Investigation.

Figure 6.1 – Basic steps for a PTSI Site Inspection

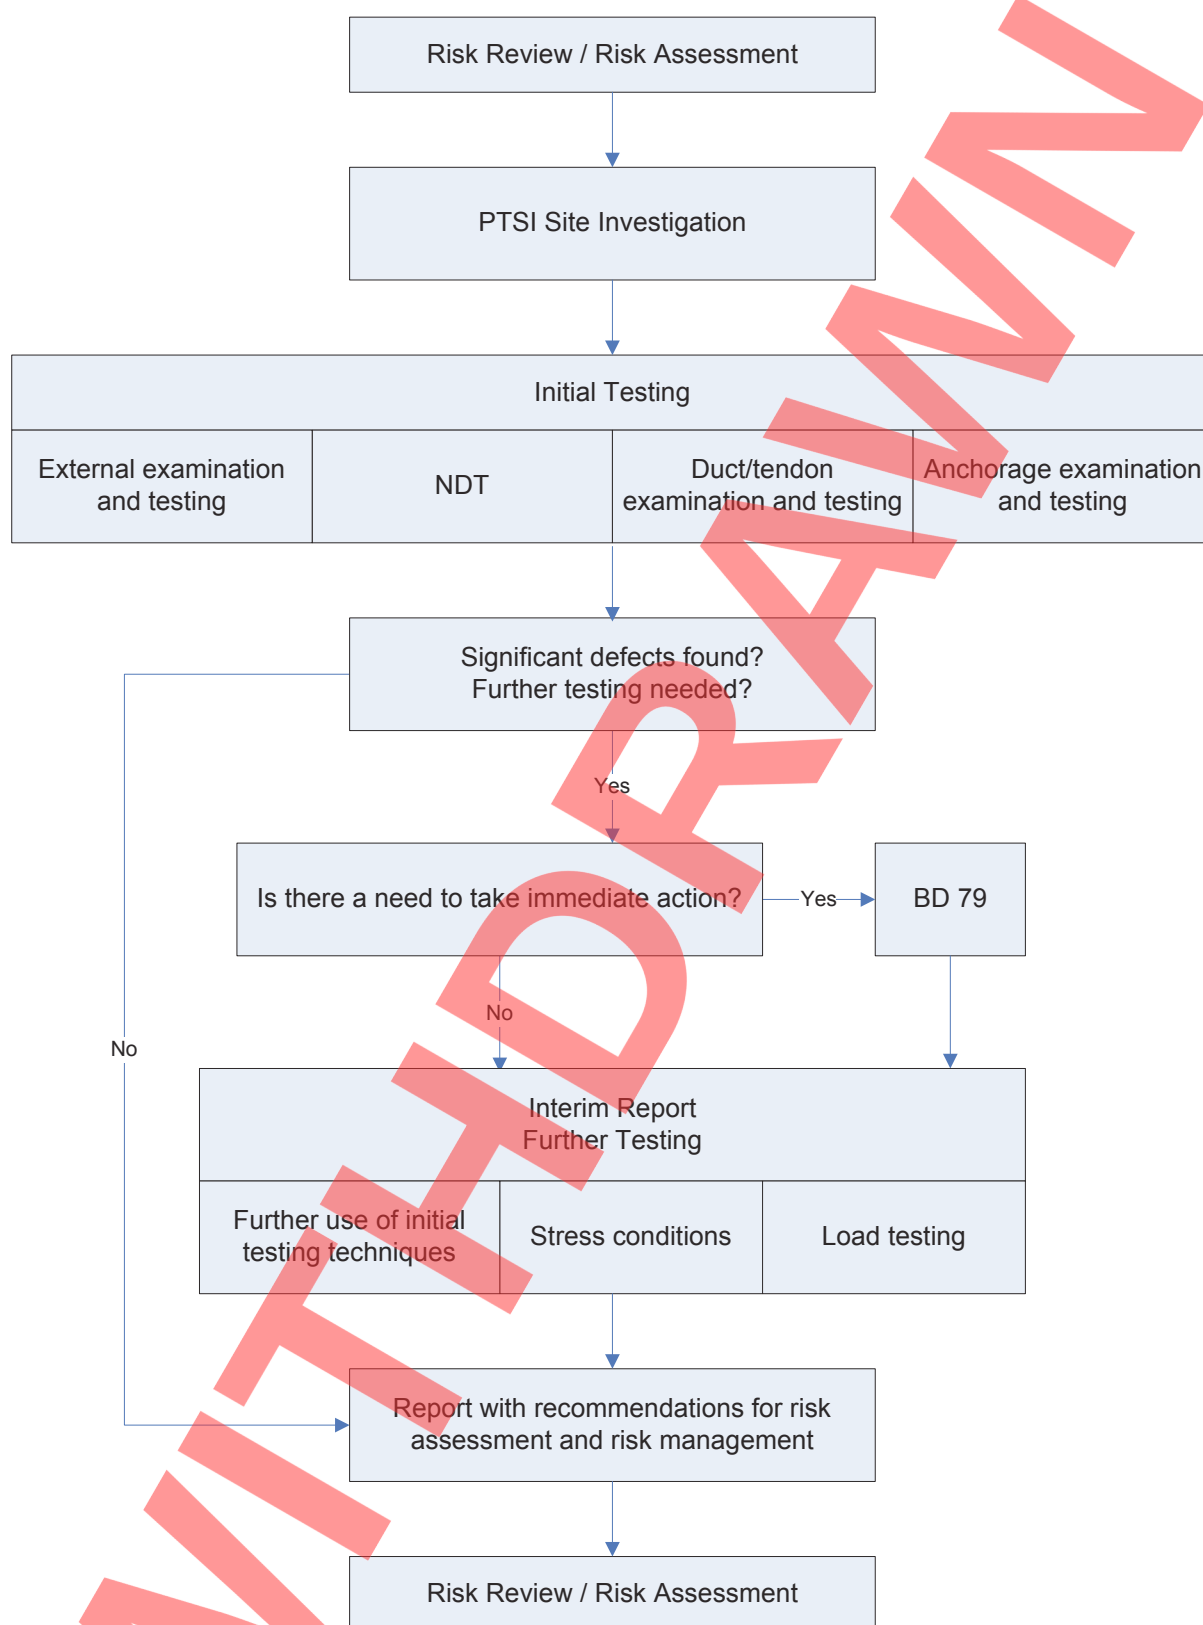
- 7.1 The general procedure for a Site Investigation is illustrated in Figure 7.1. In many cases, it may be sufficient to carry out only the initial testing tasks. Where problems are encountered and additional testing is considered necessary, then further investigation should be undertaken.

Figure 7.1 – Basic steps for a PTSI Site Investigation

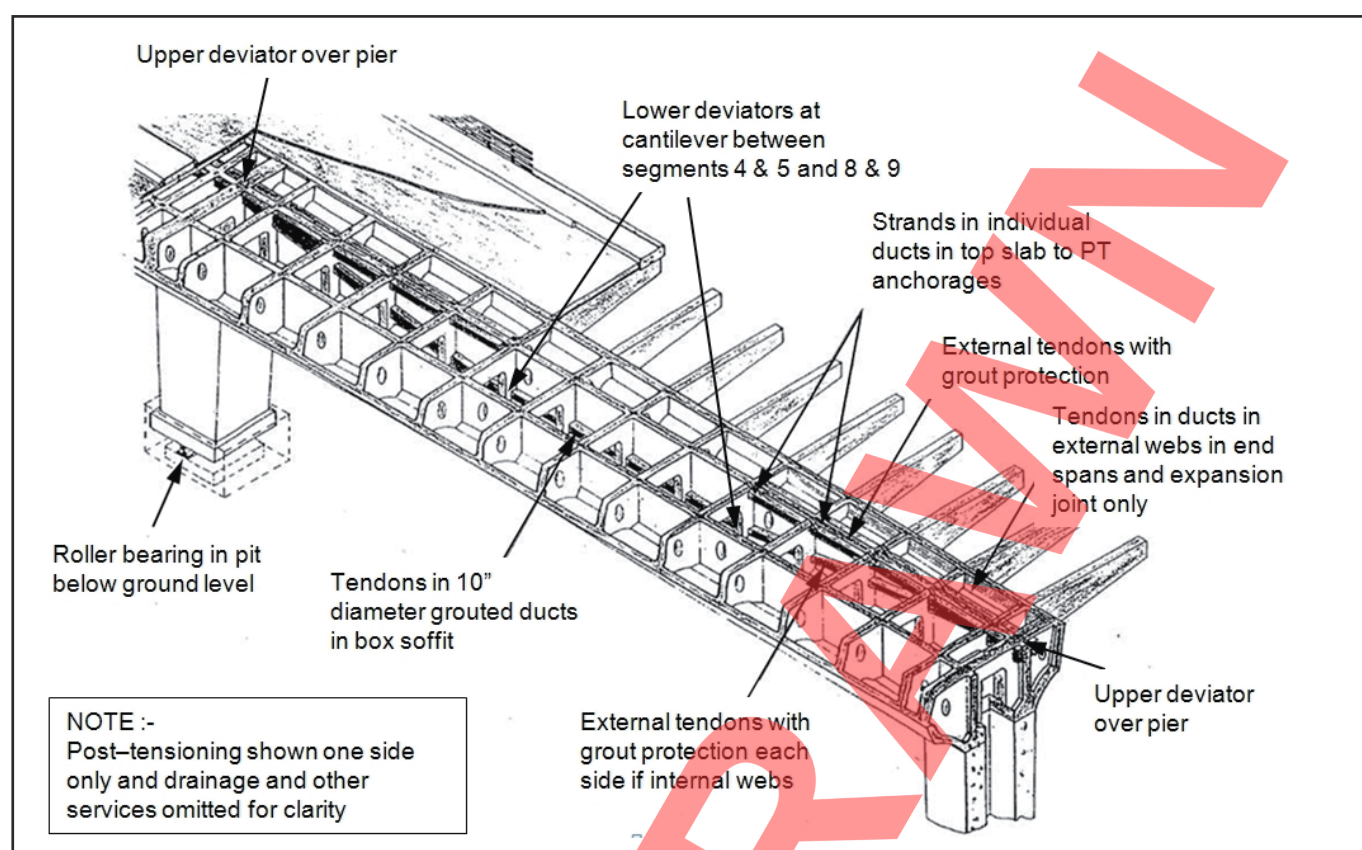
There are four tendons, one either side of (but external to) the inner webs. At mid-span, the tendons run in 254mm grouted ducts in the bottom slab of the spine beam. At 7.62m either side of mid-span, the strands are directed upwards via saddles to run externally along the webs, protected by a grout casing tied into the webs by reinforcement. Each tendon has minimum ultimate strength of 83.9 tonnes and comprises 16 No. 29mm strands of nineteen wires.

The tendons are arranged in overlapping groups, each passing through two spans and anchored at both ends in the top flanges of the beam on the far side of the extreme piers of the pairs of spans affected giving 50% more pre-stress at the piers than at mid-span.

**Figure B5.5.1 – Sectional view of post-tensioning layout in a typical span**
