**VOLUME 3 HIGHWAY STRUCTURES:
INSPECTION AND
MAINTENANCE**

BA 50/93

**POST-TENSIONED CONCRETE
BRIDGES
PLANNING, ORGANISATION AND
METHODS FOR CARRYING OUT
SPECIAL INSPECTIONS**

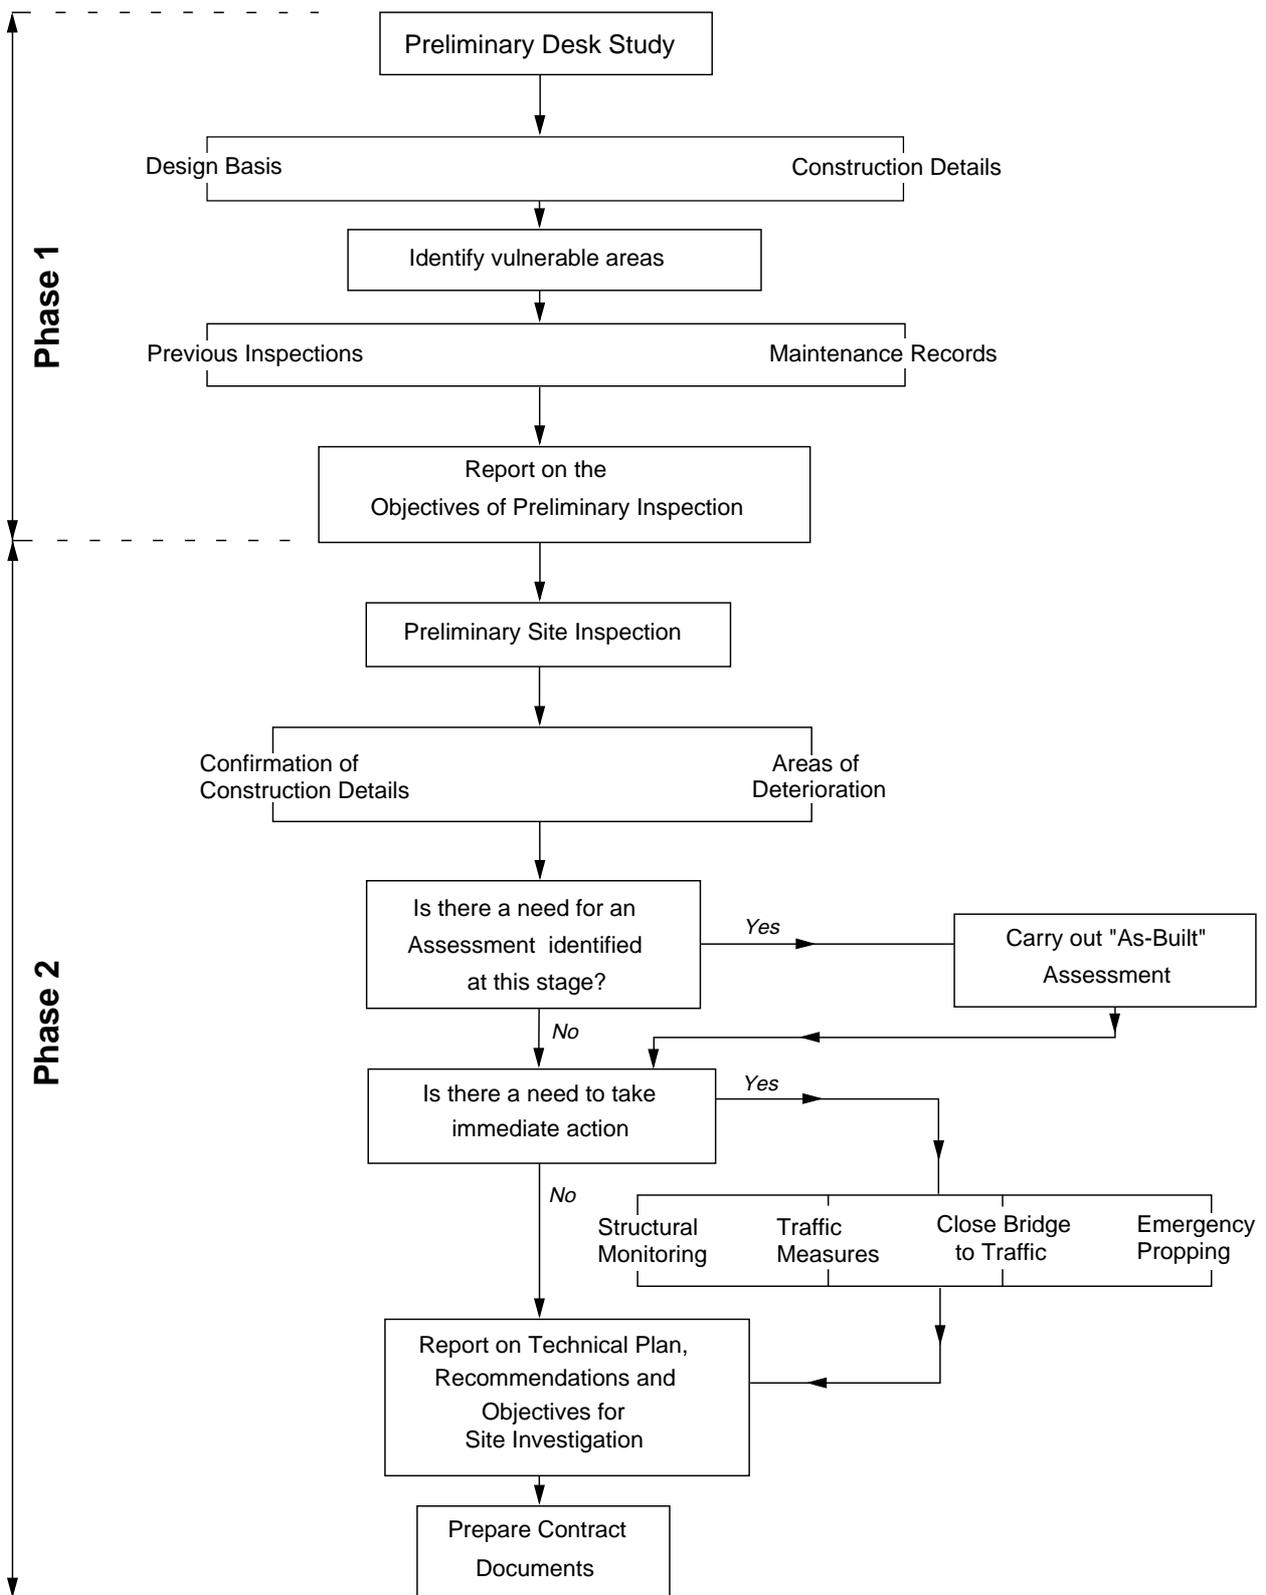
FIGURE 1 - BASIC STEPS FOR PLANNING A SPECIAL INSPECTION

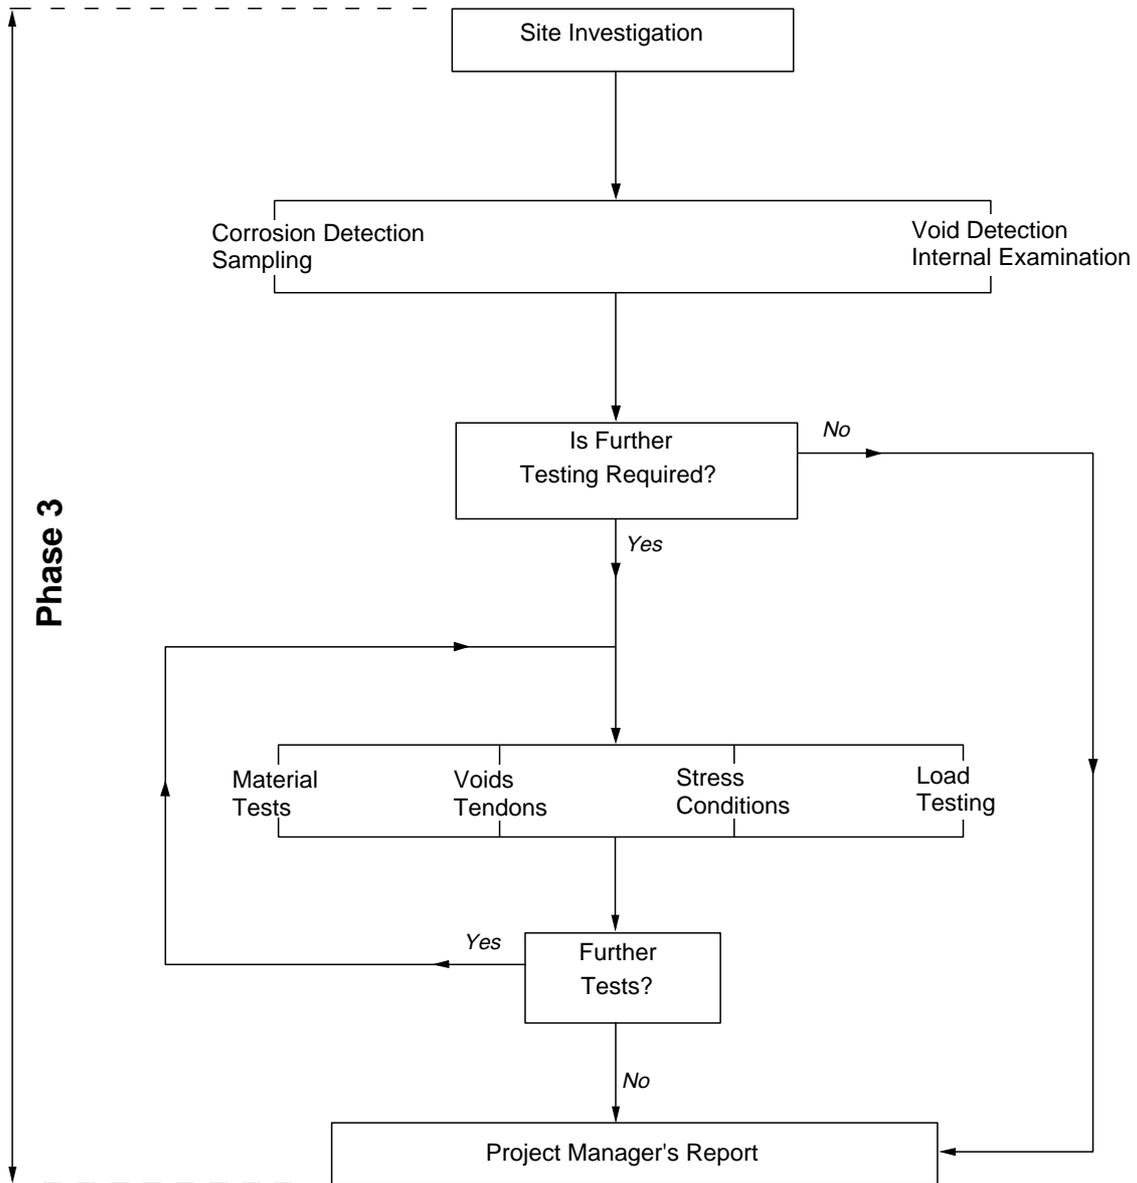
FIGURE 2 - GENERAL PROCEDURES FOR A SITE INVESTIGATION
