BA 50/93

**POST-TENSIONED CONCRETE
BRIDGES
PLANNING, ORGANISATION AND
METHODS FOR CARRYING OUT
SPECIAL INSPECTIONS**

This Advice Note outlines the organisation and planning procedures for carrying out Special Inspections of post-tensioned concrete bridges. It includes advice on the application of general and specialised methods of inspection and testing.

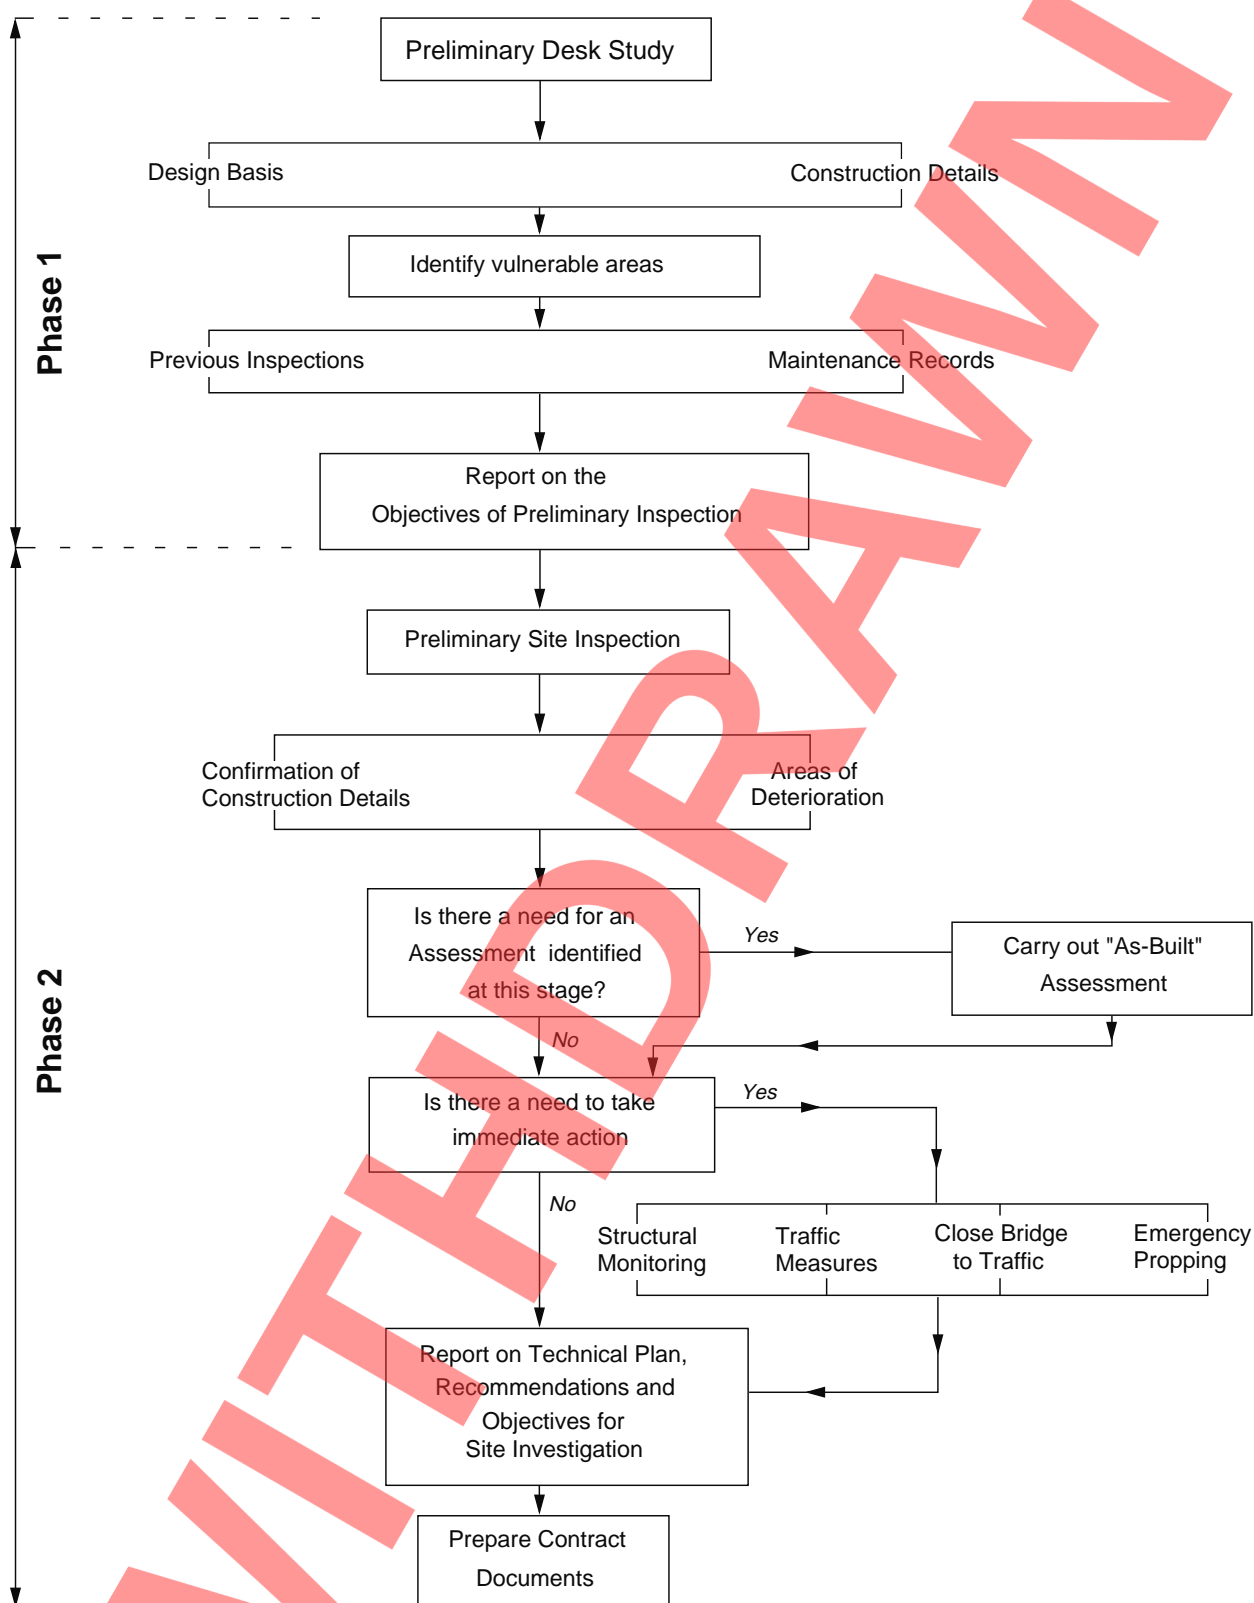
FIGURE 1 - BASIC STEPS FOR PLANNING A SPECIAL INSPECTION

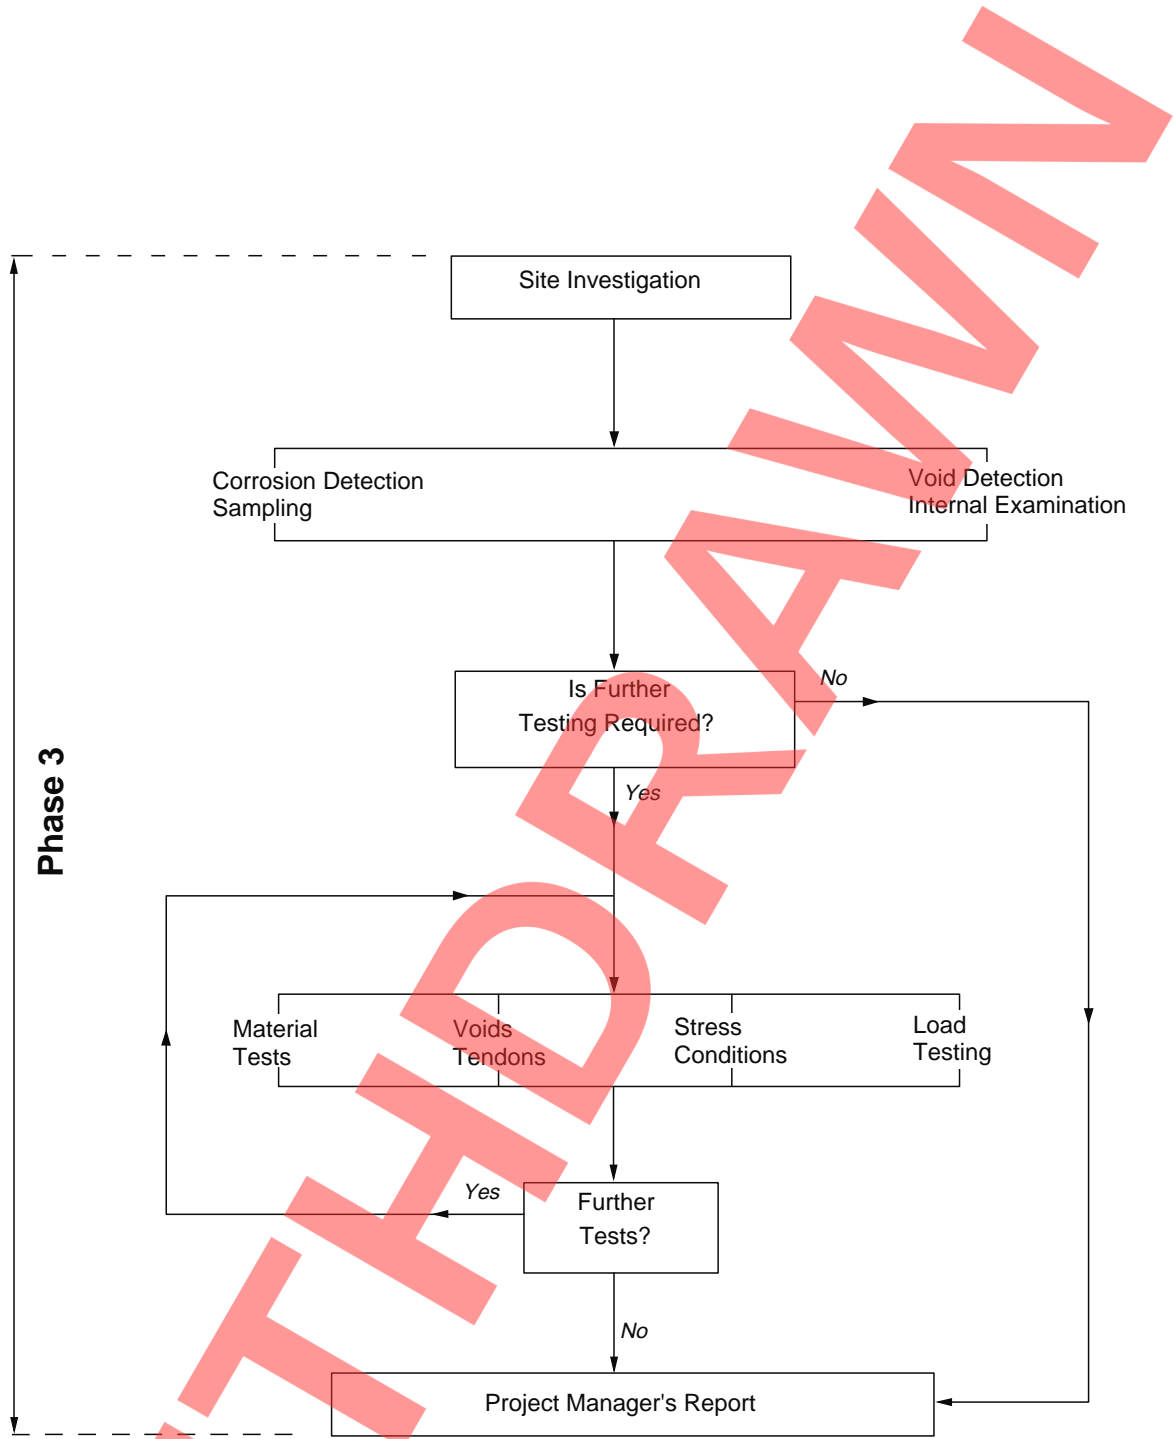
FIGURE 2 - GENERAL PROCEDURES FOR A SITE INVESTIGATION
